A-036/2001

TECHNICAL REPORT

**Accident of EUROCOPTER
AS-350-B3, registration
F-OHCU, in Gorges de Nuria,
Queralbs (province of
Girona) on 26 June 2001**

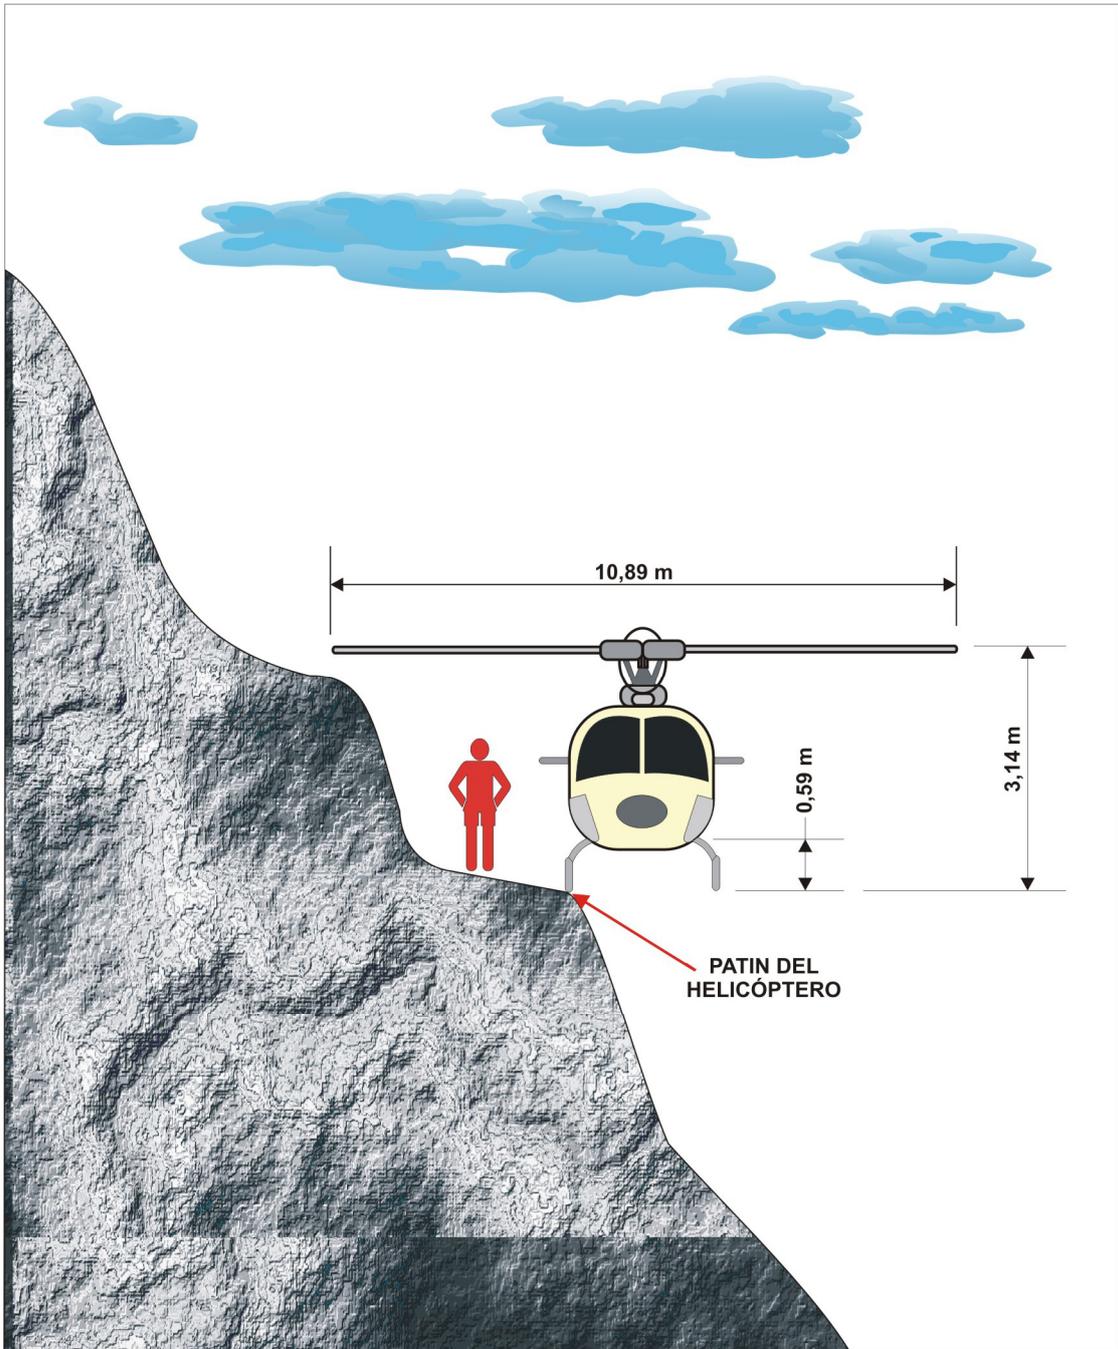
Zone of the accident

Disembarking of personnel and equipment was to take place on a small, almost horizontal ledge (see diagram in Appendix A), its width being under two metres, following an inclined path at the steep rocky face where the aforementioned rack railway tracks are located. The ledge is situated in the upper part of the mountain, some 1,600/1,700 metres of altitude and at 200 metres from the end of the first tunnel of rack railway tracks in the Nuria direction.

The site to disembark was a very small mountain side flat area some 2 meter width. The recommended area of a helisurface should have 4 x 4 m as a minimum.

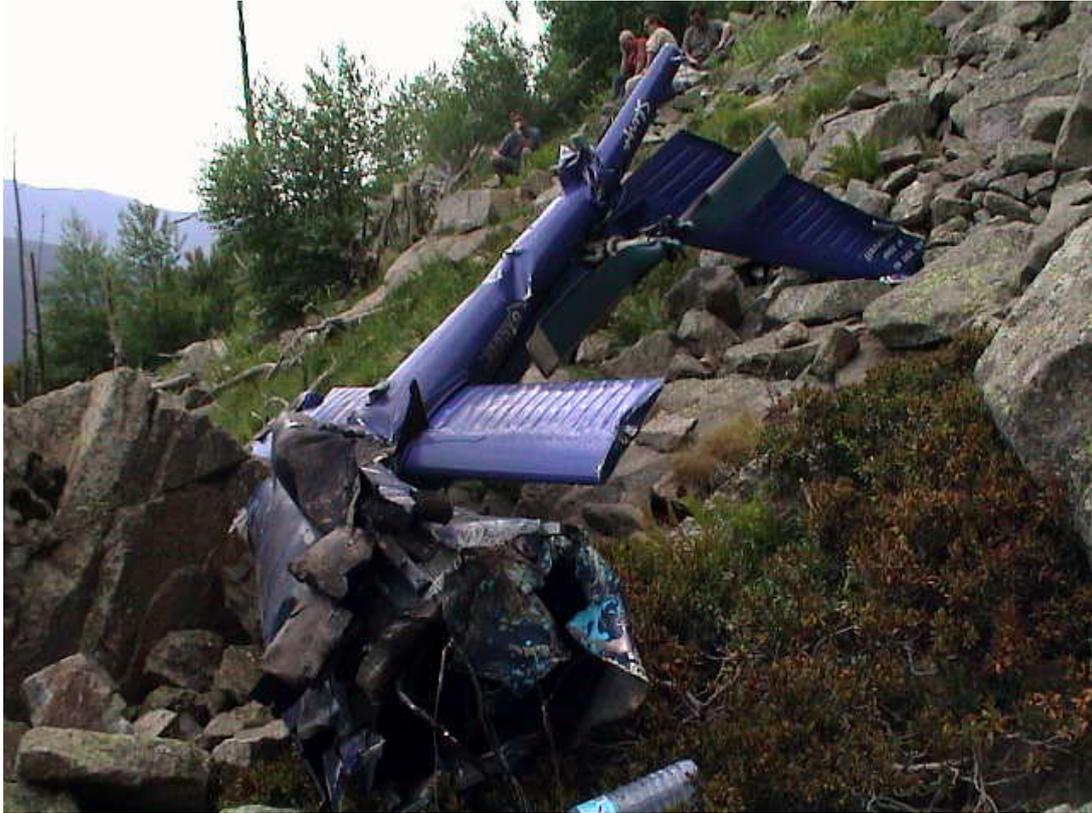
Figure 1.- Tail boom

Studying the wreckage you could see that the right forward door was on the highest area. On the right, 10 meters downhill, was the main rotor and some blades. Following the slope there was a blade beside the helicopter lower fuselage and at last, very close to the railway track, it was the tail cone almost without damages.

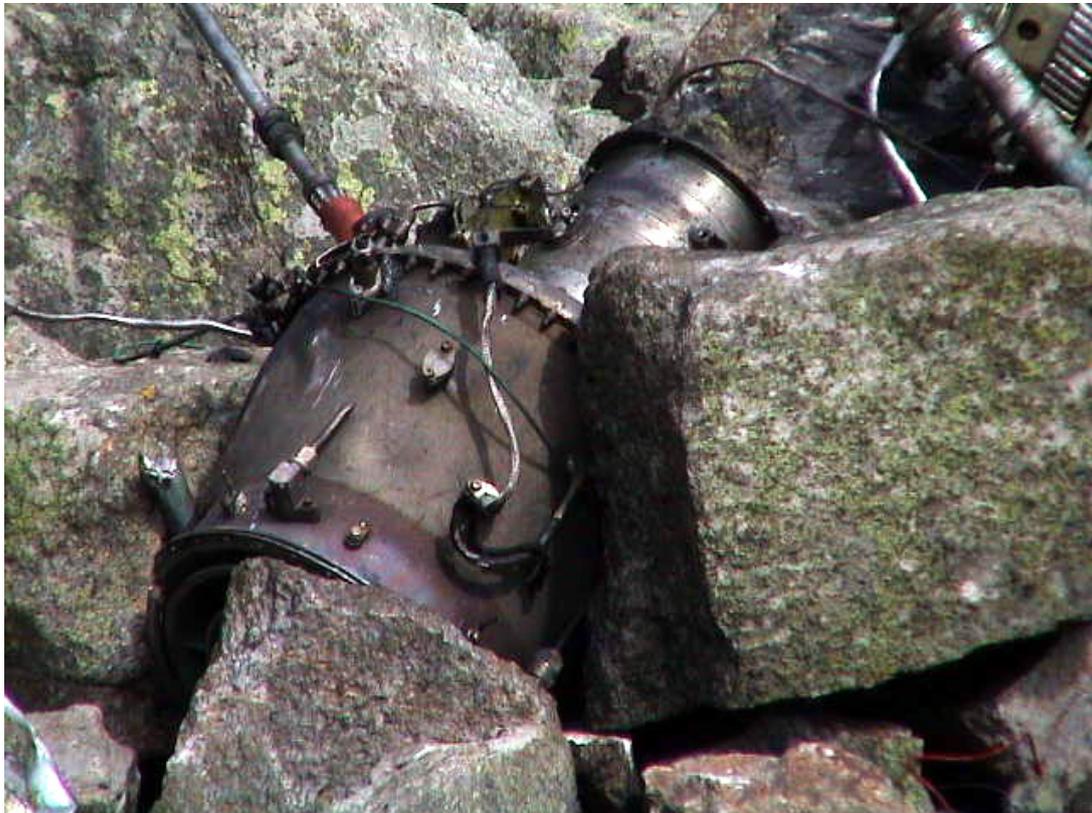
Figure 2.- Engine

This fact was confirmed by the data extracted from the recorder the aircraft had installed. Among them, the torque value of 140% must be highlighted. This is the maximum recordable torque value, and it largely exceeds the values achieved during normal flight conditions. It is considered that this value was reached when the main rotor blades hit the rocks. At that moment, the breakage of the shaft that joins the engine with the main gear box started and the torque began to descend to zero.

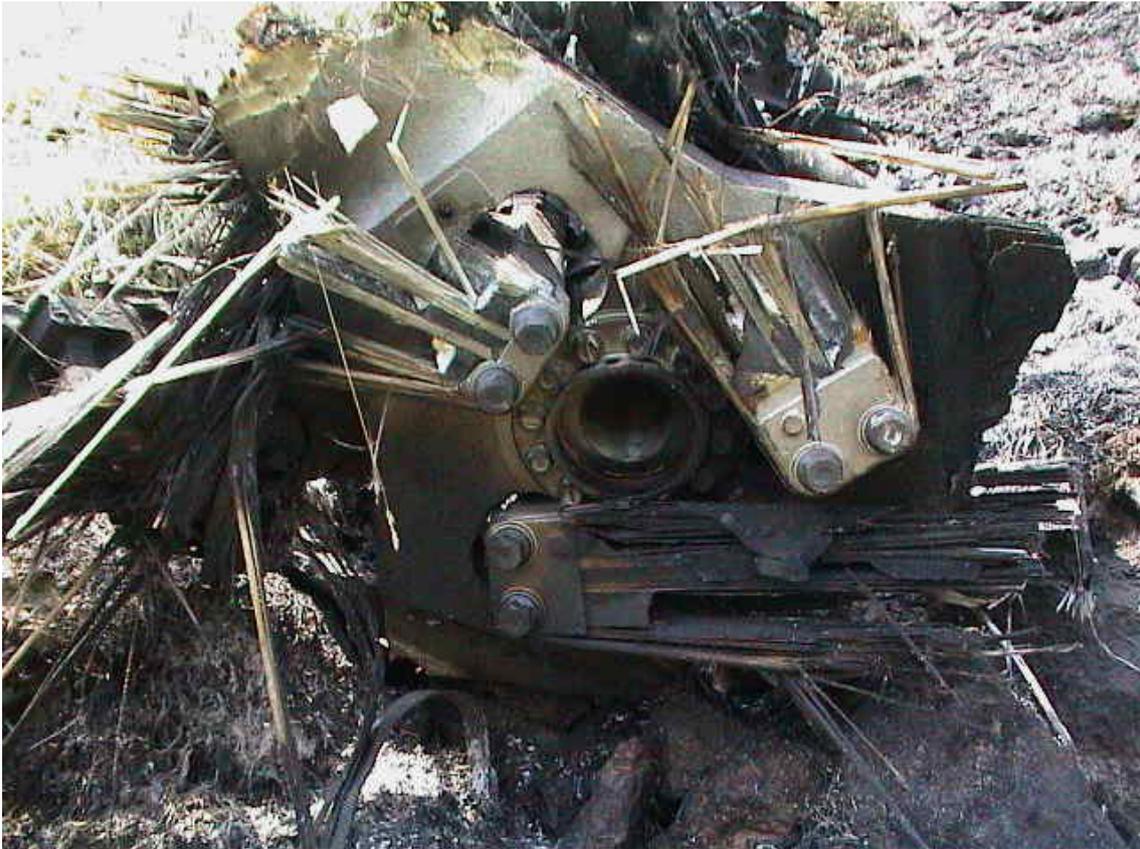
Figure 3.- Main rotor hub

The wreckage of the helicopter was scattered within a radius of some two hundred metres downhill from the point of impact. Some of the wreckage burnt, particularly, the main rotor mast and some of the blades which caused local fires.
