DATA SUMMARY

Date and time	Tuesday, 31 May 2005; 10:09 h UTC
Site	Tenerife Norte Airport (Santa Cruz de Tenerife)

Registration	TF-ATJ
Type and model	BOEING B747-400; S/N 24108
Operator	Air Atlanta Icelandic

Aircraft	Minor
Third parties	Several runway lights broken and scratches to the runway surface

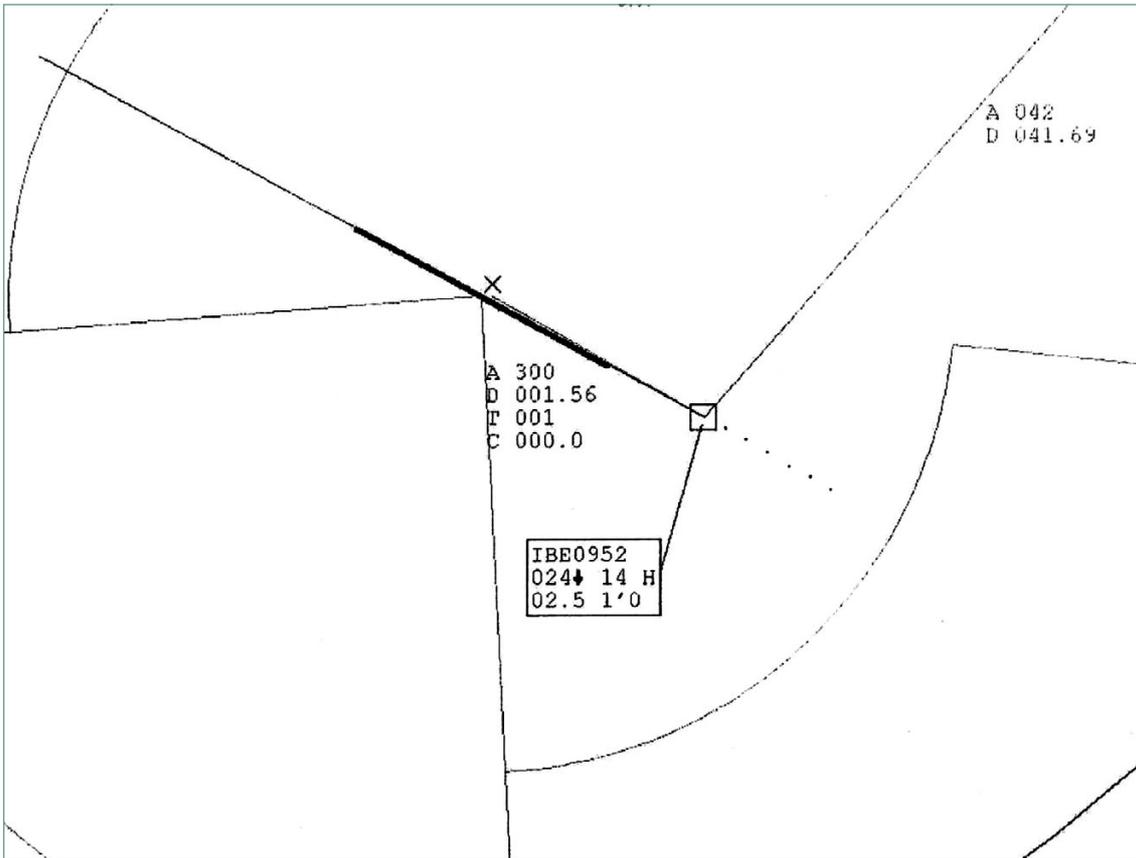
Figure 1. Radar Track image showing the aircraft aligned with the runway extended centreline on short final, descending through 2,400 ft and around 140 kt of groundspeed, at 10:04 h radar time

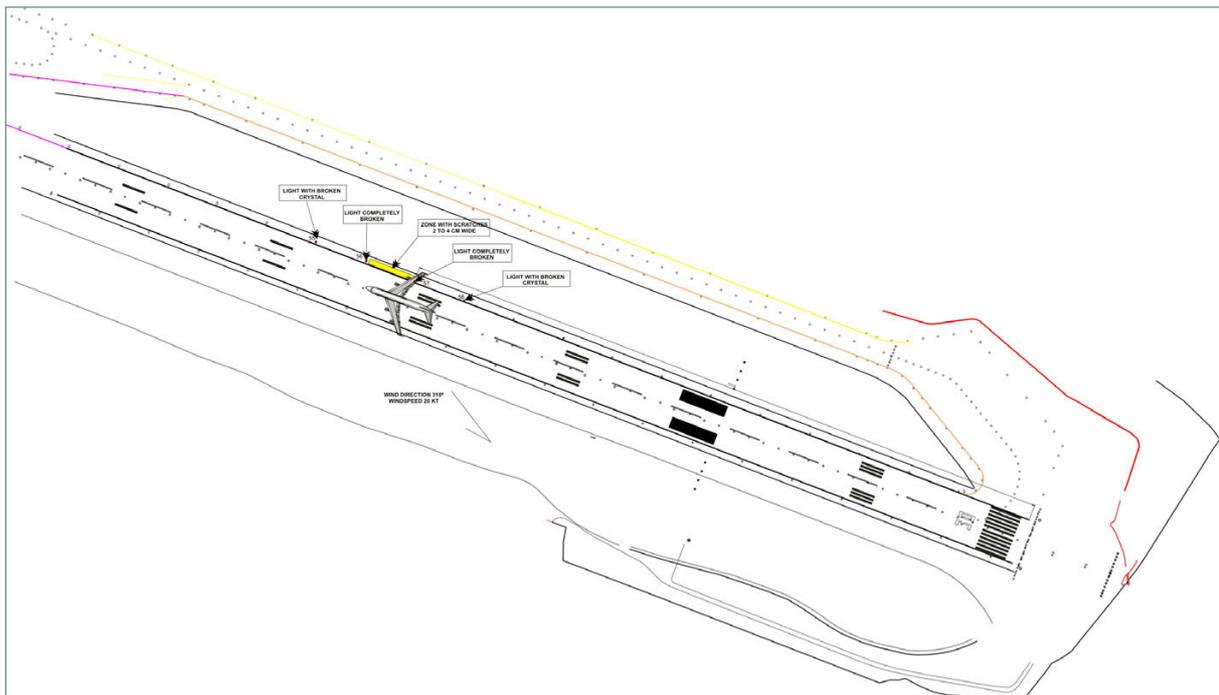
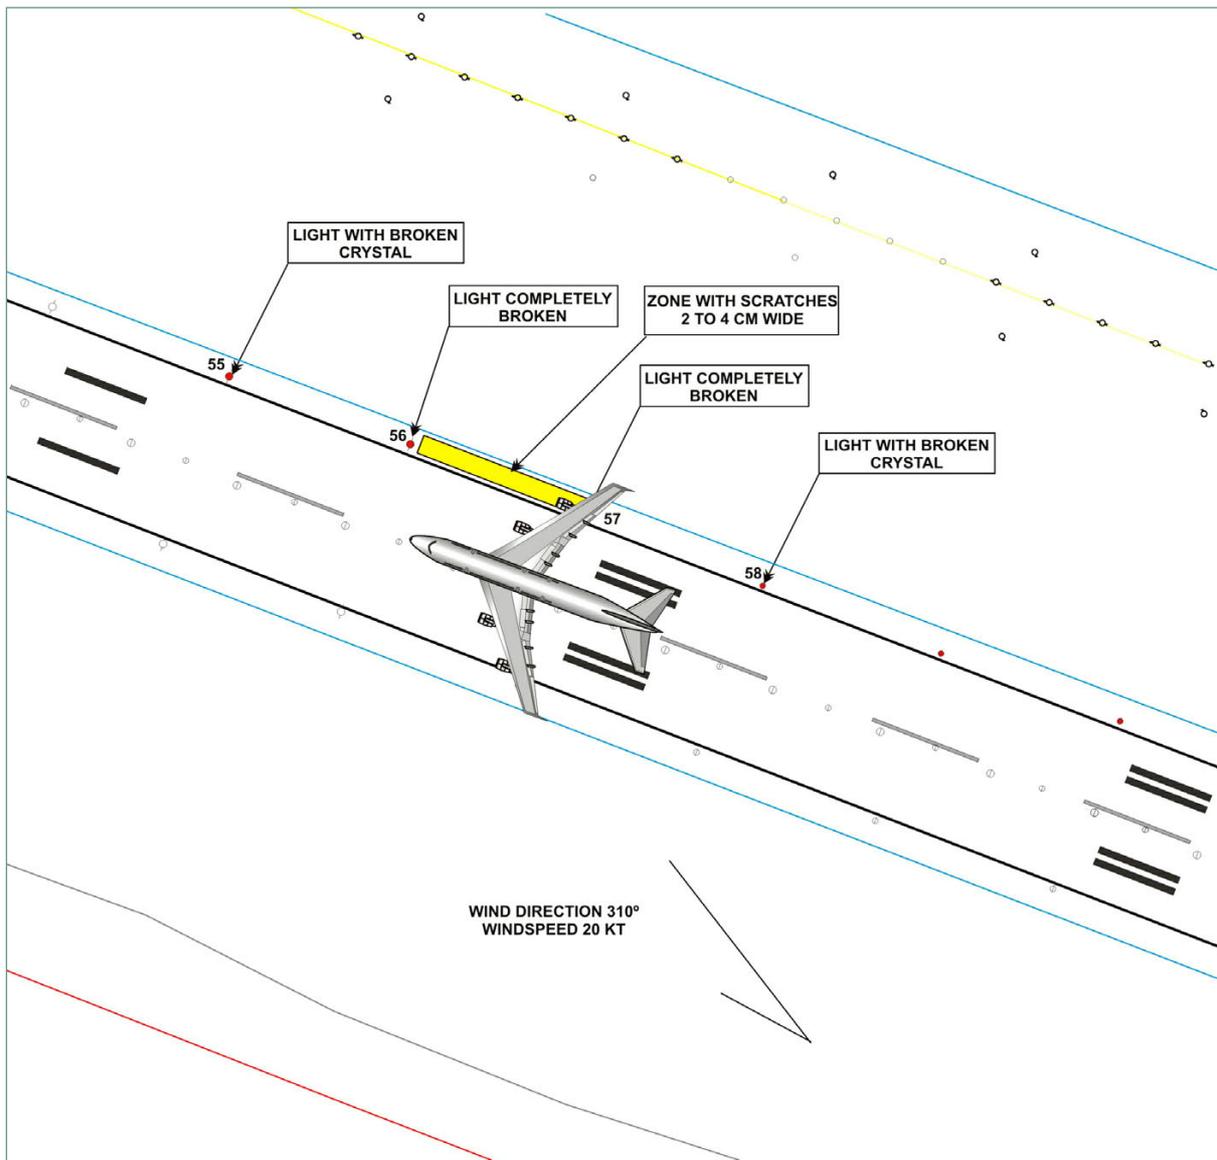
The flight crew advised the ATC at 10:27 h and a runway inspection was ordered. Two runway edge lights on the right side of the runway were observed to be completely broken. Two other lights showed broken glass. Between the two broken lights, there was an area of deep grooves and scratches some 2 to 4 cm in width (see Figure 2).

Figure 2. Drawing prepared by airport personnel after the runway inspection. Runway width is 45 m. Distance between lines of runway edge lights is 48 m. Distance from the longitudinal axis of the B747 to the outboard part of nacelle 4 is around 23 m

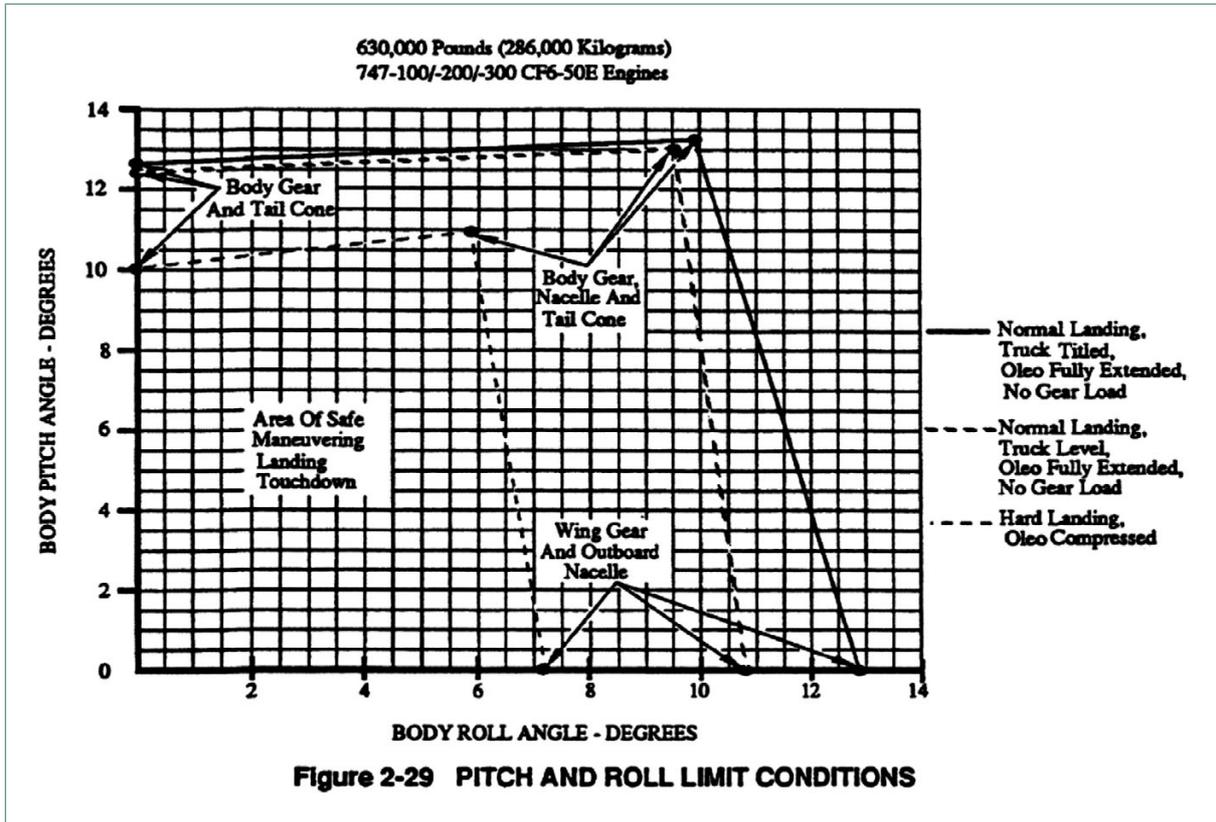
Figure 3. Pitch and roll limits conditions from the Boeing B747 Flight Crew Training Manual, page 2-52, 16 August 1993

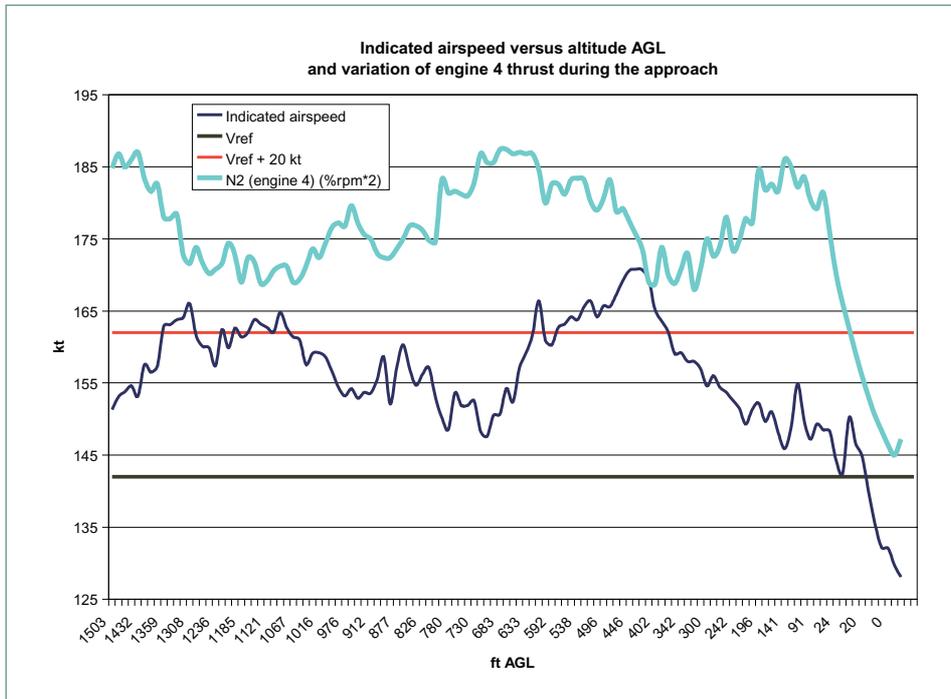
The available data showed that there had been an unstable approach. During the last 1,000 ft of altitude, the airspeed varied between 150 and 175 kt. Airspeed was higher than V_{ref} (142 kt) plus 20 kt (i.e. a total of 162 kt) from 700 ft to about 350 ft AGL. Below 200 ft, airspeed was around V_{ref} plus 12 kt. The recorded values of some parameters for the last seconds of the approach appear on Tables 1 and 2.

Figure 4 shows the variation of indicated airspeed with the altitude from 1,500 ft AGL.

Figure 4. Vref was 142 kt. The rotational speed N2 is multiplied by two for better readability (i.e. 95% RPM in reality is represented as 190 in the graph)

Later on, when descending through 1,000 ft, the flight crew remembered a shift in the wind direction that caused a sudden increase of indicated airspeed (IAS) and they took action to rectify conditions and adjust speed again. However, the FDR shows that airspeed was above 162 kt ($V_{ref} + 20$ kt) from 700 ft to about 350 ft AGL, with a peak of 171 kt for three seconds at around 400 ft AGL.

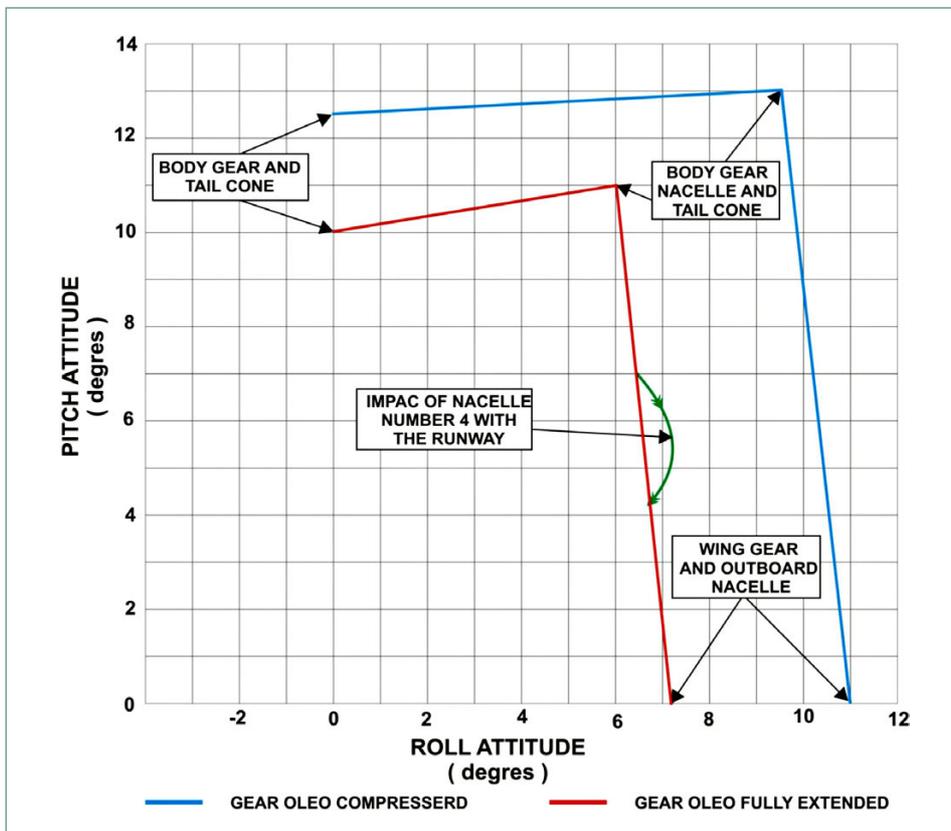
h, and maximum recorded vertical acceleration was 1.40 g with a roll of around 7.6° that exceeded the aircraft's ground contact envelope and caused the number 4 nacelle strike (see Figure 5). The lateral accelerations in the three seconds around touchdown were always negative (to the left) and were between -0.005 g and -0.176 g.

Figure 5. Exceedance of the geometric limits according to the FDR data

At 10:04:07 h, nine seconds before touchdown, the flare was initiated and it seems that it was at that point when the actual circumstances arose that directly led to the incident, with large control column and control wheel inputs that caused important pitch and roll angle variations that eventually (at around 10:04:16 h) exceeded the ground contact envelope for the outboard nacelle of the aircraft with the gear oleo compressed. The combination pitch/roll that caused the strike was between $6.7^\circ/7.6^\circ$ and $4.0^\circ/9.0^\circ$ respectively. The roll inputs were attributed by the crew to the wind conditions. However, the reasons for the large pitch changes during the flare are unclear. The analysis of the last seconds of the landing shows that it is possible that both the decrab and the flare were made somewhat prematurely (i.e. at a height above the runway higher than the optimum) given the unstable wind conditions being faced by the airplane at that moment.

The incident probably happened because the turbulent wind conditions at the airport caused the pilot flying to use large control inputs which resulted in the aircraft exceeding its geometrical ground contact envelope.

- REC 16/07.** It is recommended that Air Atlanta consider the possibility of providing the ground geometrical envelope of the Boeing B747-300 to the flight crews in an easily useable format, to increase their awareness of the danger of large control inputs during flare.

- REC 17/07.** It is recommended that Air Atlanta includes in the SOP of the aircraft standard callouts to be made by the PNF during the landing in the event the pitch or roll ground geometrical envelope limits of the aircraft are exceeded to avoid an impact of the wingtip, tail or nacelle with the runway surface.
