Report A-010/2013

Accident involving a Boeing 767-200 aircraft, registration XA-TOJ, operated by Aeromexico, during takeoff from the Madrid-Barajas airport (LEMD, Spain) on 16 April 2013

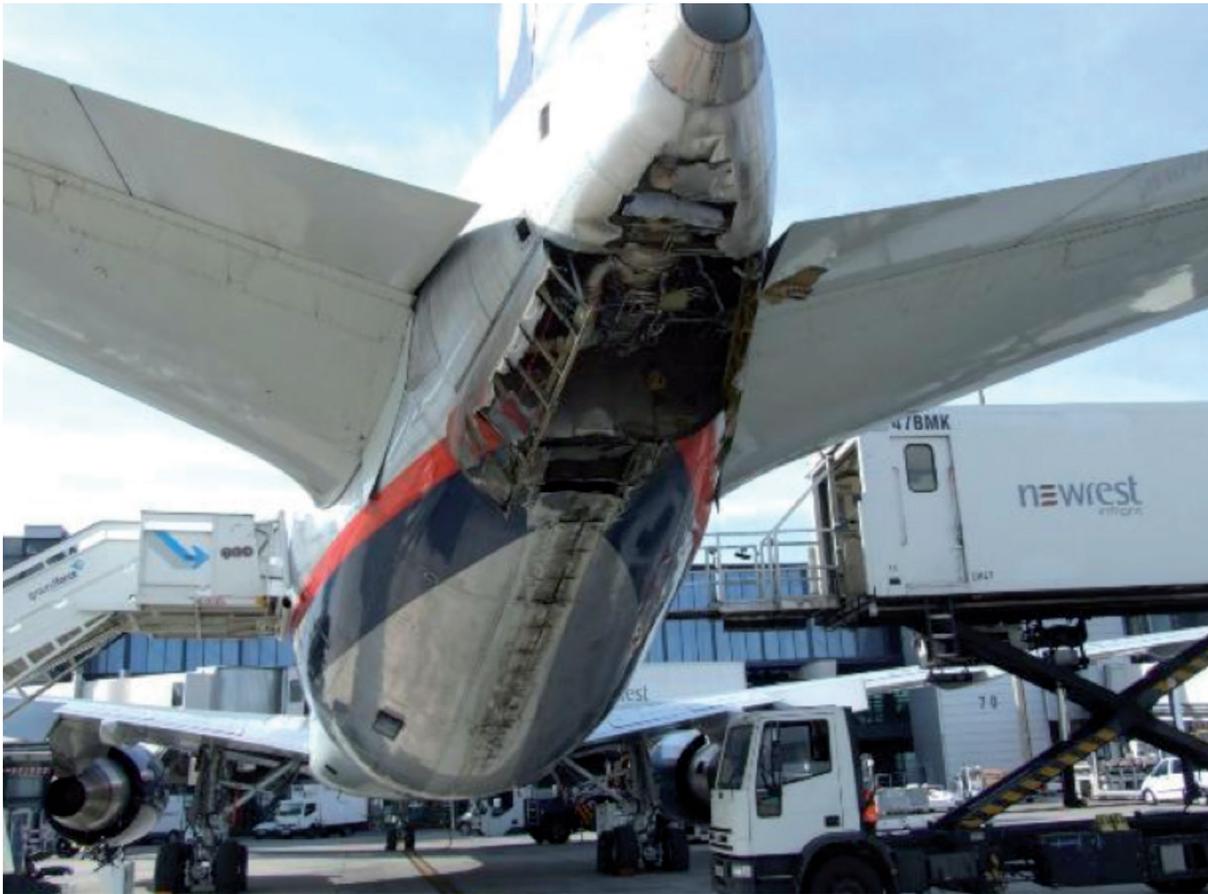
Figure 1. View of the aircraft after it reached its parking stand

The aircraft sustained structural damage to its tail assembly, to the APU housing, and to the trim on the aft door of the service hatch, with scraping and loss of material from

station 1480 to 1950. The main gear tires were also deflated by the thermal fuse plugs due to the brake overheating caused by the overweight landing.

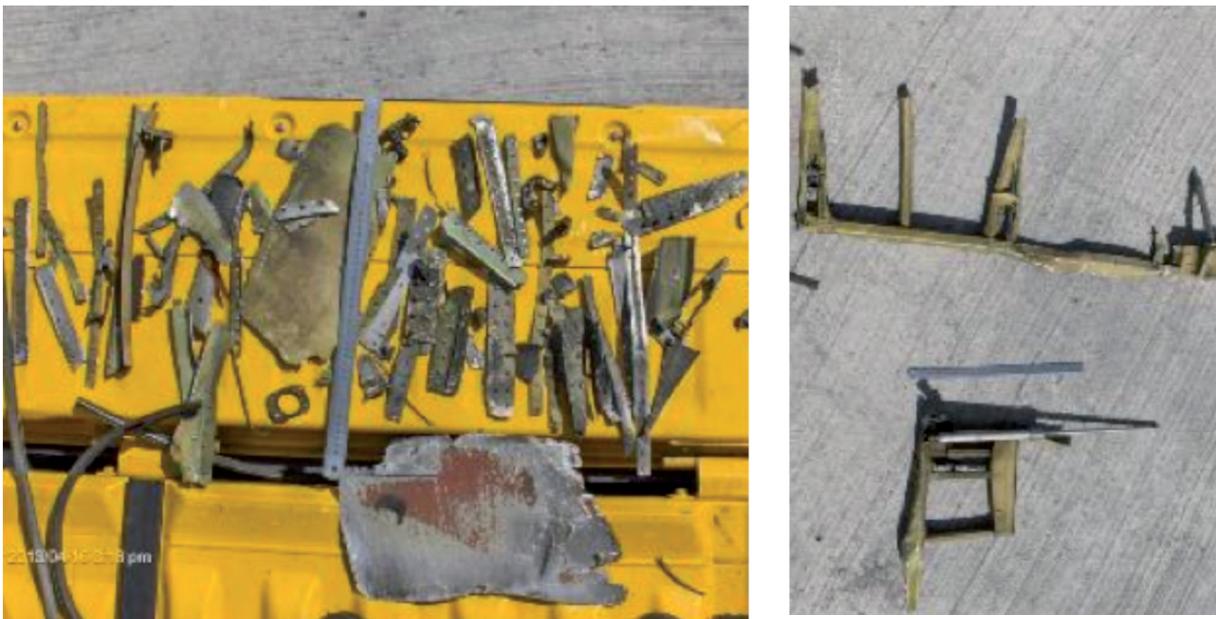
Figure 3. Pieces picked up by runway personnel in the last third of runway 36L

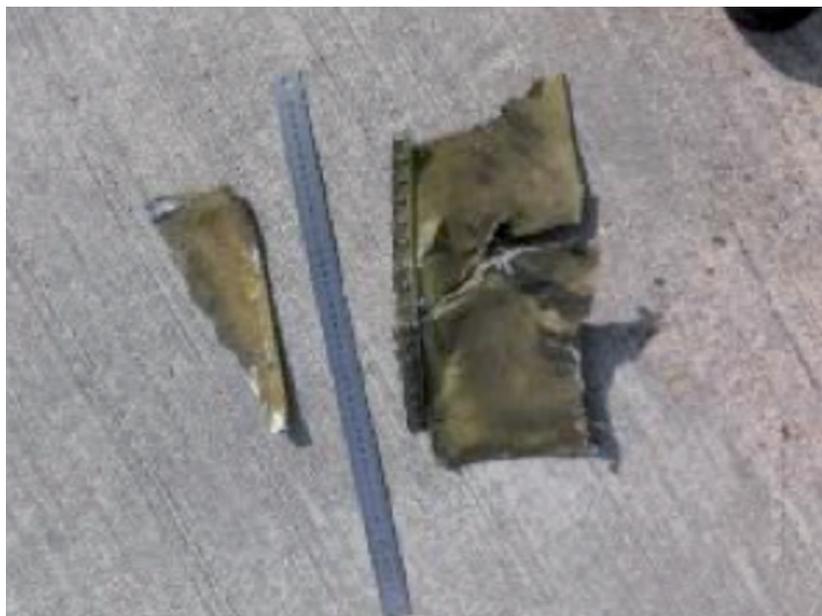
Figure 4. Pieces picked up by runway personnel in the runway 18L landing area

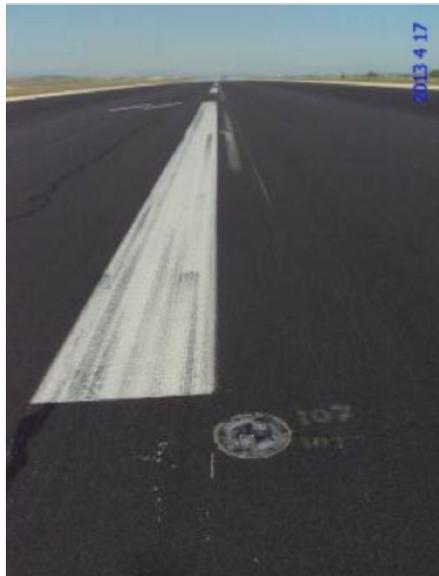
During the takeoff run, the aircraft damaged the runway pavement and several runway centerline lights with its tail (see Figure 5). Debris from the tail left on the runway then damaged the nose gear on an Air Europa A330-200, callsign AEA071, the eighth airplane to take off after the Aeromexico AMX002.

The runway used for takeoff (36L) showed damage along the entire section where the aircraft impacted it during rotation (see Appendix D). There were marks on the runway from light 107 (in the direction of takeoff, 360°) to 137. In all, the area affected was 525.4 meters long (see Figure 5).

Figure 5. Marks on the runway
