Report IN-036/2013

Incident involving a Boeing 737-800 aircraft, registration G-FDZG, operated by Thomson Airways, while on approach to the Fuerteventura airport (Spain) on 22 August 2013

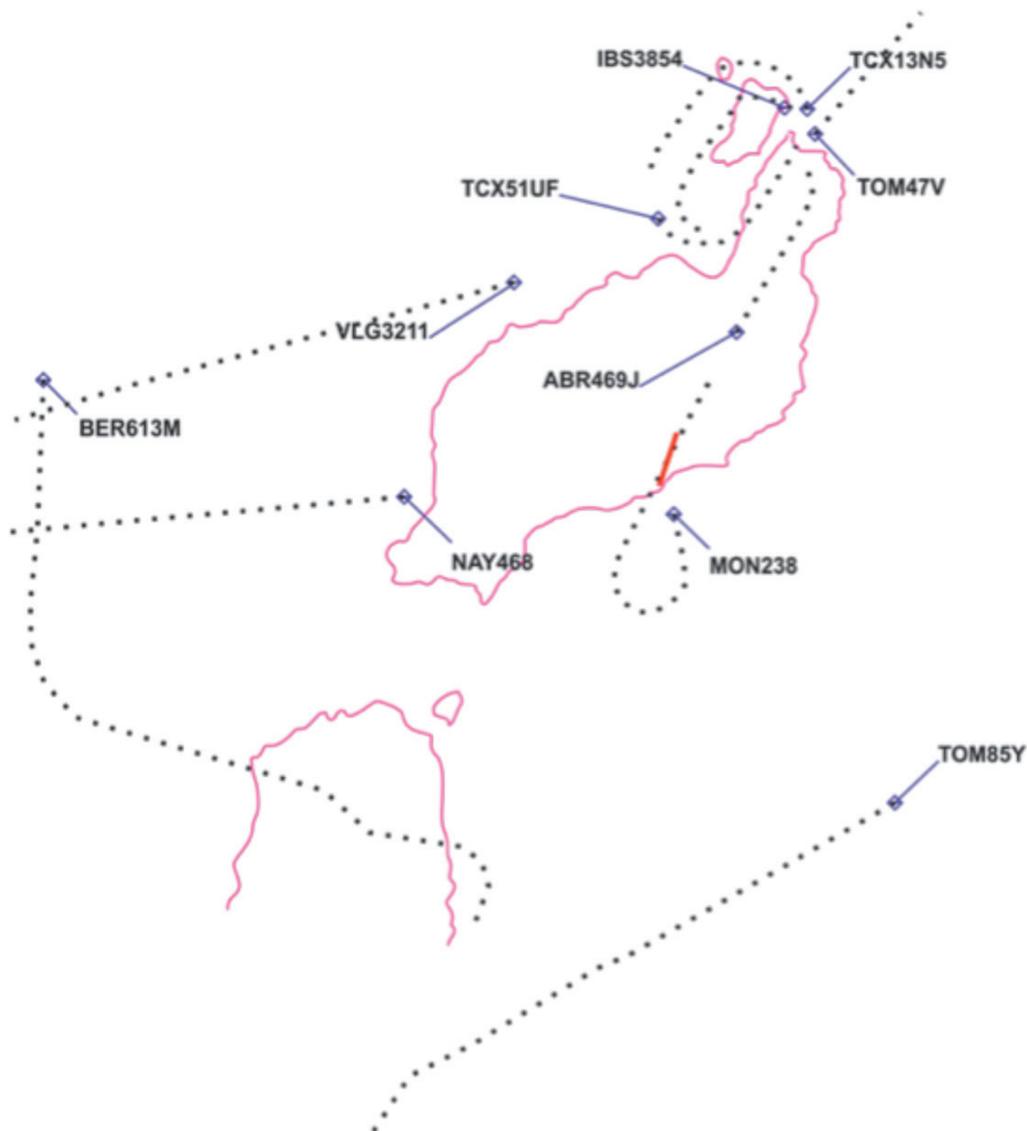
The traffic demand planned in the hour between 09:00Z and 10:00Z was for nine movements, a figure that increased to 13 and 17 in the following hourly intervals, which had the highest activity.

The Lanzarote tower had a single watchstander until the 10:00Z period, when an additional controller went on duty. The criterion used by SAERCO is to have a single controller on duty when 10 or fewer hourly operations are planned, to have two watchstanders with 15 or more operations planned, and to leave the number of watchstanders to the controllers' discretion when between 10 and 15. The stated capacity for the Lanzarote control tower is 22 movements per hour.

The Lanzarote tower controller saw that the wind readings in the tower would require changing the runway in use from 03 to 21.

This change coincided with the start of the period of peak activity for controllers in the AAC approach sector, which is why they complained about the little advance warning they received of the tower's intentions, since many of the expected aircraft had already started or were close to starting their approach maneuvers.

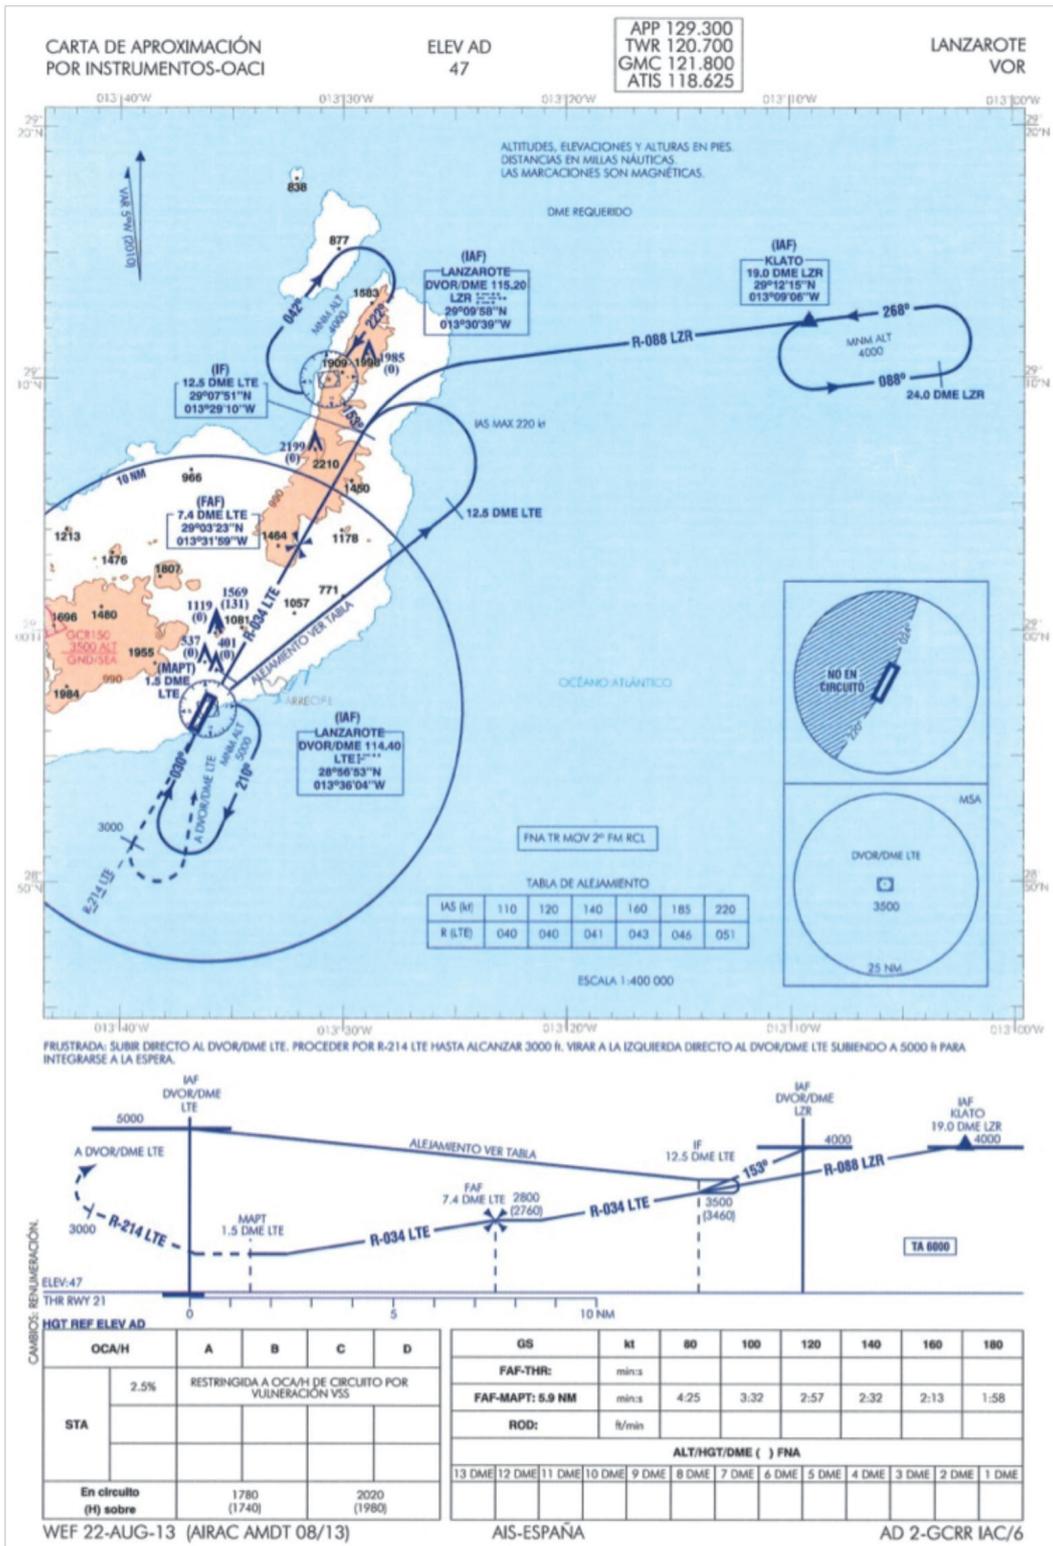
VOR APPROACH MANEUVER TO RUNWAY 21 AT LANZAROTE

The approach to runway 21 at Lanzarote is complicated by the characteristics of the approach and of the surrounding geography. The published approach is a non-precision approach requiring specific conditions, as a result of which it must be categorized as a circling approach.

The mountains and the coastal location lead to unstable wind conditions. When the wind is from the south, the geography often causes windshear conditions that can compromise an operation's safety. Similarly, the steep approach angle required, with no vertical guidance in the final segment, is not conducive to stabilized approaches.

REC 61/15. *It is recommended that the air navigation services provider SAERCO conduct a detailed study of the meteorological and operational conditions that require placing runway 21 into service so as to enable controllers to make a decision that provides for stable operations.*
