## Report A-011/2017

Accident involving a Eurocopter  
AS 350 B3 aircraft, registration F-HETH,  
operated by Sky Helicópteros,  
in Garrovillas de Alconétar  
(Cáceres, Spain) on 17 June 2017

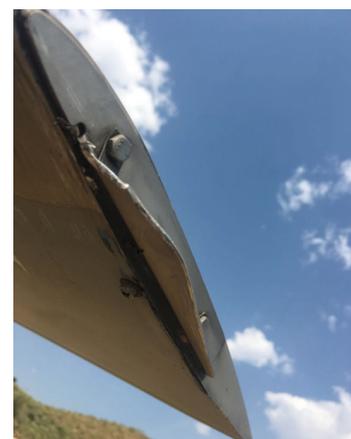
**Illustration 1.**  
Close-up of damage caused by impacting the cable

- bits of the cable in the lower cable cutter,
- a crack on one of the aircraft's two mirrors,
- a scrape on the structure that holds the mirrors,

- several scrapes on the nose and lower cowling, and
- a small dent at the tip of the yellow blade.

The previous image shows the damage to the tip of the blade (yellow blade):

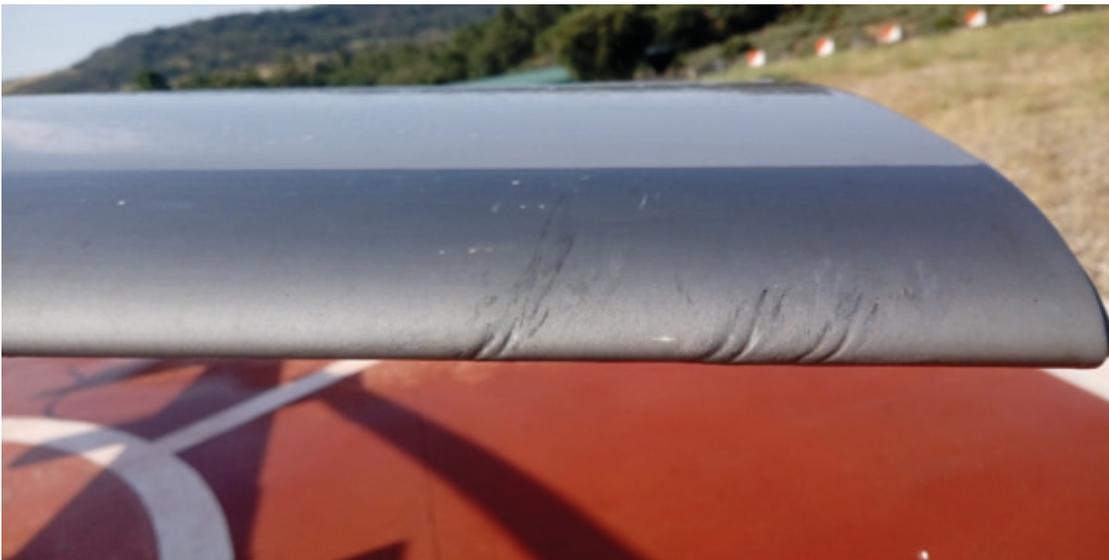
**Illustration 2.** Close-up of the helicopter's blue blade

2 – Later, on 20 June, the same mechanic, during the end-of-day daily inspection, saw some marks on another blade (the blue blade) that seemed to have been caused by the impact with the cables. These impact marks had not been detected earlier. The following image shows the marks on the blue blade:

On 20 June, the same pilot flew the same helicopter again. At the end of the day, during the daily check, the mechanic saw marks on another blade (blue blade) that seemed to have been caused by the impact with the cables. These impact marks had not been detected earlier. The maintenance mechanic carried out other tasks in the AMM for the blue blade, reaching the conclusion that it had to be replaced<sup>4</sup>. The helicopter was grounded.

4 According to the aforementioned procedure from Airbus Helicopters, any impact to the leading edge with the rotor turning is major damage.

On 27 June 2017, the blue blade was replaced and the aircraft was returned to service, after which it operated normally.

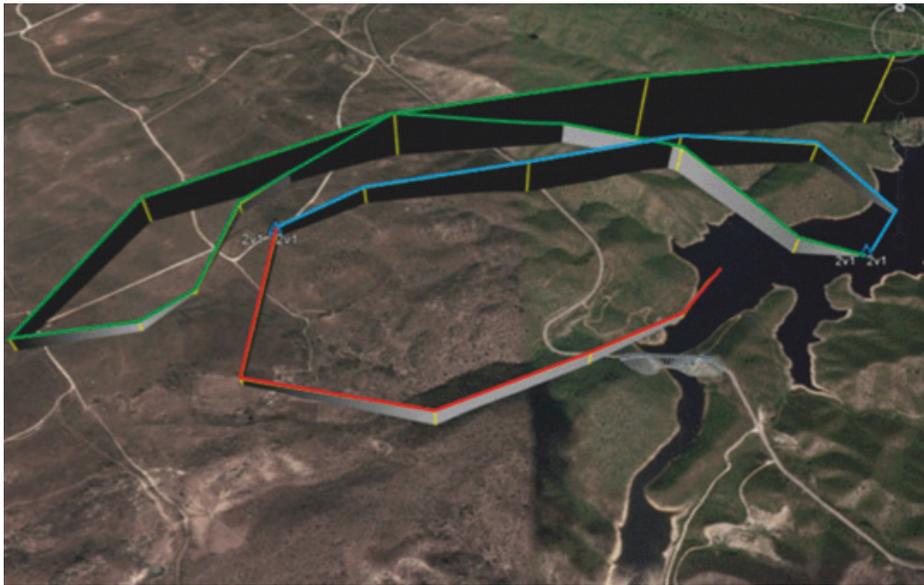
**Illustration 6.** Final instants of helicopter's flight

Before running into the power lines, the helicopter was only able to make one water drop in the area of the fire. The graph below shows the helicopter's activity at the site of the fire:

- 1 – Upon reaching the area of operations, the helicopter flies one counter-clockwise circle to reconnoiter the area before disembarking the firefighting squad. (Flight path in green color)
- 2 – Firefighting squad disembarks.
- 3 – Helicopter flies to the reservoir along route similar to that taken to reach the area of operations. (Flight path in green color)
- 4 – Water picked up.
- 5 – Returns to area of operations also along similar route to ones taken before. (Flight path in blue color)
- 6 – First water drop made at the site of the fire, and
- 7 – Returns to reservoir along different route from before and runs into power lines. (Flight path in red color)

The information taken from the GPS indicates that the pilot did make a reconnaissance flight prior to disembarking the firefighting squad, but he did not reconnoiter the water loading area in an effort to locate potential obstacles along the approach and takeoff paths, as recommended in the Sky Helicópteros Operations Manual.

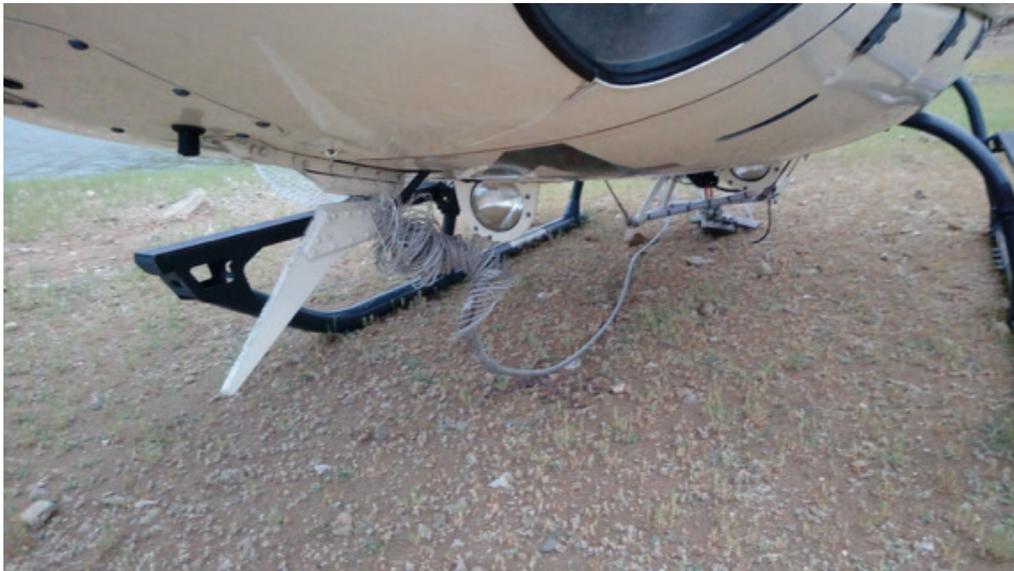
**Illustration 7.** Close-up of cable cutter

The figure below shows the cable cutter, along with the remains of the power lines that it impacted.

Despite the cable cutter, the helicopter sustained some damage, namely:

- a crack in of the aircraft's two mirrors,
- a scrape in the structure holding the mirrors,
- several scrapes in the nose and lower cowling,
- a minor dent on one blade tip (yellow blade), and
- several marks in another blade (blue blade).

One of the three power lines was cut by the cable cutter installed on the helicopter. The other two lines were severed by the helicopter's rotor blades. The cable cutter is deemed to have aided in the pilot's survival and in reducing the damage to the aircraft.

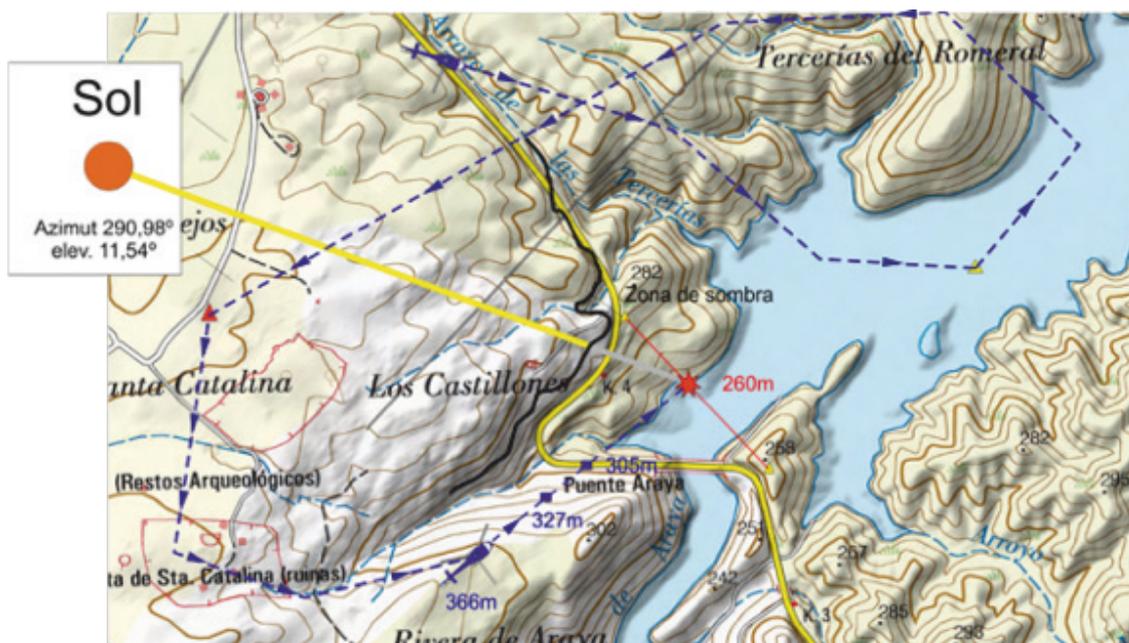
**Illustration 8.** Visibility in the accident area

The graph below shows that when the pilot first picked up water from the reservoir, the power lines were at his back, meaning the pilot did not notice them. A yellow triangle is used to show on the figure the location of the initial water pick-up. The red line shows the power lines.

The pilot returned to the reservoir to pick up water again, but approached it from a different direction, which was in the shadows at the time. The contour line beyond which the area was already in the shadows, considering the position of the sun, is bolded in black. On the day of the accident, the sun set at 21:55.

This would have hampered the pilot's visibility of the power lines in that direction.

In the area of the fire, visibility was reduced not only by the approaching sunset, but by the weather conditions, since the wind in the area was dispersing the smoke from the fire. This complicated the task of identifying potential obstacles, like the power lines, in the water loading area.
