DUTCH
SAFETY BOARD

Fatal fall overboard during loading operations

M/V Azoresborg, Bilbao, Spain, 27 February 2013

The Hague, May 2014

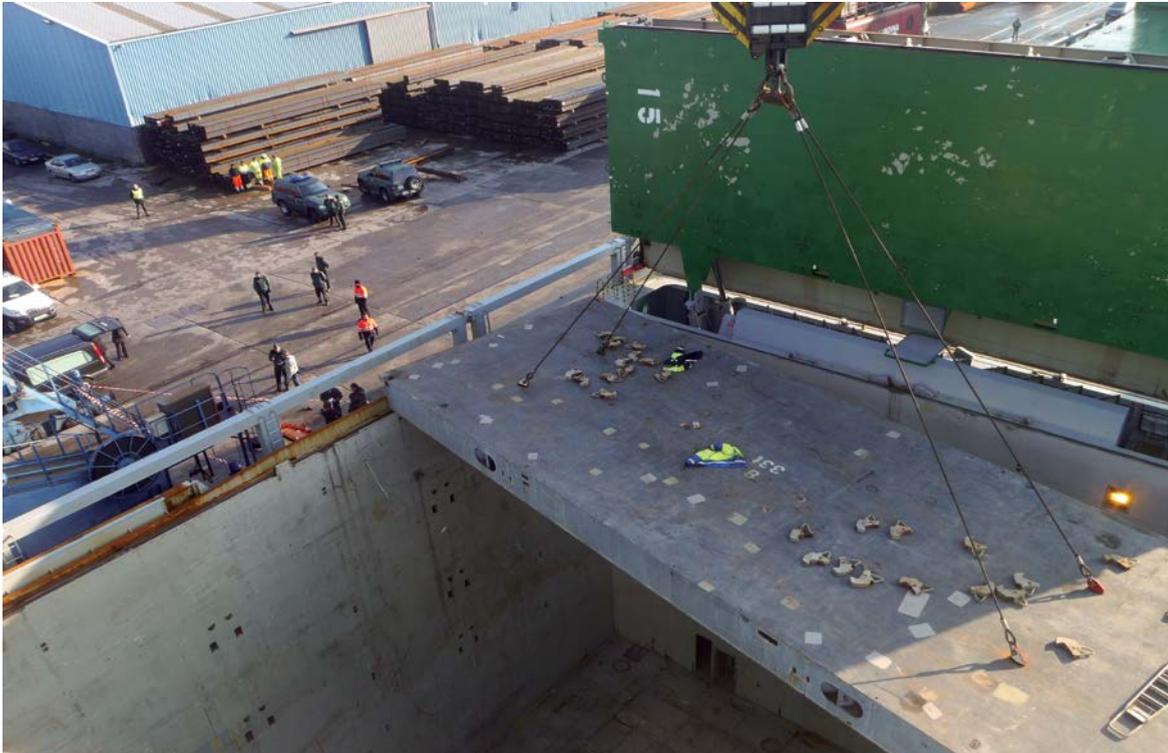
Consoles are usually installed on board the Azoresborg and its sister vessels using a pontoon as a work platform. After placing the consoles that are to be installed on the pontoon, the crew then position themselves between the four hoisting cables, to which they secure themselves with a safety harness (see figure 4).

Figure 4: The pontoon used as a work platform. (Source: Dutch Safety Board)

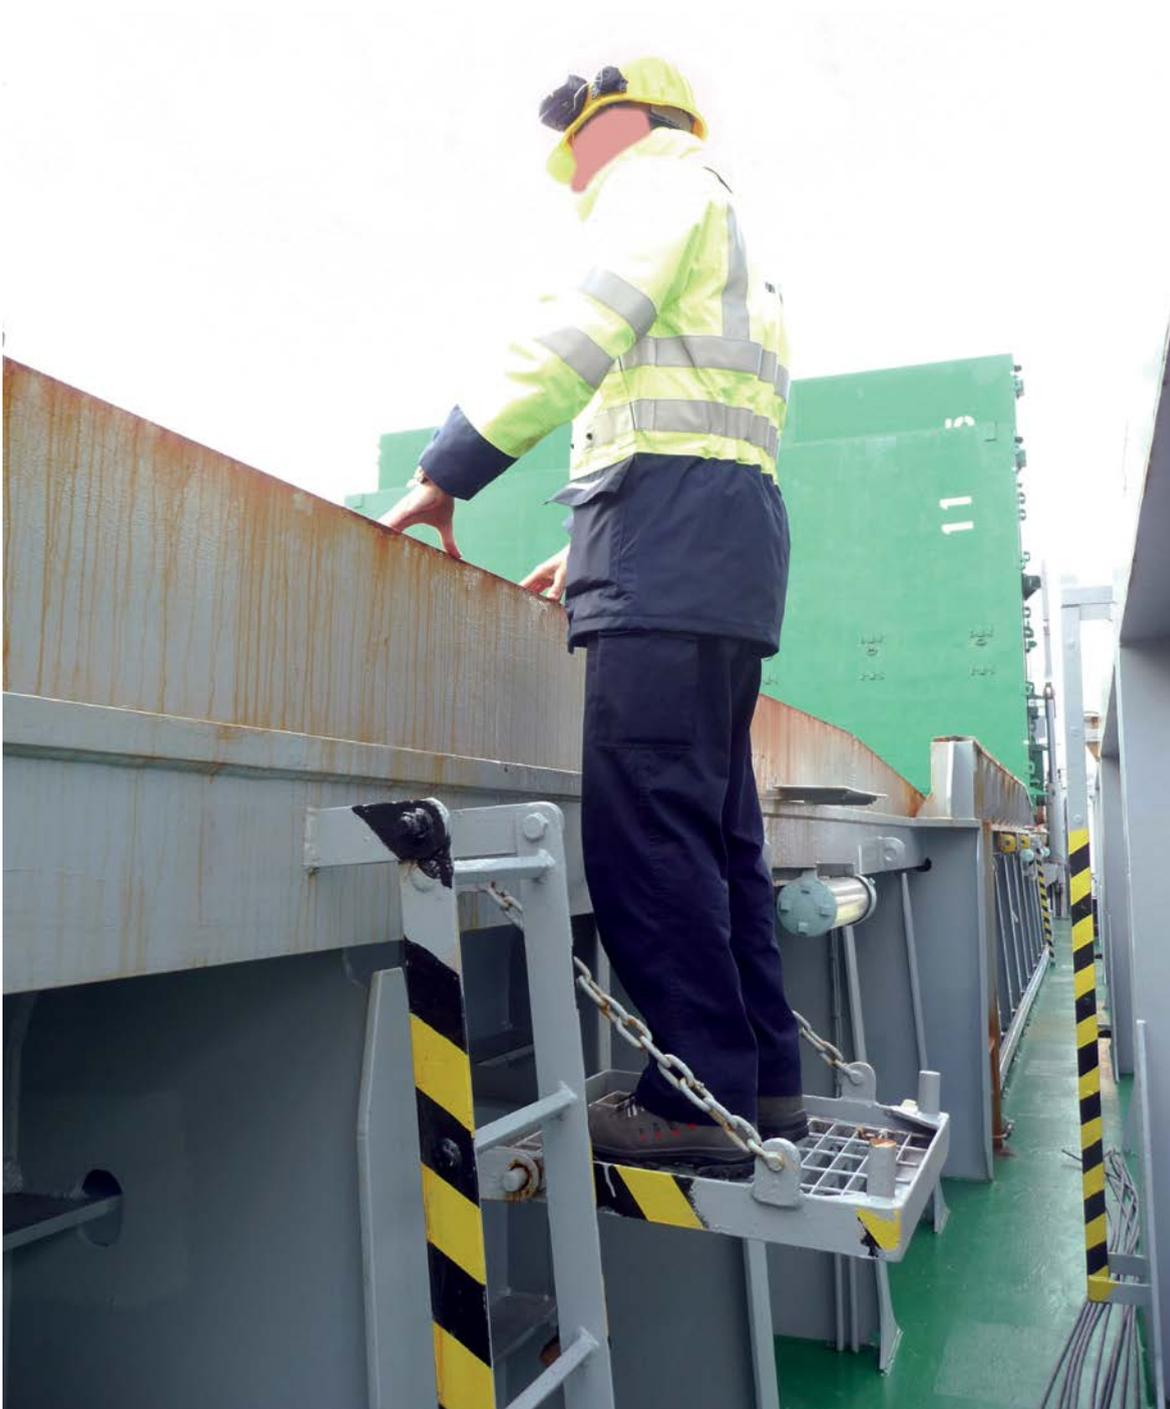
The Azoresborg uses what is known as stevedore platforms to supervise loading and unloading operations from the side opposite to where the ship is being loaded or unloaded (see figure 5). The crew can reach the fold-out platform with a fixed ladder. The platforms contain supports on which detachable fall protection can be installed. None of the platforms had (recently) been equipped with fall protection. This is evident from the fact that none of the platforms, particularly the supports, showed any paint damage. This type of damage inevitably occurs when installing fall protection.

Figure 5: Reconstruction of the position on the stevedore platform. No fall protection had been installed. The platform is located on the aft side of the forward hold. (Source: Dutch Safety Board)

The position and design of the stevedore platform near the ladder made it unsuitable to use for the work carried out. With the removable fall protection installed on the platform, a quick and easy escape would be impossible, once a load would come to close.

As a result of the accident, Wagenborg Shipping B.V. emphasized to ships' crews that the person issuing instructions during tweendeck operations must stand in a safe position, where he can maintain visual contact with the crane driver at all times. Before an operation to hoist and shift tweendecks, a leading line should be attached to the pontoon in order to turn it. In June 2013 the shipping company also reiterated the importance of the safety briefing to seamen in its circular *FleetNews*. The accident was discussed in the safety committee on board the Azoresborg.

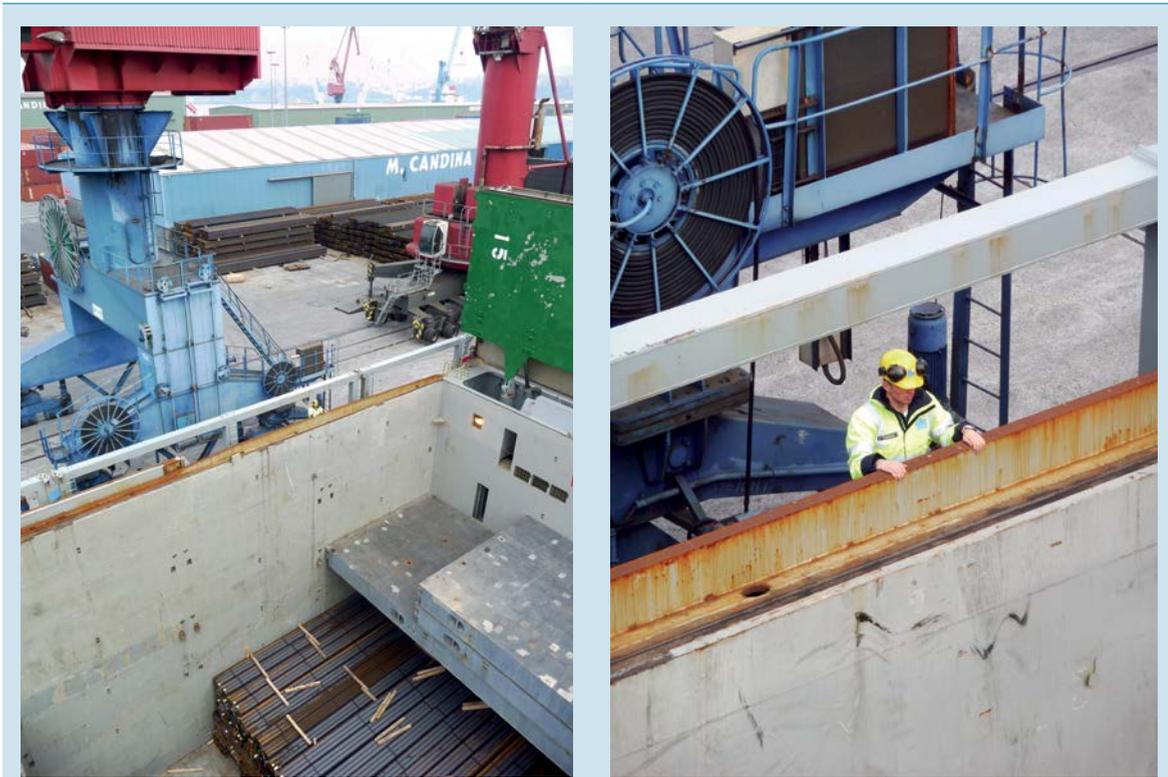
Figure 6: Simulated position of the chief mate on the ladder near the hatch coaming. The person in the photograph is around the same height as the fatally injured chief mate. (Source: Dutch Safety Board)

During the installation of the tweendeck pontoons, the chief mate was carrying out two tasks. He acted as supervisor and gave instructions to the crane driver. He was able to perform these tasks from three positions, i.e. by positioning himself on the cross deck amidships, by using a ladder at the front of the hold or by using a ladder at the rear of the hold. He chose the latter option. This was the only position from where he could reach the pontoon directly in order to turn it by hand. If he had used one of the other positions, he would still have had to move to the location of the accident in order to turn the pontoon. From this position the chief officer could directly see the crane driver and the hoisting operations, as long as the pontoon had not been lifted above the hatch coaming.

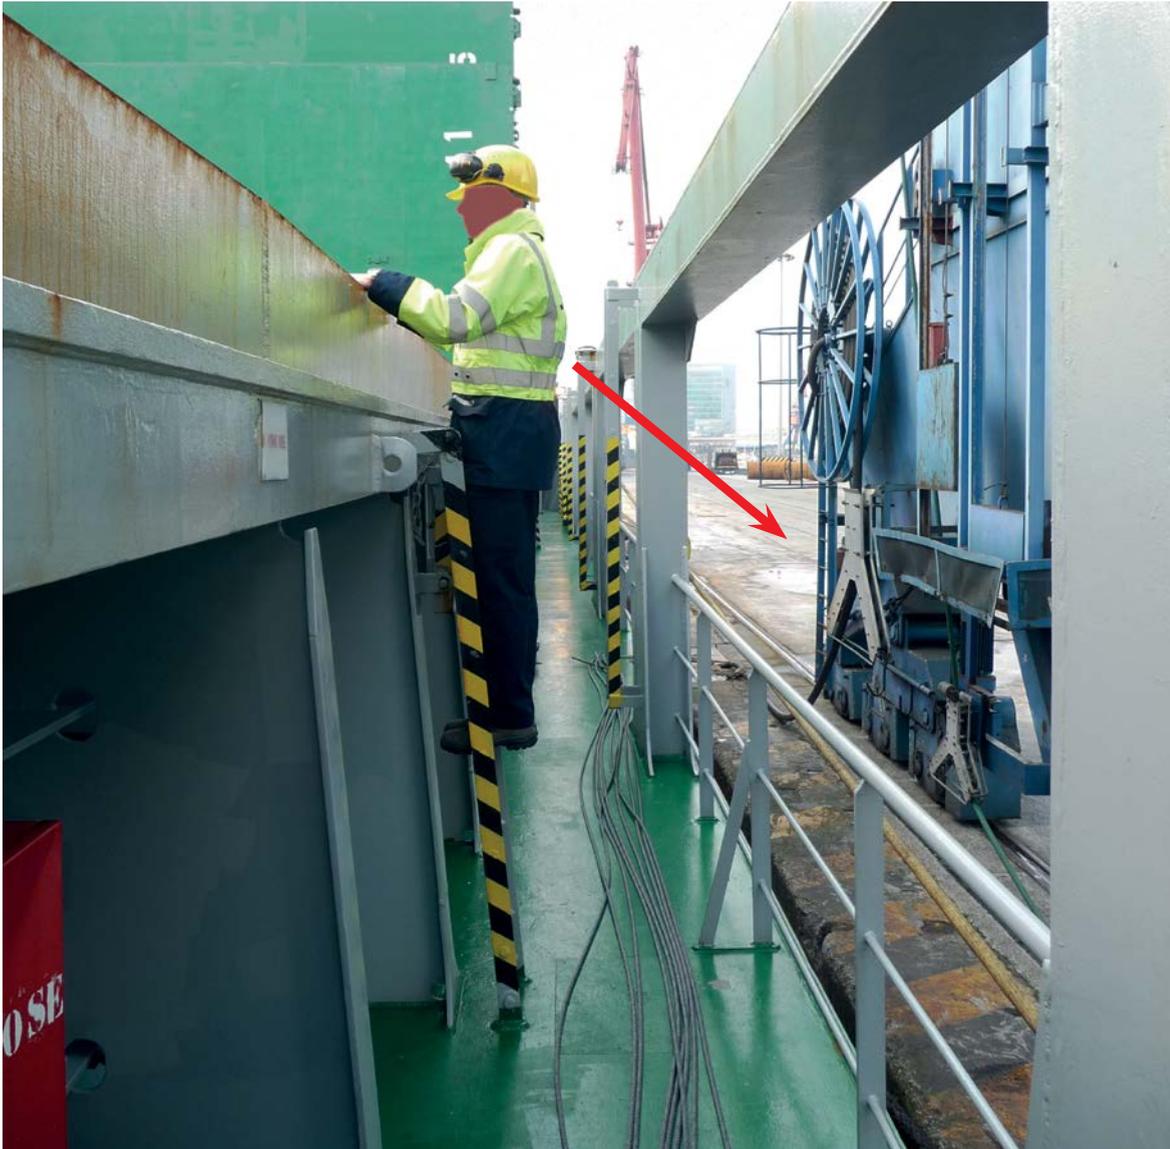
No one actually saw the chief mate fall. However, in view of the chief mate's position on the ladder, his tasks and the proximity of the moving pontoon, there most probably is a relationship between the fall and the activities performed. It is conceivable that he lost his balance, either because he had been hit by the swinging pontoon, or due to a startle response. The exact direct cause, however, could not be ascertained.

Figure 7: Reconstruction of the chief officer's position and fall. (Source: Dutch Safety Board)

When the chief mate was last seen, he was standing on a ladder at a height of about 80 centimetres. It follows from the witness statement and the autopsy report that the chief mate fell over the railing onto the quay and then ended up between the quay and the vessel. The proximity of the hoisted pontoon and his unstable position on the ladder meant that it was all the more relevant to have effective fall protection in place. However, there was no fall protection. Because the chief mate was standing on a ladder, the height of the railing proved to be insufficient.

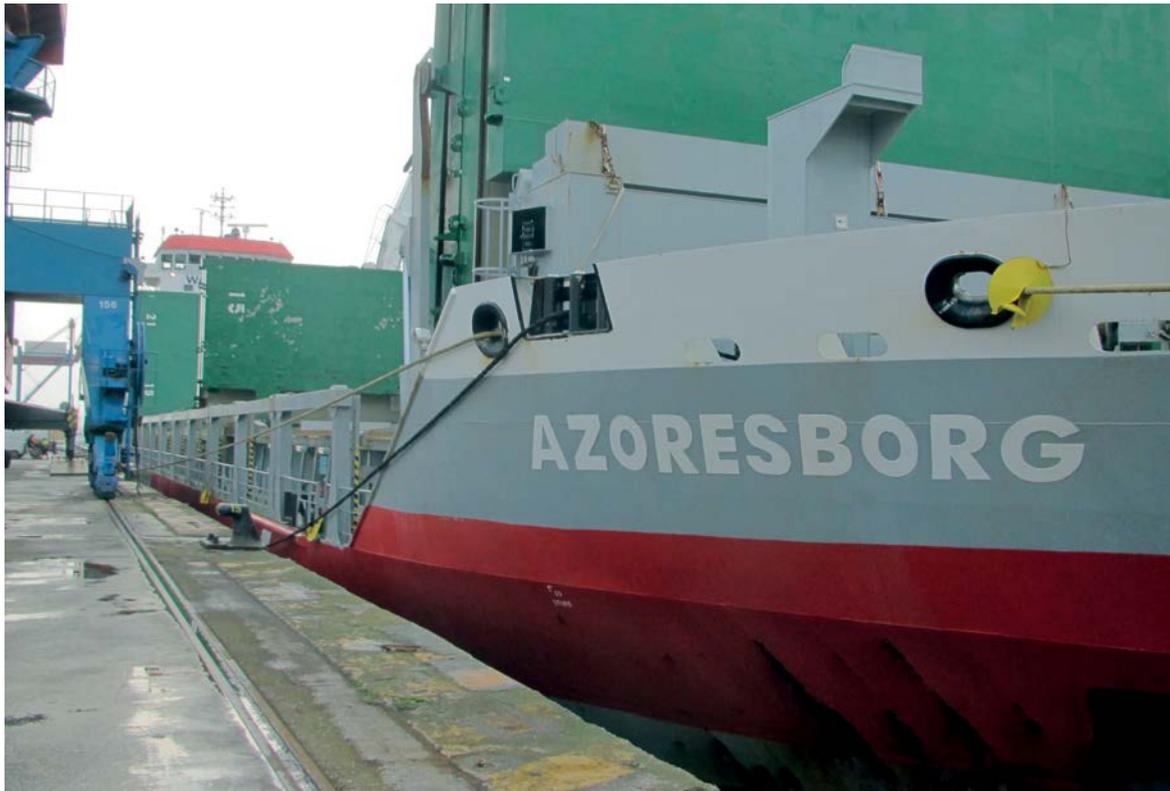
Figure 8: mv Azoresborg moored in Bilbao on 1 March, two days after the accident, showing a gap between the quay and the vessel (seen from the forward part of the forward hold). (Source: Dutch Safety Board)
