# Technical report

## A-032/2019

Accident on the 19th of July 2019,  
involving a Piper PA 28-140 aircraft,  
registration EC-GDC, in Villarrubia de  
Santiago (Toledo)

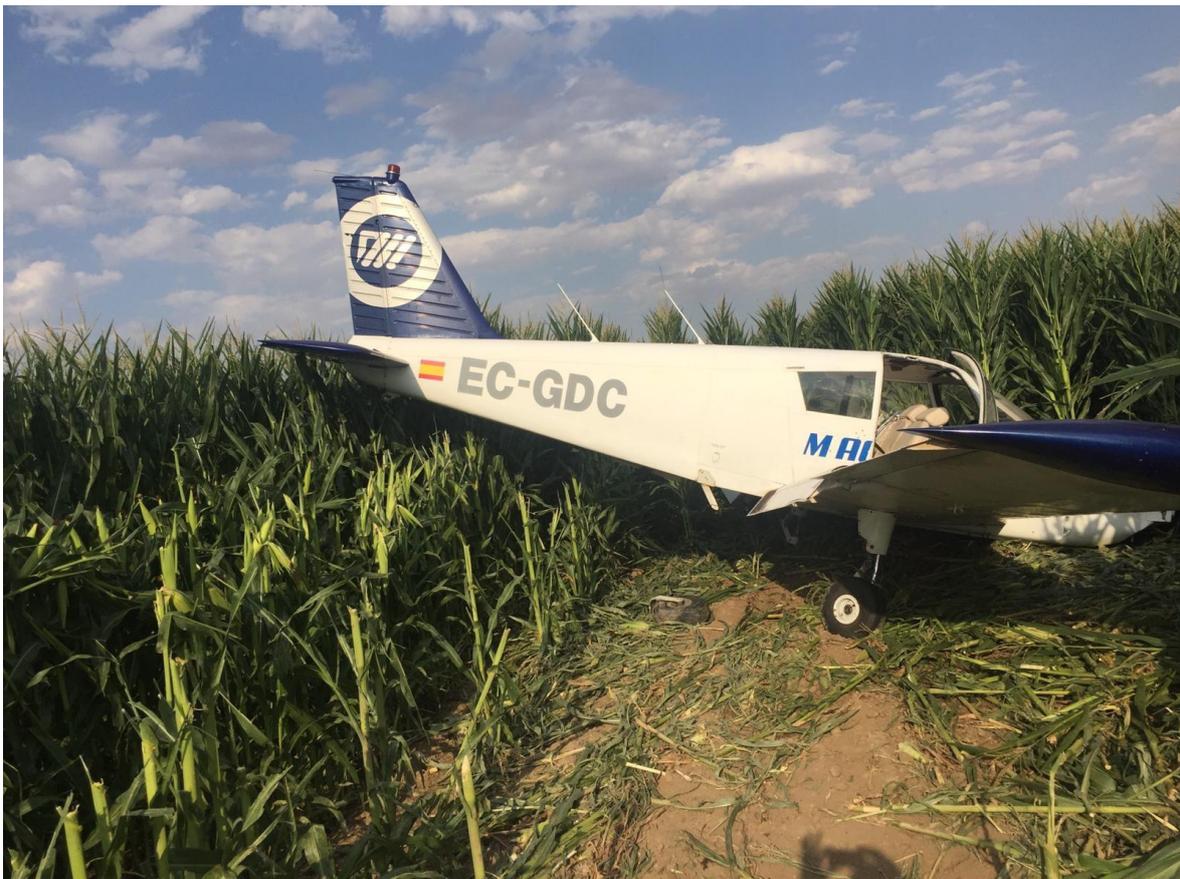
Photograph 1. Damaged aircraft at the accident site

The aircraft suffered significant damage as a result of the accident, particularly to its landing gear, the aircraft nose and wings.

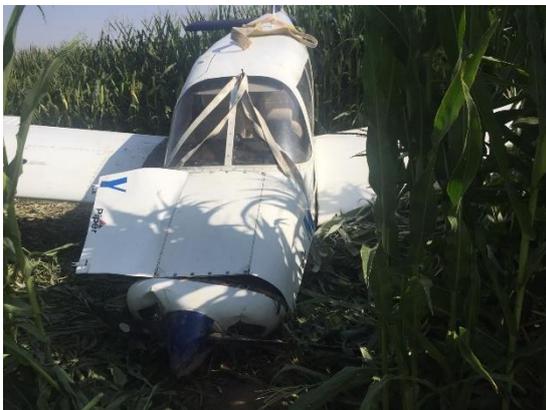
Significant damage to the aircraft, particularly the landing gear, aircraft nose and wings, will occur.

Photograph 3. Aircraft at the accident site

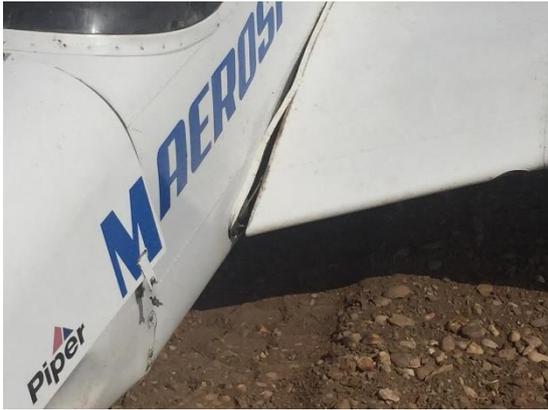
Photograph 5. Left fuselage-wing joint

- Deformation and breakage of anchors of the upper engine cowlings. Deformed and eroded propeller.
- Wing deformation and separation of the left fuselage-wing joint.
- Landing gear: the main gear was damaged and deformed and the nose gear destroyed.

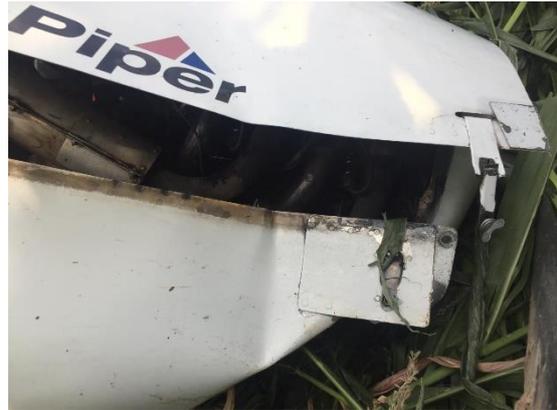
Photograph 6. Engine cowling

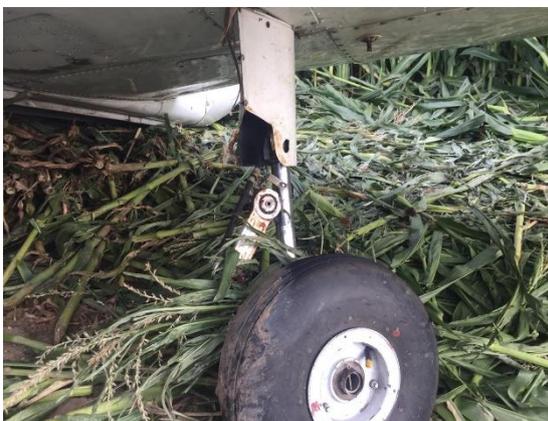
Photograph 7. Main landing gear

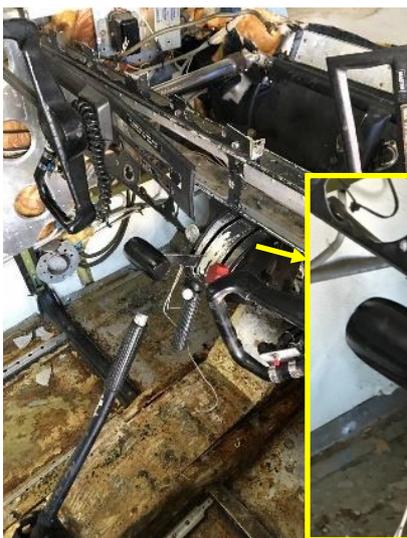
Photograph 11. Mixture knob in the flight cabin and detail

When the mixture knob was moved to the lean position, the cable offered no resistance and pulled the carburetor rod, making the mixture leaner. However, because the cable was not clamped and bent into a deformed position when the mixture knob was operated to the rich mixture position, the

cable didn't push the connecting rod forward to allow more fuel through and enrich the mixture. As a consequence, the mixture controller worked to make the mixture leaner but not to enrich it.

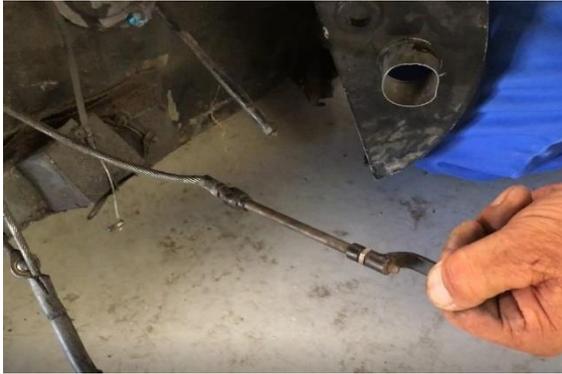
Photograph 12. Mixture controller cable in the lean mix position

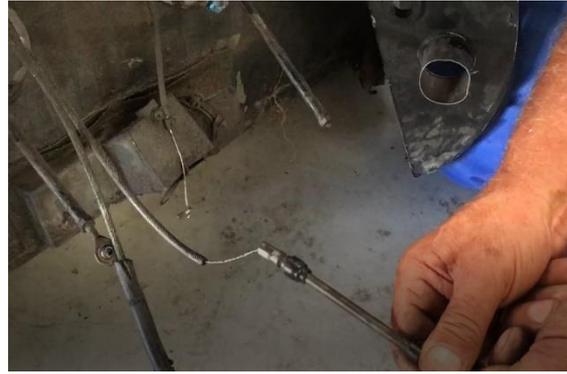
Photograph 13. Mixture controller cable in the rich mix position

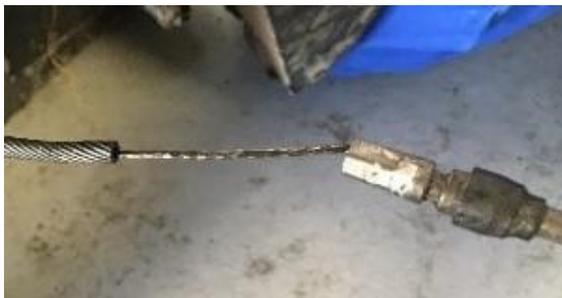
Photograph 14. Detail of the non-crimped mixture controller cable

However, when an enriched mixture was finally required, the mixture controller didn't work properly because the sleeve of the connecting cable between the controller and the carburettor had come loose, and the cable had been bent. This rendered the controller useless because it did not push the carburettor rod to inject more fuel. If this control had worked properly, the loss of engine power would probably have been recovered.

Regardless, the engine would have provided power if the mixture controller had been connected and operated the fuel inlet on the carburettor. As it wasn't detected during the maintenance revision, the connecting cable probably became decrimped during the flight. It seems unlikely that the deterioration and eventual breakage of this cable could have occurred in such a short amount of flying time. However, it would have been impossible to foresee, even if preventive maintenance could have reduced the risk of it occurring.

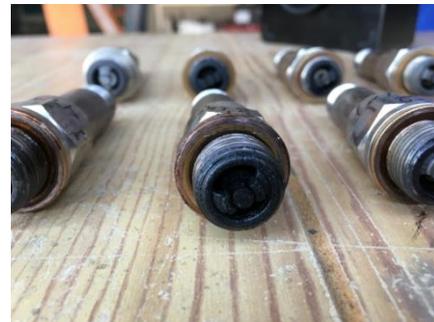
- The cylinder compression and operation of the intake and exhaust valves were checked and found to be acceptable in all four cylinders.
- The condition of the spark plugs was also checked. They were found to be new and in good condition except for those of cylinder number 3, where both the upper and lower spark plugs were blackened and had excess oil.

Photograph 15: Cylinder n.3 spark plug

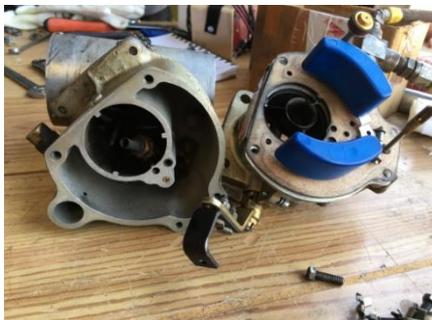
- The carburettor was dismantled, and it was confirmed there was no fuel inside. The floats were new and in good general condition, no dirt was detected, the venturi was clean, and the butterfly valve was unobstructed.
- The pipes could not be checked in their layout to the fuel tanks given the fragmentation of the aircraft.

Photograph 16: Carburettor

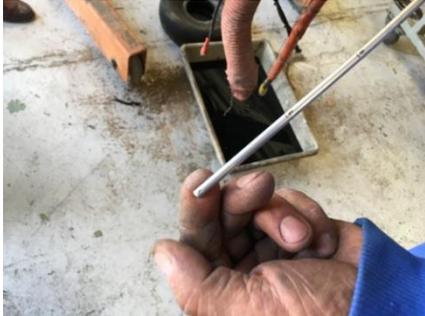
Photograph 17: Oil dipstick and remaining oil in the float bowl

- The oil level in the tank was checked; the rod was extracted completely clean; there was no oil and no evidence of possible leaks in the area.
- The oil filter was disassembled and metallic (steel) particles were observed inside.
- The remaining oil was drained from the sump. Approximately 2 litres of extremely dirty and dark-coloured oil were obtained.
- The condition of the engine oil lines was checked. There were small remnants of oil in the intake hoses but no obstructions. The insulating joints were in good condition.
- The condition of the radiator was checked. It appeared adequate, although it contained traces of soil from the scene of the accident.

However, the tests that could be performed during the engine inspection did not show compression failures or faulty operation. What it did show was a general lack of oil in the engine. Only 2 l was obtained from the sump. Although during the transfer of the aircraft and disassembly of the engine it was probably necessary to drain both oil and fuel, the amount of oil inside the engine was deemed insufficient for correct function.

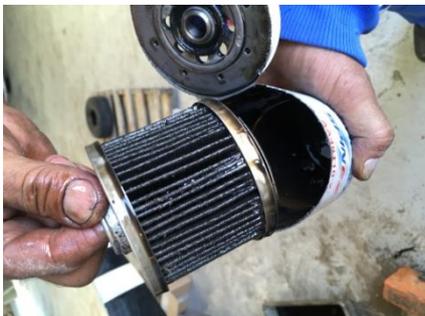
Photograph 18: Oil filter

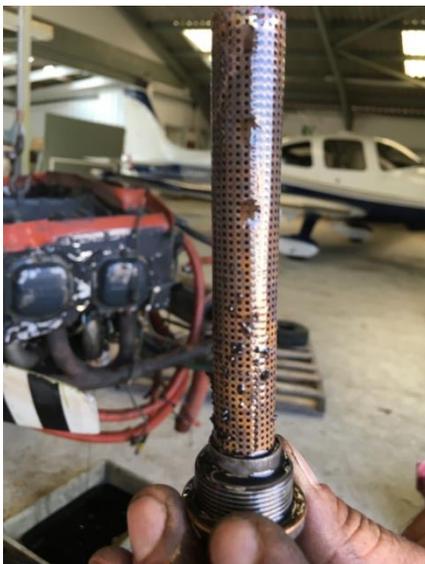
Photograph 19: Oil filter with metallic particles

Between this check and the time of the accident, the aircraft had flown for a total of 35 minutes on the previous day, and 2 hours 5 minutes on the day of the incident. The check included, among other things, changing the oil and the oil filter. This detail is not consistent with the engine oil found in the wreckage, which was very dark and dirty, or the condition of the oil filter, which was also deteriorated and contained metal particles.

Considering oil changes take place every 50 hours of flight, it's unlikely that recently changed oil could have deteriorated to such an extent in just 2 hours and 40 minutes flying time. As for the metal particles, it is not possible to specify how long they had been in the filter, but they indicate that an internal component of the engine was deteriorating as a result of a malfunction, probably due to a lack of lubrication.
