**HELLENIC REPUBLIC  
HELLENIC BUREAU FOR MARINE CASUALTIES' INVESTIGATION**

**MARINE CASUALTY SAFETY INVESTIGATION REPORT  
04/2018**

**GROUNDING AND FOUNDERING OF TUG BOAT VIKING**

**January 2021**

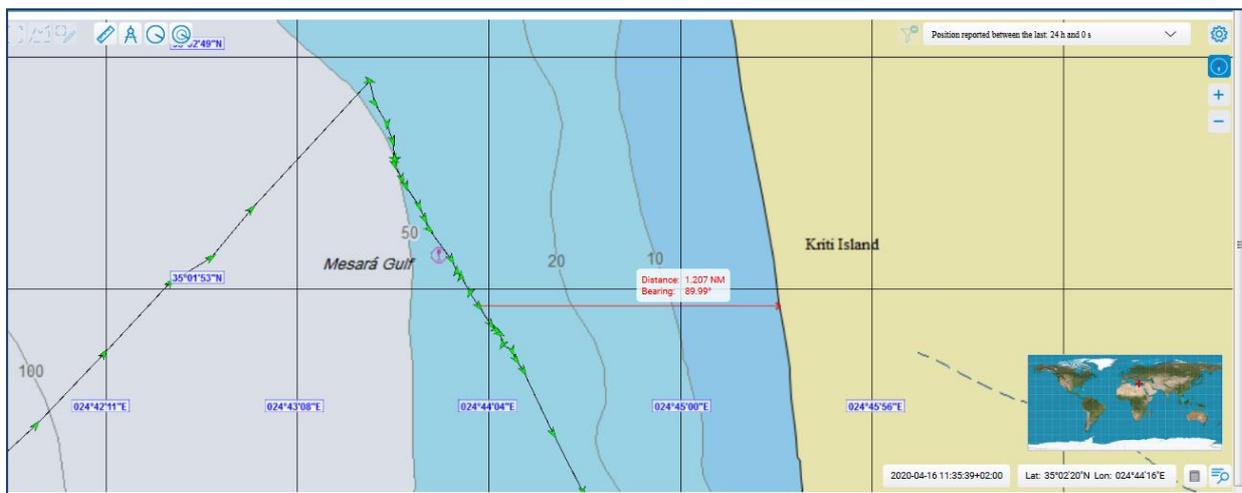
At approximately 03.00 of the 7<sup>th</sup> of December the Chief Officer called the Master on the bridge and they tried to hold the convoy in position by using the anchor and the engines. At that time the VIKING was 1.2 nm from the coast.

**Figure 4:** The position of the VIKING from the coast when the Master was summoned to take control.

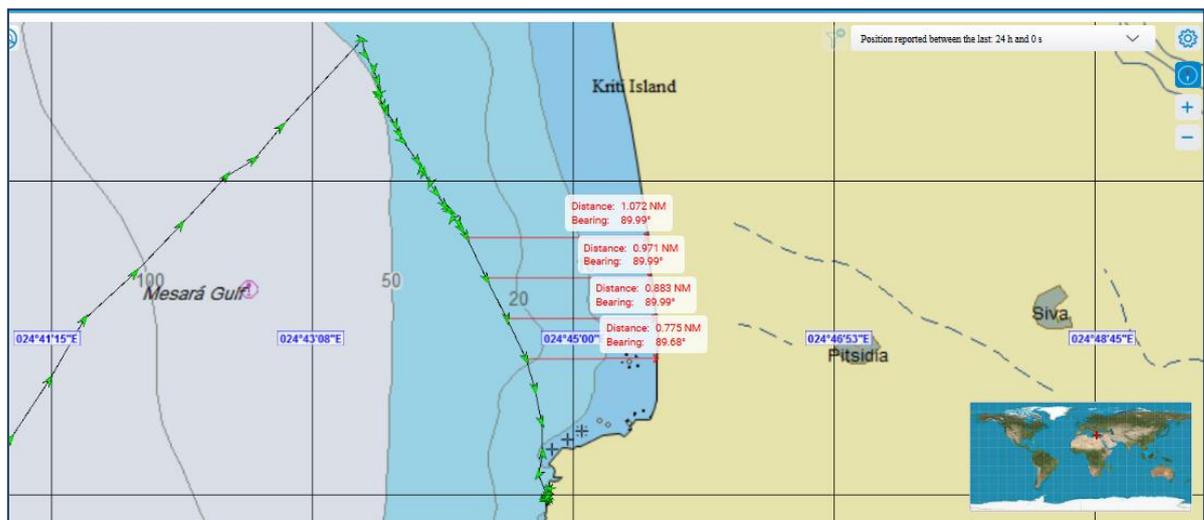
The Master took control of the engines, while the C/O was managing the anchor (heaving and dropping as per Master's order). Despite such efforts the convoy continued to drift towards the coast.

**Figure 5:** The continuous drifting of the convoy towards the coast. The four positions marked with their distance from the coast are within the time period from 04.10 to 04.38 (1 position every approx.10 minutes)

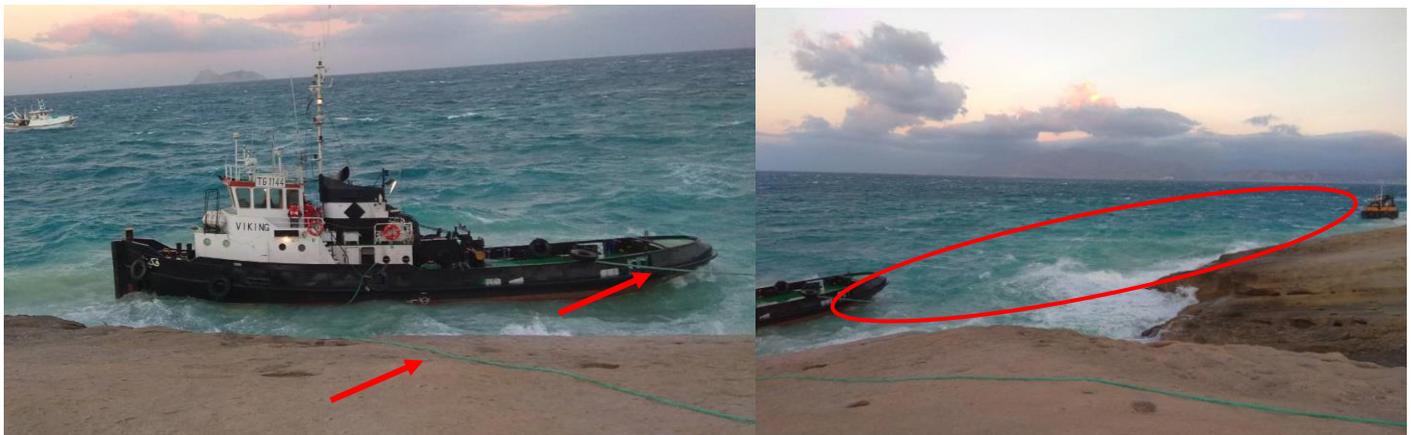
At 05.40 the VIKING grounded on the sea bottom a few meters from the rocky coast, with her port side towards the coast. The Master then ordered to check the vessel for damages, while he reported the grounding to the Coast Guard authorities, requesting for immediate assistance. The C/O checked below deck and found out that the vessel had suffered damage to her hull and water ingress was ongoing.

It should be noted here, that as visual evidence reveals, the tow line from the dredger remained attached to the tug boat, even after the grounding of the latter.

**Figure 6:** Captures during the grounding of VIKING; in the left image, the two lines indicated are the ones used for abandonment and the tow line, still attached to the dredger. In the right image the tow line is discerned floating (within red ellipse).

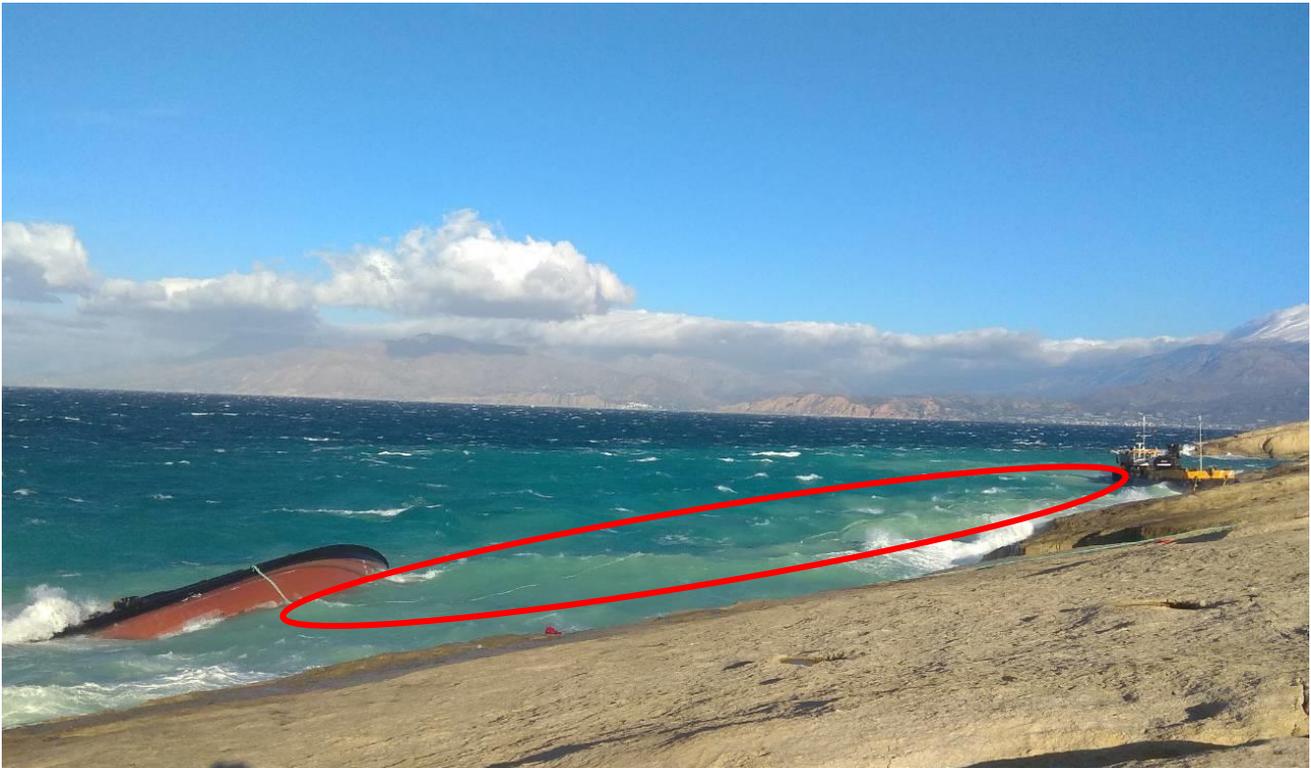
**Figure 7:** Capture after the sinking of VIKING. The tow line to the dredger is still floating, attached on VIKING (red ellipse).

However, direct assistance was not possible at the time of the emergency due to the adverse weather and sea conditions and the inexistence of vessels that could effectively assist in towage in the proximity of the convoy. Under the circumstances, the Master decided not to release the towed dredger, as evidence revealed (see figures 6 and 7 in chapter 3.3) and this had an impact in the safety of the tug boat itself, as she was not clear of the towed object which in the chain of events grounded first on the rocks, thereafter acting as an anchor and dragging the tug boat towards the coast.

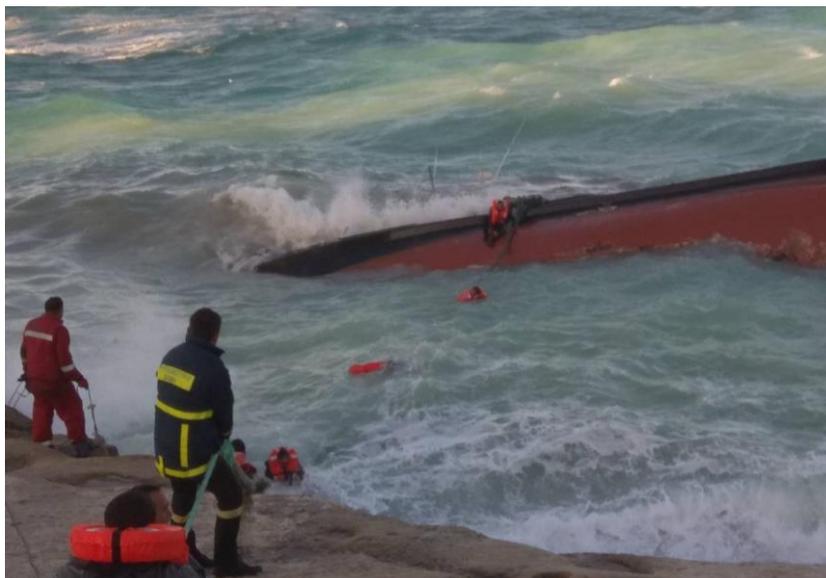
The crew of VIKING abandoned the vessel one by one, with the assistance of the Coast Guard and Fire Brigade officers by the use of a line thrown from the tug boat towards the coast. All of them reached the coast safely and the VIKING remained semi-foundered on her STBD side. One crew member was provided with first aid by the crew of an ambulance which had arrived at the scene, without further need of hospitalization.

**Figure 8:** capture during the abandonment of VIKING.

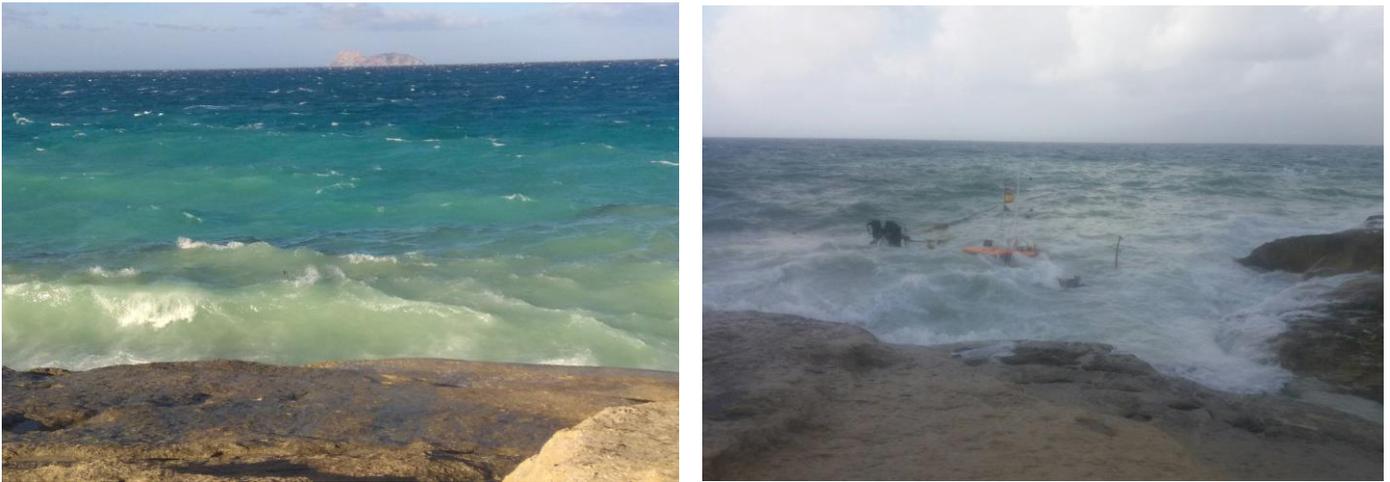
Within the next hours the VIKING foundered due to the water ingress and wave impact, while the dredger also foundered due to the same conditions.

**Figure 9:** Both VIKING (left capture) and NEPTUNE KHAN (right capture) foundered following their grounding on the rocky coast.

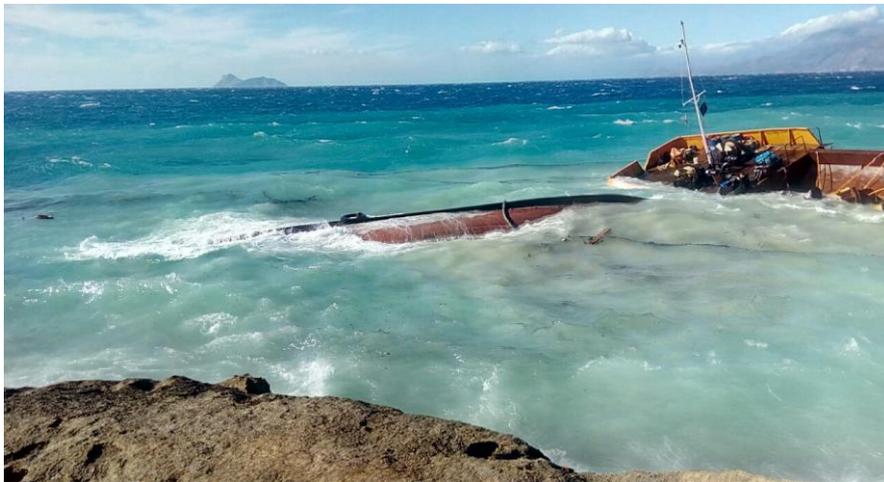
**Figure 10:** VIKING and NEPTUNE KHAN foundered; being still connected with the towing line they were drifting together under the waves' impact

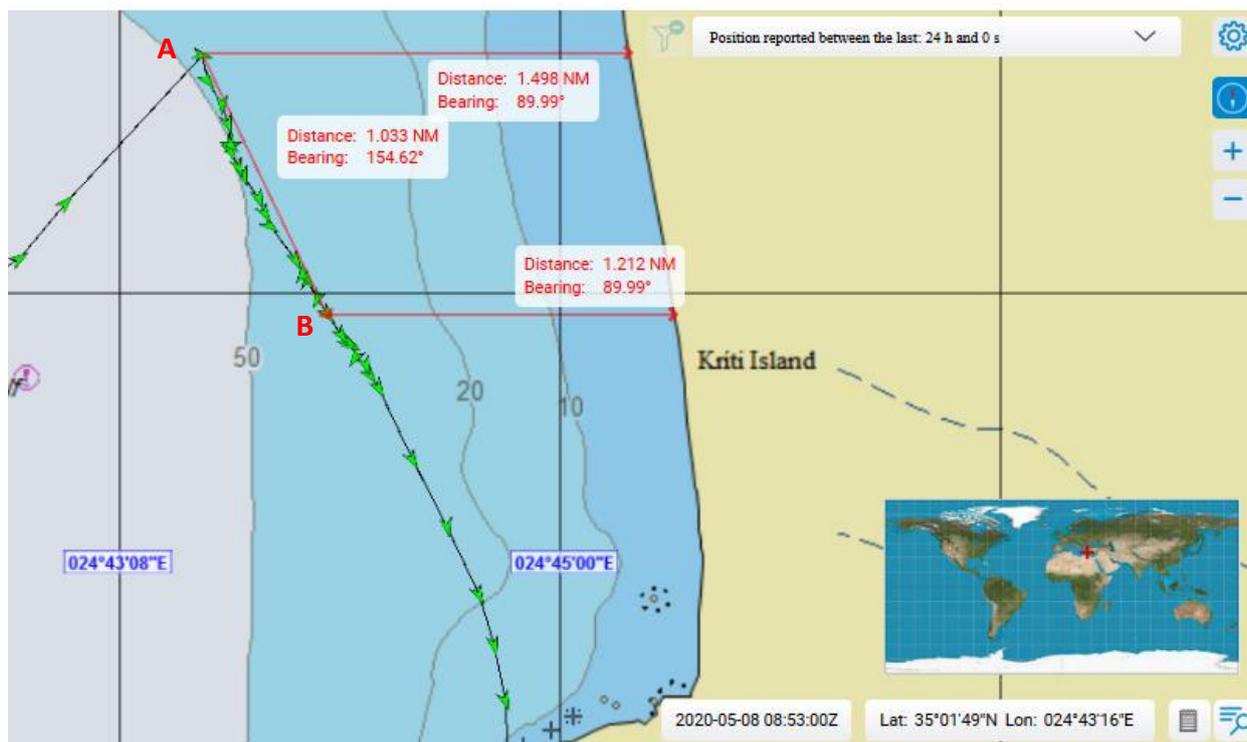
The Chief Officer who remained on watch notified the Master at approximately 03.00, when the convoy was at 1.2 nm from the coast, but had already drifted for more than 1 nm, under the waves' and wind's impact.

**Figure 13:** Depiction of the drifting of the VIKING from the time the Master handed over the watch (position A), to when he has summoned on the bridge by the C/O (position B)

The facts that took place from the anchoring position until the request for assistance by the Master reveal a case of inadequate risk assessment. The situation of the convoy as it appeared was not safe and secured before the handover of the watch to the Chief Officer, while the threshold of declaring the necessity of remedial actions and calling the Master at the bridge was not set at a reversible – for the developing situation – point, thus the Chief Officer called the Master after of more than 2 hours of continuous drift of the convoy and a drifting distance of more than 1 nm.

02/2018: Establish processes for ocean towage (based on the advisory provisions MSC/Circ.883) concerning contingencies due to bad weather and emergency handling with reference in particular to conditions of releasing the towed object, in order to support the decision making of Masters and Officers on board its vessels and ensure their safety.
