**DATA SUMMARY**

Date and time	<b>Thursday, 17 January 2013; 17:26 local time</b>
Site	<b>Runway 28 at the Cuatro Vientos Airport (Madrid, Spain)</b>

Registration	<b>EC-ICG</b>
Type and model	<b>PA-60-601P (Aerostar 601P)</b>
Operator	<b>Private</b>

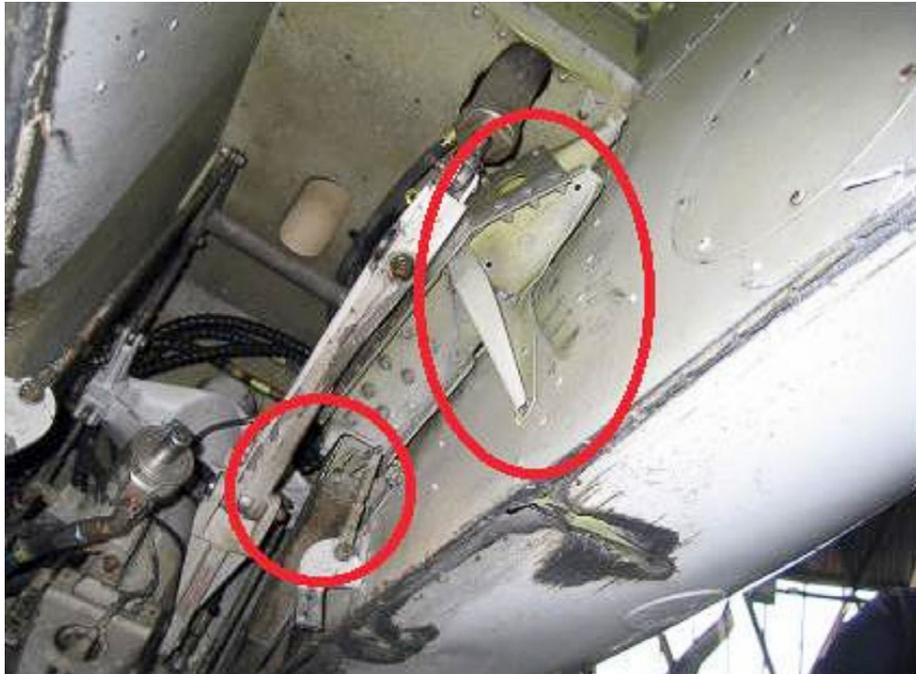
The U-beam that houses the axle on which the nose gear's upper drag link pivots was broken near the housing where the actuating rod that moves the front left well door shifts back and forth. The part of the beam forward of this housing had lost the rivets that attach it to the side bulkhead and was loose (Figures 3 and 4).

Figure 3. Forward gear wheel well showing the fracture area and the loss of the rivets that hold the drag link in place

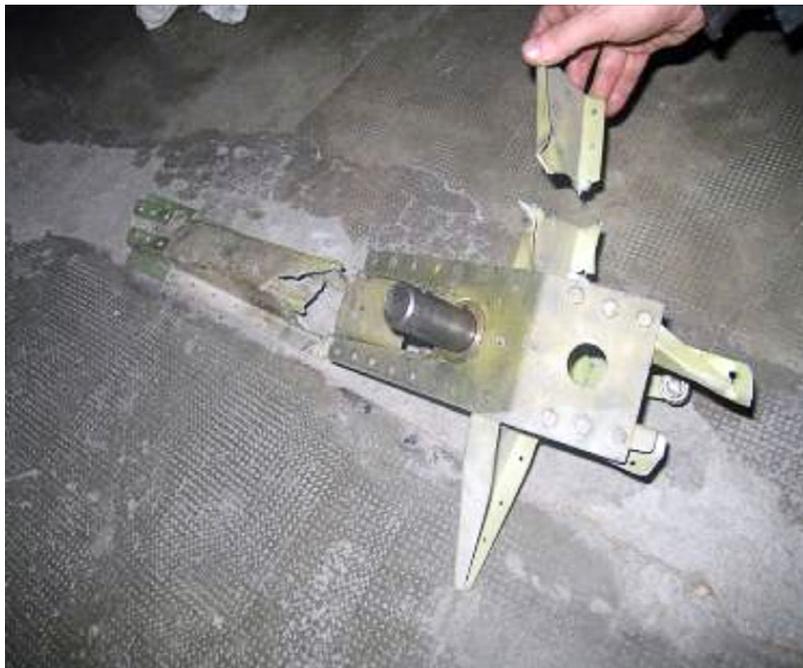
Figure 4. Beam disassembly

The rivet holes in the top front part of the component exhibited a micro-morphology indicative of a fatigue process. The crack developed over the course of many cycles that encompassed a relatively long period of time, as evidenced by the signs of corrosion that were found. The end of the piece, which had been repaired, and the red-tinged hole for the mounting screw, also exhibited fatigue cracks of the same nature.

In contrast, the fracture in the central part of the beam, which had broken the part in two, resulted from a ductile tearing mechanism, typical in this material when subjected to excessive stress. The rivets used to attach the part to the component that were closest to this central area also broke as a result of this same ductile mechanism. Likewise, on the section of the arm that remained attached to the bulkhead, a stress fracture was identified on both the transversal fracture on the body of the arm and on the rivets.

The laboratory analysis concluded that the fracture sequence most likely started with the incubation and development of the fatigue mechanism, which propagated through cracks in the riveted junction. Once this junction was weakened, the beam was subjected to bending stresses that caused the adjacent rivets to break, eventually causing the fracture of the central part and arm of the beam.

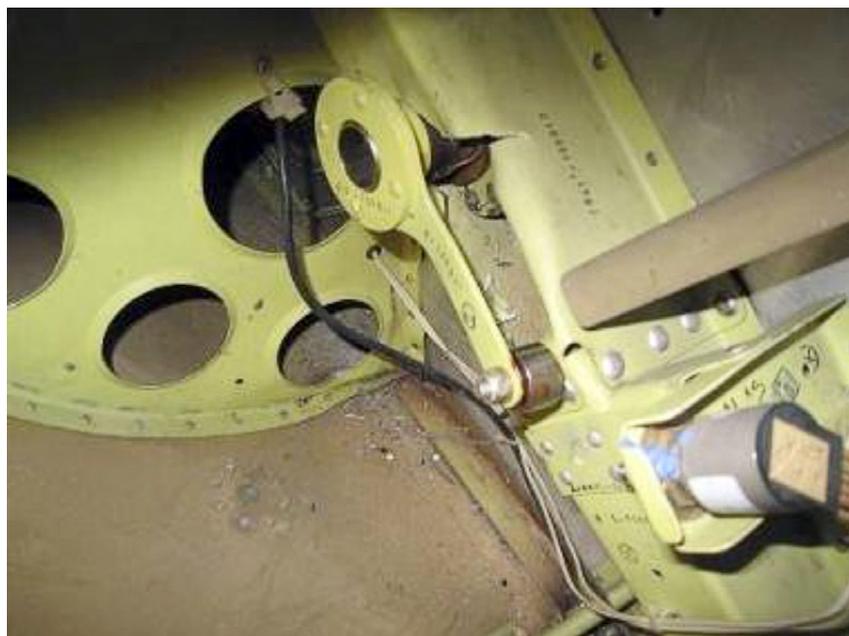
The beam that houses the extension of the link axis on the other side of the bulkhead was also broken, such that the axle had moved from its position. Due to the motion, with the leg in the retracted position, the cam that is attached to the axle and that makes contact with the micro-switch responsible for transmitting the gear-up signal could not reach its normal position, meaning it was unable to make contact with the micro-switch (Figure 5).

Figure 5. Cam and gear-up micro-switch

The stresses associated with the subsequent taxiing, takeoff runs, cycling of the gear and landings (including the last landing in Axarquía under very windy conditions) would have deteriorated the structure of the beams even more such that on the return flight to Cuatro Vientos, even with the gear retracted, the cam that activates the micro-switch and switches on the gear-up amber indicating light was unable to reach its position due to the weight of the leg.

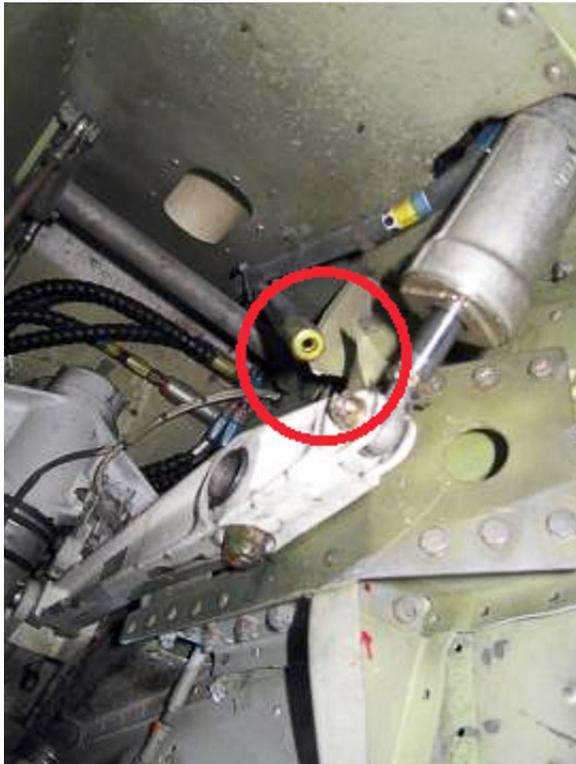
There was a reddish mark on the beam next to a crack that started in the hole for a screw that attached the part to the bulkhead (see figure 6). Workshop personnel could not ascertain its origin, indicating that it was probably present when the airplane was first taken to the workshop in 2007. Two other centers that had carried out maintenance on the airplane before were contacted, but neither one had records indicating that this crack had been detected and was being monitored.

The hydraulic return line from the actuator was broken, possibly as a consequence of the movement of the actuator itself when it was dragged by the locking arm when its axle moved (Figure 6).

**Figure 6.** Return of the hydraulic line that supplies the actuator

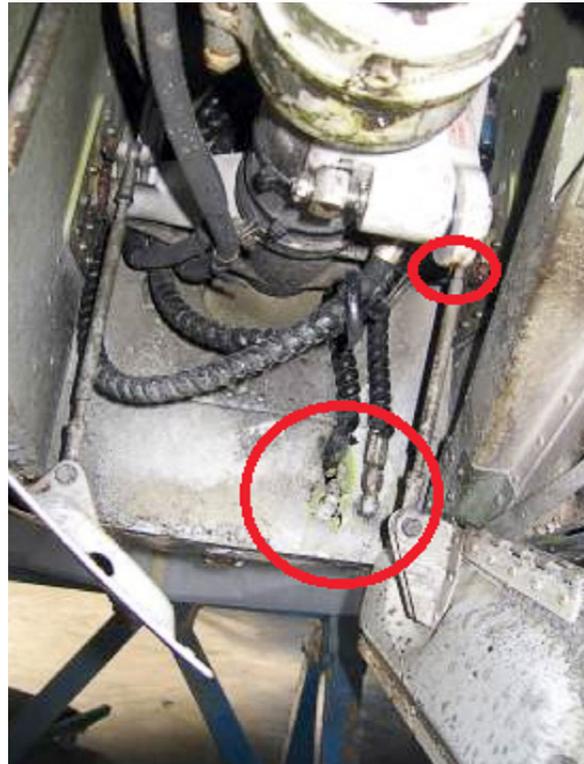
As a result of the loss of rigidity of the locking system caused by the fracture and motion of the beam, the leg swung excessively toward the rear, such that its structure made contact with the wheel well's rear bulkhead at the point indicated by an impact mark. This part of the bulkhead houses an elbow of the hydraulic line for the nose wheel steering system, which had broken (Figure 7).

**Figure 7.** Impact on the rear bulkhead and part of the leg responsible for the impact

At this point the weakened structure would have been unable to withstand the landing stresses. The loss of rigidity in the locking system allowed a certain degree of motion in the leg, which probably struck the wheel well's aft bulkhead during the first few meters of the landing run. This would explain the dull thud felt by the pilot and the break in the hydraulic line that crosses the bulkhead. The return line on the gear actuating system broke when the end of the piston that pivots at the end of the locking arm moved excessively. Both hydraulic system failures took place on the ground and thus did not affect the gear retraction on takeoff or the extension of the flaps before landing.
