Technical report

A-011/2021

Accident occurring on 19 April 2021 involving the DIAMOND DA20-C1 aircraft, registration EC-LAO, at Sant Jaume dels Domenys (Tarragona)

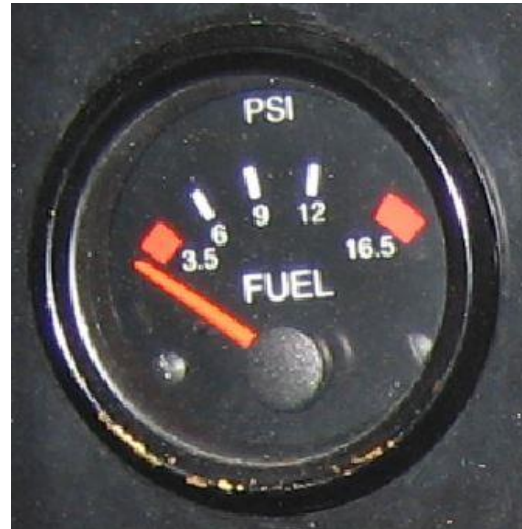
Figure 1. Fuel pressure gauge

After the high fuel pressure warnings were issued by one of the crews that flew the aircraft, the plane was inspected by maintenance personnel, who found that although the fuel pressure markers were inside the red zone, they had not reached the upper limit; therefore, according to the flight manual, the fuel pressure was within the operational limits.

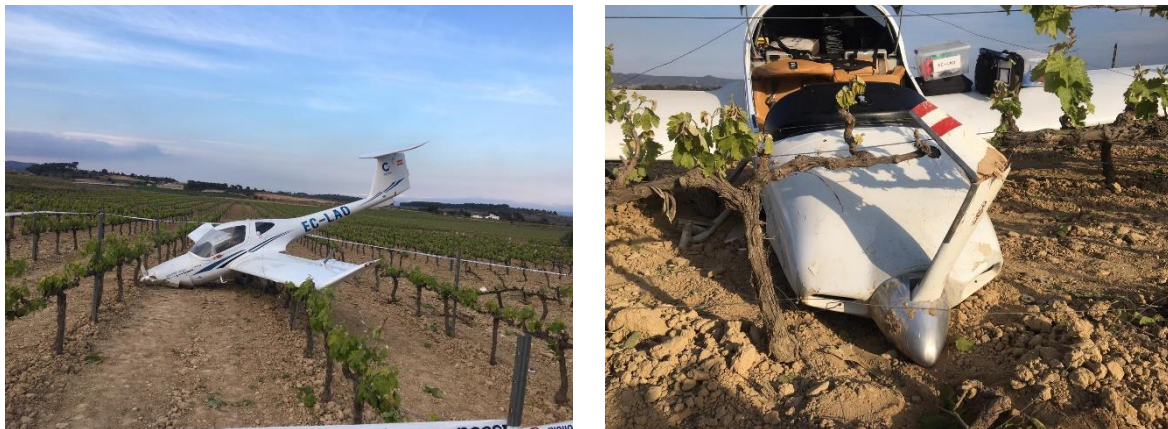
Figure 7. Photographs of the aircraft at the site where it landed

The aircraft landed on a north-west heading, while the rows of the vineyard's espalier structure were laid out south-west to north-east; in other words, virtually perpendicular to the direction of landing.

As soon as the aircraft made contact with the ground, it began to strike the lines formed by the espalier structure. The propeller and each of the three sections of the aircraft's landing gear became caught in the wires of the vineyard's espalier structure, resulting in abrupt deceleration.

The striking of these wires also resulted in the collapse of the front landing gear.

As a result of this collapse, the front of the aircraft dropped down, coming to a rest on the ground. One of the propeller blades was broken off at the bottom, and fell to the ground next to the propeller. The other blade was bent backwards approximately halfway along its length. Neither of the two blades had impact marks or scrapes consistent with spinning.

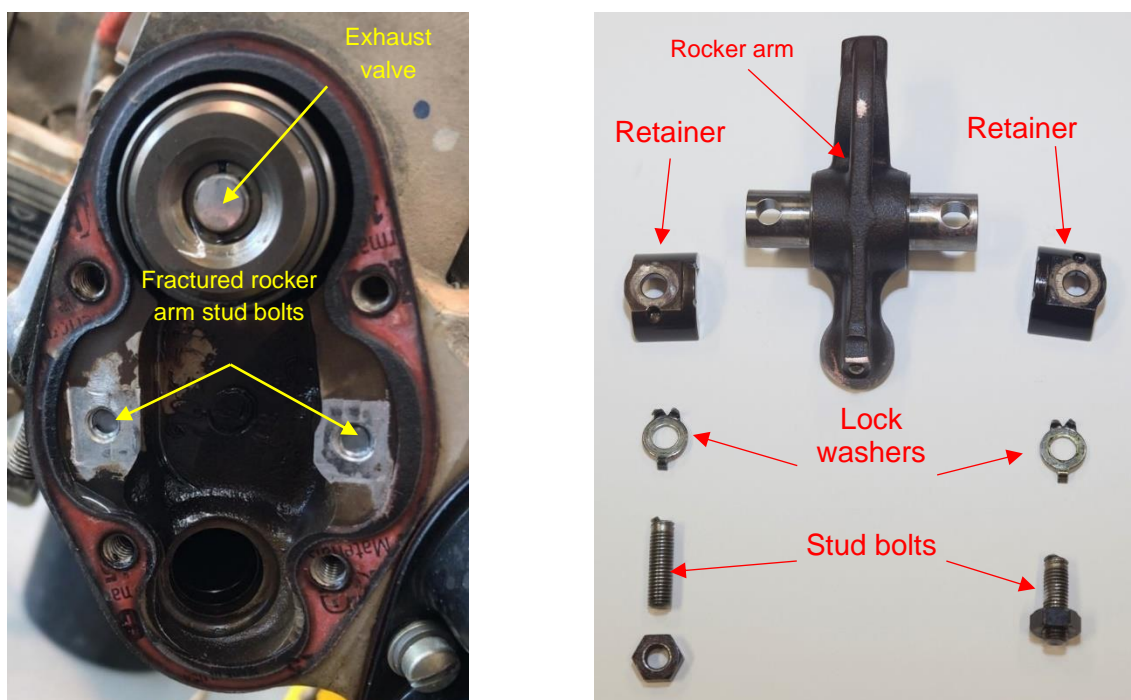
Figure 8. Photographs of the exhaust valve area on cylinder no. 4 (left) and the components that were found to be loose (right)

Once it reached a suitable temperature, the throttle was opened to full power. The RPM increased, albeit not to the expected level. The engine produced an unusual noise and vibrated forcefully.

After the engine was turned off, the rocker covers were removed, and it was observed that the rocker arm of the exhaust valve on cylinder no. 4 had become loose and detached.

- The shaft remained assembled in the rocker arm housing. The two washers on either side of the rocker arm were also in position.
- The retainers were loose but showed no signs of significant damage.
- The two stud bolts that hold the retainers had fractured at the point where they enter the cylinder head (Figure 8, left-hand photograph).
 - One of the bolts still had its threaded nut, while the other did not.
 - The threads on the stud bolt that was missing its threaded nut showed no significant damage. The nut on this bolt was loose, and there was no apparent damage to its threads.
- The two lock washers were also found to be loose, intact, and with no appreciable damage.

The failure of this particular component caused the two valves on cylinder no. 4 to remain closed, thereby rendering the cylinder inoperative.

REC 12/21: It is recommended that Continental Motors, Inc. should carry out the necessary actions and investigations to determine the cause and nature (isolated, organisational, etc.) of the circumstances that led to the faulty installation of some of the rocker shaft lock washers at its facility in Mobile (Alabama).

REC 13/21: It is recommended that Continental Motors, Inc. should take action to ensure the correct installation of the lock washers.

REC 14/21: It is recommended that Continental Motors, Inc. should determine which engine units have potentially left its factory in Mobile (Alabama) with incorrectly installed lock washers.

REC 15/21: It is recommended that Continental Motors, Inc. should contact all operators of aircraft equipped with engines potentially affected by this problem in order to verify the extent of the problem and, where necessary, replace the defective washers.

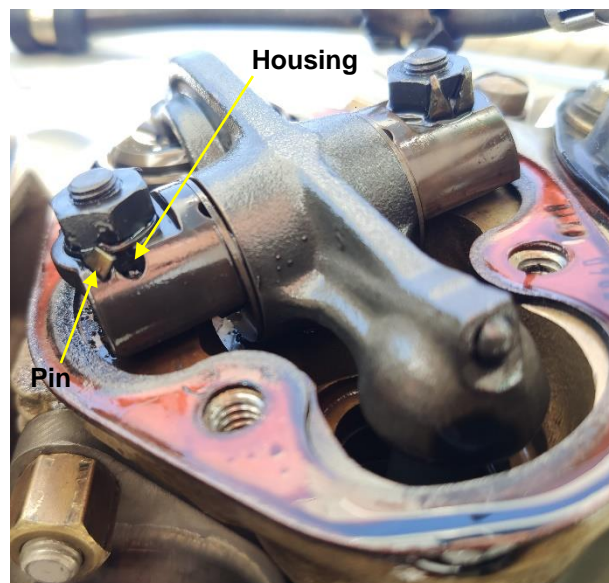
Figure 9. Photograph of exhaust valve rocker arm cylinder no. 3, engine IO-240-B32, s/n: 1035257.

One of the lock washers for the nut securing the shaft retainer in the exhaust valve of cylinder no. 3 was found to be defective, as the pin had not been inserted into the retainer housing (see Figure 9).

Under such conditions, the washer would not perform a sufficient braking action on the nut, which could therefore become loose.
