CIAIAC

Report A-012/2018

Accident involving a Cessna
525C – CJ4, registration
EC-MOQ, operated by Aluminios
Cortizo, at the Santiago
de Compostela Airport
(A Coruña) on 4 May 2018

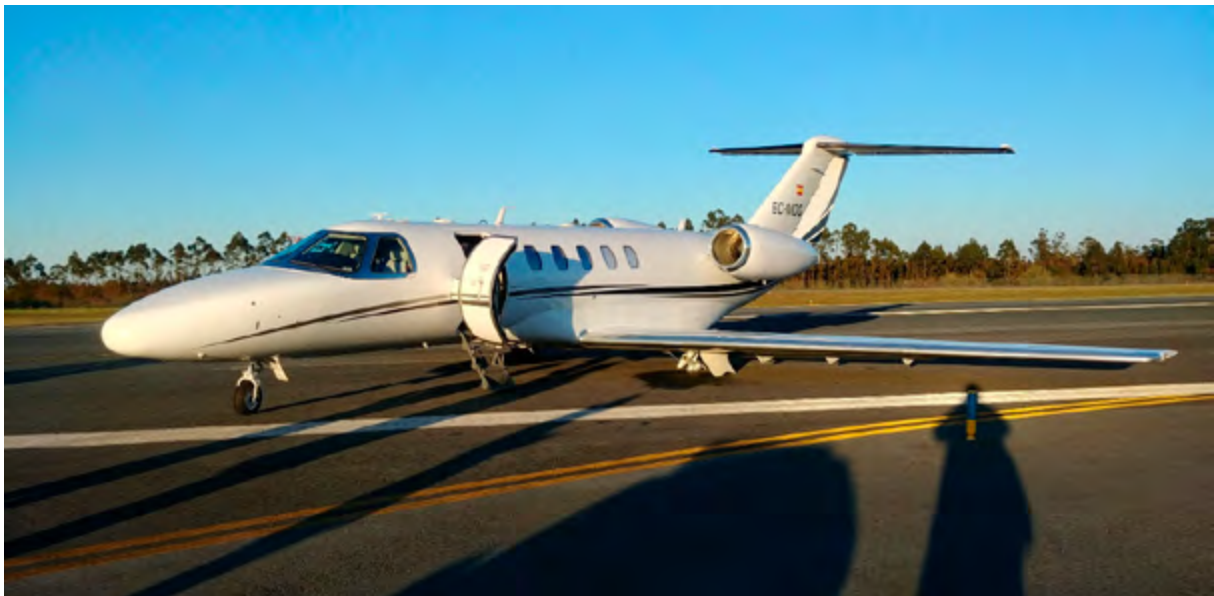
Figure 1 – Position and condition of the aircraft after collapse of left leg

The damage to the aircraft was limited to the left landing gear assembly and part of the left wing, which had been affected by the collapse of the same-side landing gear leg. These deformations and damage to the left wing affected primary structural components.

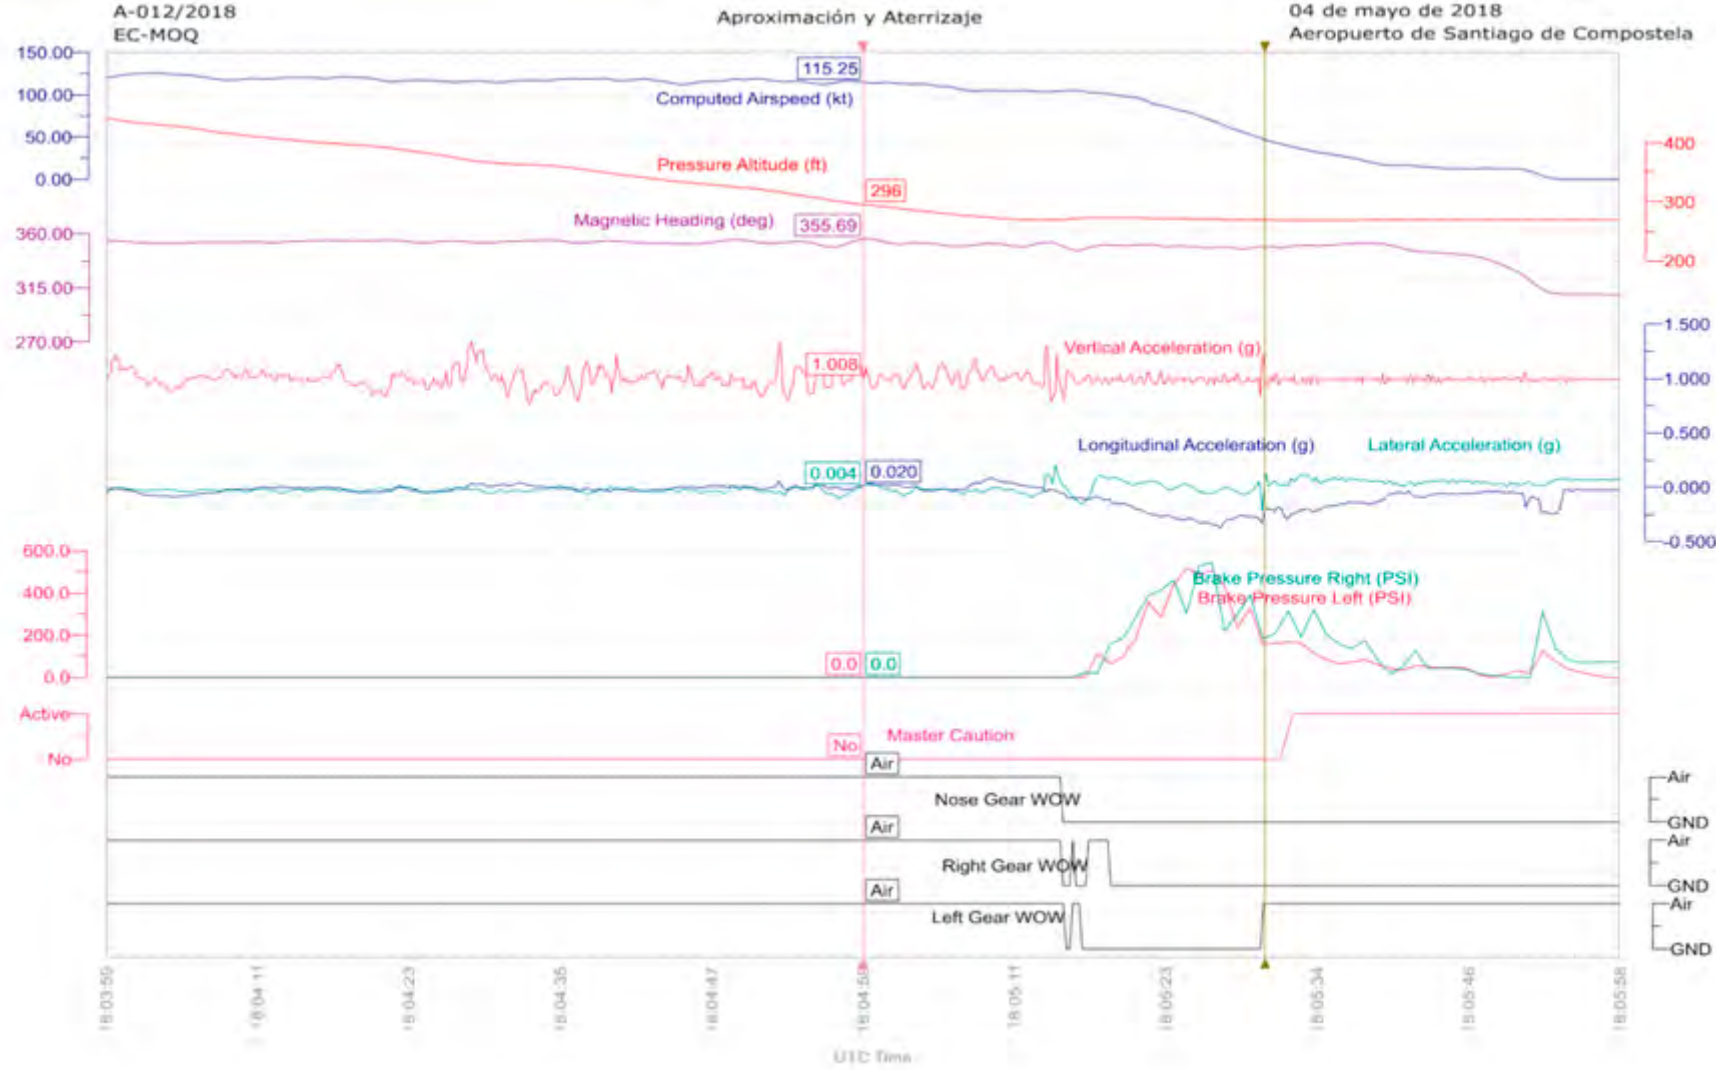
The graph below shows the trends in the DFDR parameters over two minutes during the landing, which clearly indicate the instant when the left leg collapsed.

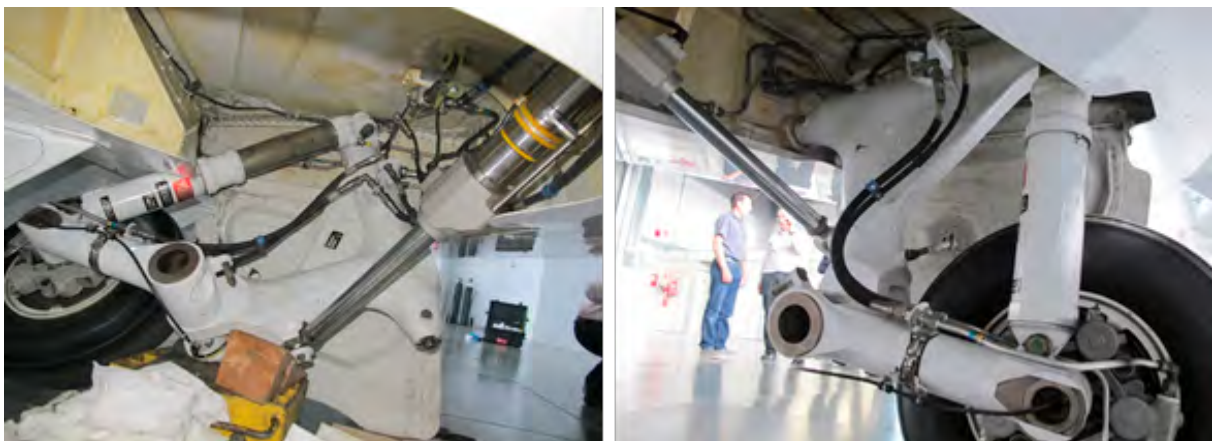
The left leg trunnion fitting was found outside its forward and aft supports at both wing spars (star-shaped reinforcement with a support coupling where both trunnion fittings rest). After coming out of the longitudinal axis of the gear (about which it extends and retracts), it turned forward and to the right. This leg remained attached by

Figure 2 – Left leg outside the wheel well (l), and right leg in its normal extended position (r)

the hydraulic extension/retraction actuator, and its weight was supported by the lower wing structure.

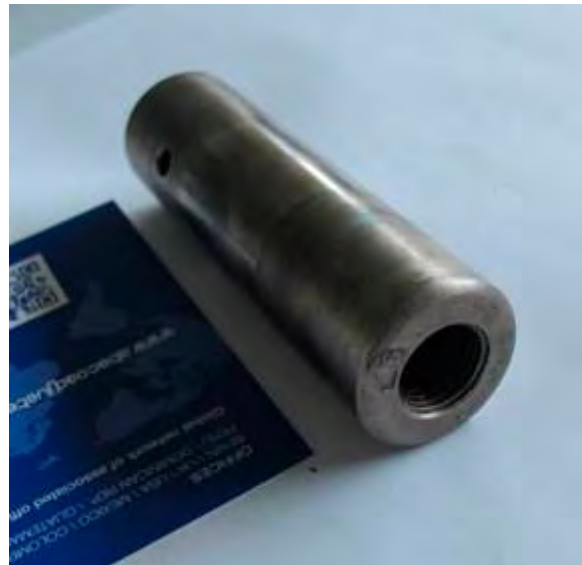
The initial examination of the left leg showed that the left trunnion was outside its housing on both sides of the trunnion fitting axes in the coupling in the left-wing spars. The aft trunnion pin was in its housing in the trunnion fitting and the bolt was intact in the trunnion, confirming it had been incorrectly installed outside the trunnion pin, and thus was not holding it in place.

Figure 3 – Left aft trunnion pin

This condition is consistent with an incorrect installation already described by the manufacturer, which led it to issue Alert Service Letter (ASL) 525C-32-01, "Landing gear – Aft main landing gear trunnion pin inspection", on 19 July 2012.

Coincident with the investigation into the event and the analysis of the components removed from the landing gear, the aircraft manufacturer, Textron Aviation, issued service letter SL 525C-32-12 on 9 July 2018, compliance with which is mandatory, which provided instructions for inspecting the bolts on the aft trunnion of the main landing gear in case this bolt was incorrectly installed on more aircrafts. As a precaution, this document instructed that an airplane with an incorrectly installed bolt must not be moved until this condition is corrected.

SR 24/19: It is recommended that the manufacturer of the Cessna 525C, Textron Aviation, review its procedures for assembling/disassembling the main landing gear legs, and all other maintenance tasks involving these components, and how they are applied at its maintenance centers; including the subsequent inspections of critical elements such as bolts and pins.

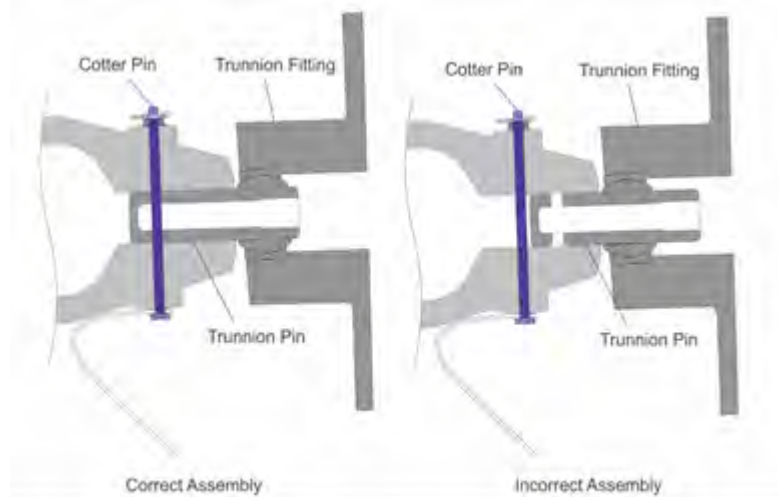
Provided in this report are illustrations supplied by Cessna in its ASL 525C-32-01, Figure 1 Aft Main Landing Gear Trunnion Inspection (sheet 1)", with two close-ups showing the position of the bolt, one correctly installed and another incorrectly installed, as well as two views from behind showing both conditions.

Diagram 2 – Detail of the bolt installed correctly and incorrectly

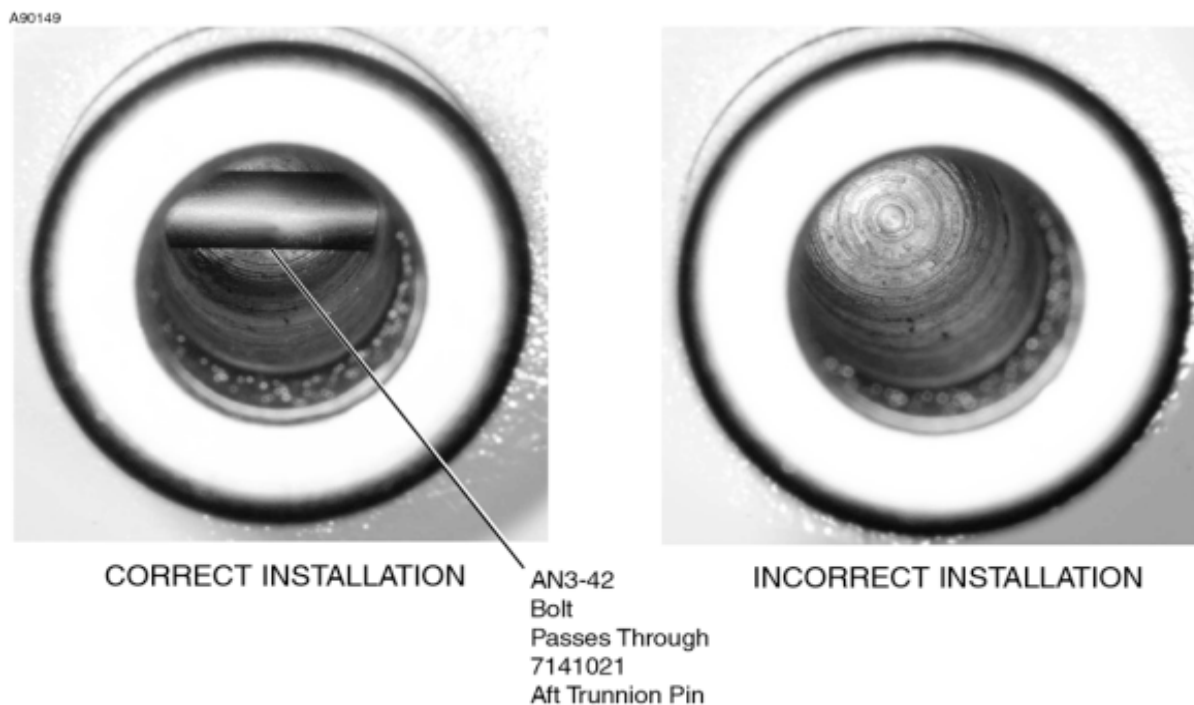
Figure 4 – View inside the aft trunnion pin

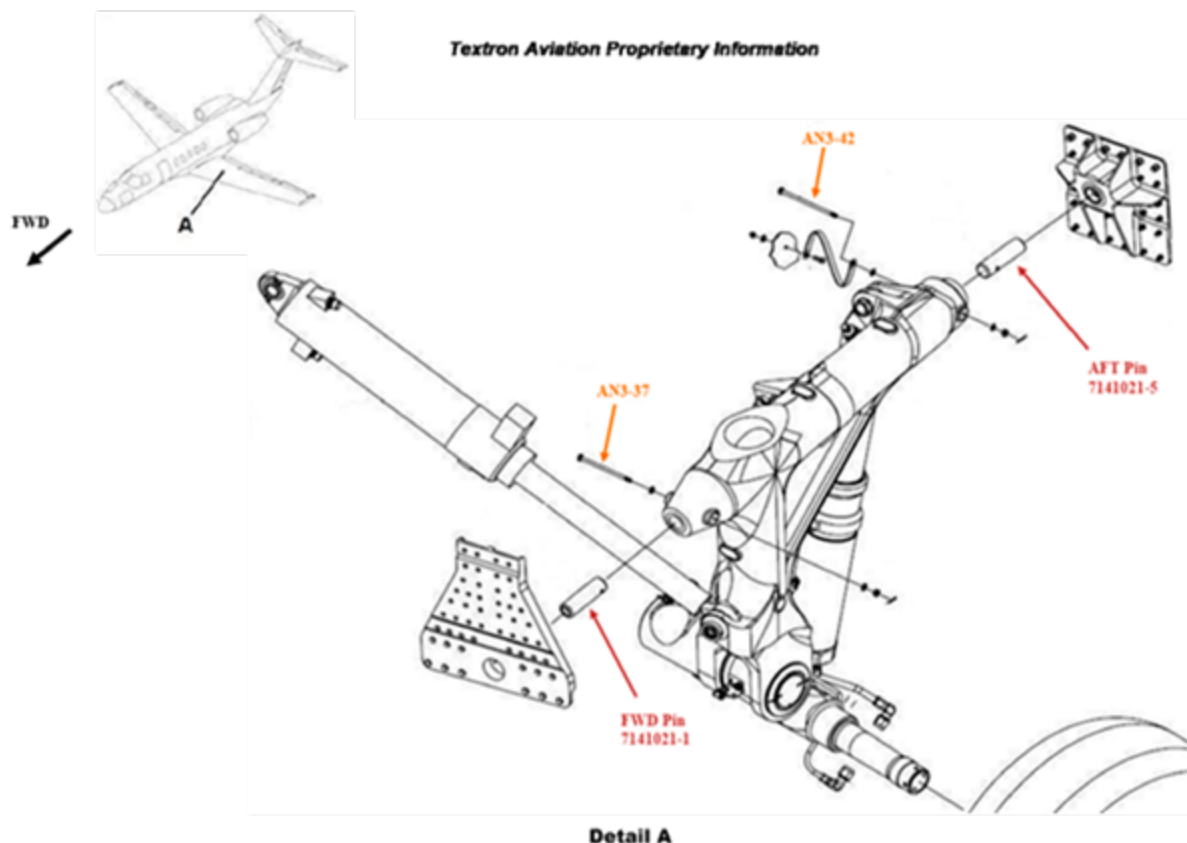
Diagram 3 – Main gear assembly

- The bolt, AN-3-42, of the rear support on the left side (side and trunnion pin that caused the accident), was broken at the threaded end and the other end had broken off. It contained a gray sealant residue over another black sealant. This was the only bolt of the four with residue from two different sealants, which indicates a repair of the connection with a bonding jumper on this pin. According to the maintenance history, it was replaced in November 2017.

- As to whether the aft trunnion pins were originally installed correctly or incorrectly, the presence of two adjacent surfaces with contact/wear marks with the fitting, analyzed using penetrant liquid tests, indicates that these trunnion pins had been installed correctly at some point prior to their last installation.
