# Technical report

## A-017/2022

Accident involving an EC145 (MBB-BK117 C-2) helicopter, registration EC-MSD, on 28 March 2022 at Tenerife Sur Airport (Tenerife)

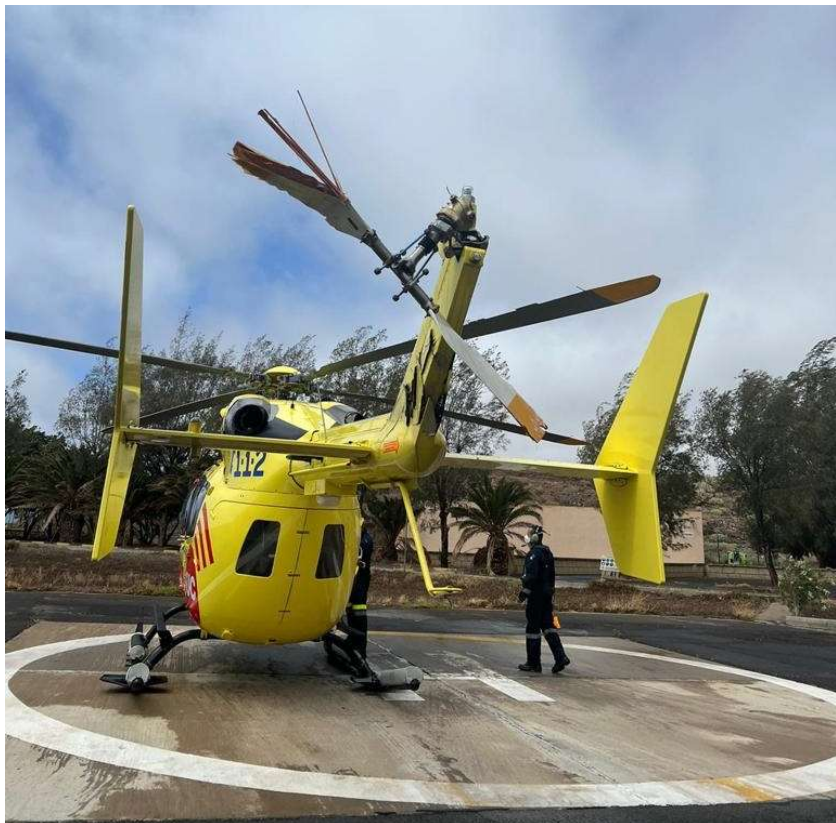
Fig no. 1. - Condition of the helicopter's tail rotor and vertical stabiliser.

The aircraft suffered impact damage to both tail rotor blades, the tail rotor shaft and its gearbox, which was partially detached. There were also signs of impact damage and cuts on the left side of the vertical stabiliser.

The impact with the tree branches severely damaged the tail rotor blades, and as a consequence of this damage and the progressive deterioration that occurred as they continued to rotate, they subsequently impacted the vertical stabiliser. In addition, the gearbox on the tail rotor shaft was partially dislodged from its position on the stabiliser and tilted downwards.

The damage inspection found that the tail rotor had been rendered useless, and the shaft gearbox had partially separated from its shaft and the vertical stabiliser; however, there was no overload on the main rotor mast, even though the exceedance warning had been triggered.

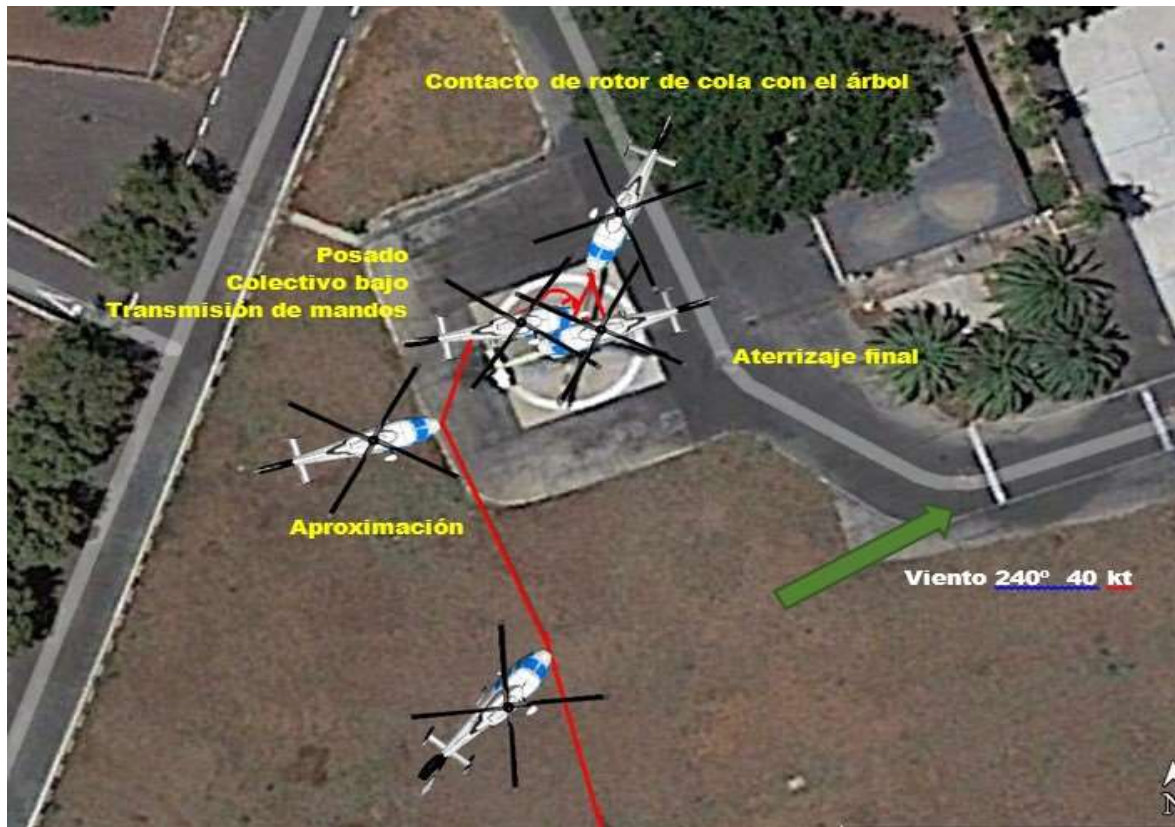
Fig No. 3. - The helicopter's significant positions during the parking manoeuvre.

In the final 36 seconds after the captain has taken over the controls, the helicopter rises a few metres and turns 180° to the right, with a more exaggerated range of movement to the rear, turning its tail to the service building before landing on the helipad.

The reality was that the surface wind conditions hampered the helicopter's manoeuvrability when hovering and hindered the transfer of the flight controls, as can be seen in the reaction and attitude of the helicopter shown in Fig. 3. The helicopter's wide rotation and lift occurred just after the captain took over the controls.
