Technical report

A-021/2022

Accident on 09 April 2022 involving a Diamond DA-40 aircraft with registration EC-IQD, operated by Aerotec Escuela de Pilotos, at Cuatro Vientos Airport (Madrid)

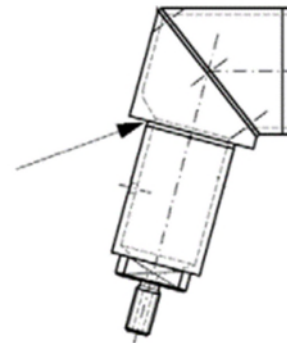
Subsequently, in 2008, Diamond issued mandatory service bulletin MSB 40-046, which specified that the pivot axle on the nose gear fork (see the area marked by the arrow in the figure on the right) should be inspected for fatigue cracks:

- It also specified that only the dye penetration method could be used.
- For aircraft operating on paved runways, as was the case for the accident aircraft, this inspection had to be carried out within the next 100 h of operation and every 200 h of operation thereafter.

Diamond stated in this service bulletin that if a crack is found, the leg should be replaced. If the installed leg was P/N D41-3223-10-00_1 or higher, no further action was required by Diamond.

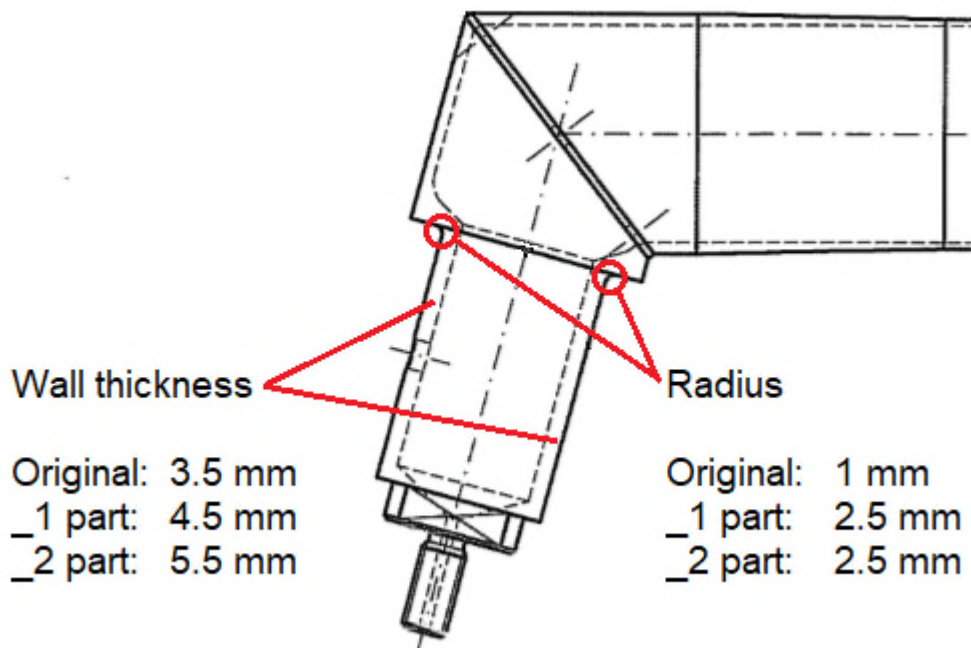
During the investigation, Diamond provided information on how the pivot design has evolved in the different versions of the nose leg:

After conducting a stress analysis on the NLG fork, Diamond concluded that the version_2 gear is less susceptible to fatigue than the version_1 gear. The results from the analysis show that the version_2 gear may last 6 to 10 times the number of cycles the version_1 gear is expected to last depending on the limit load used during the calculation.

During the investigation, Diamond detailed how the design of the pivot axle on the nose leg fork had evolved to prevent it from failing in service due to material fatigue. The company indicated that the wall thickness of the pivot axle had been increased: 3.5 mm in the original version, 4.5 mm in version_1 and 5.5 mm in version_2, as had the radius that joined it to the rest of the leg: 1 mm in the original version, 2.5 mm in version_1 and 2.5 mm in version_2.

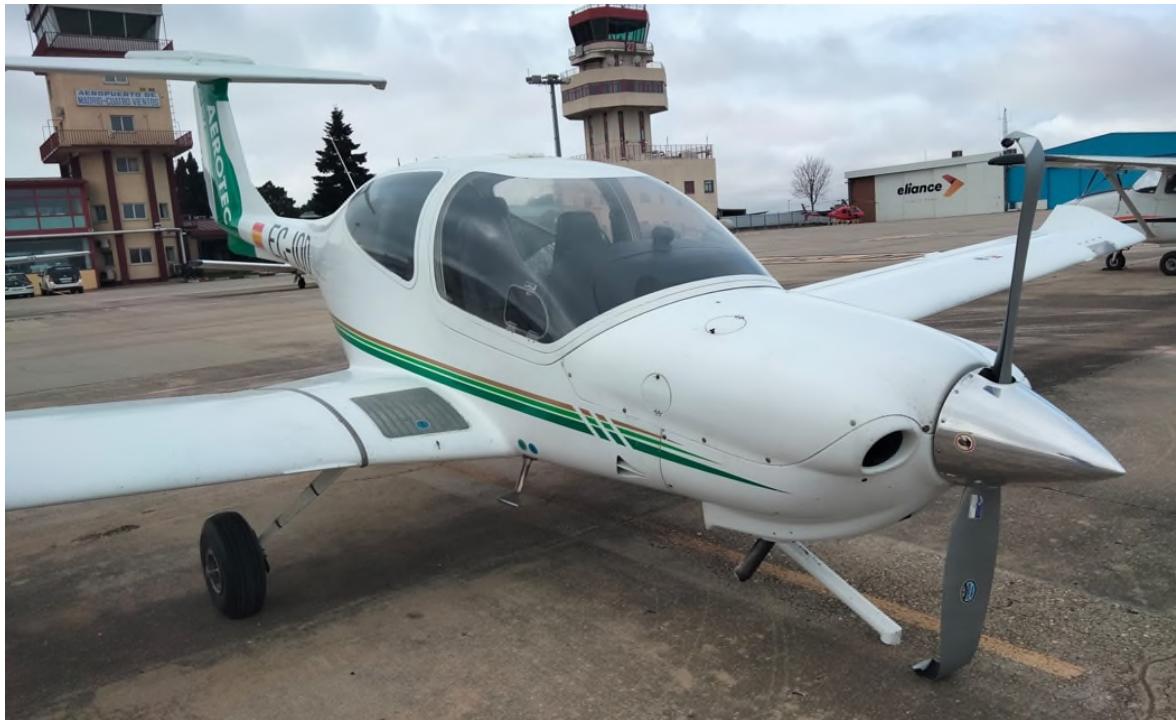
Image 3: Condition of the aircraft after the event

When the nose gear leg broke, the aircraft slid along the ground on its nose, causing damage to the propeller and engine.

The aircraft suffered damage to its forward landing gear, propeller and engine.

The following image shows the aircraft's condition after the front landing gear leg broke. The damage to its propeller blades, caused by the aircraft moving along the runway without its front leg, can also be seen:

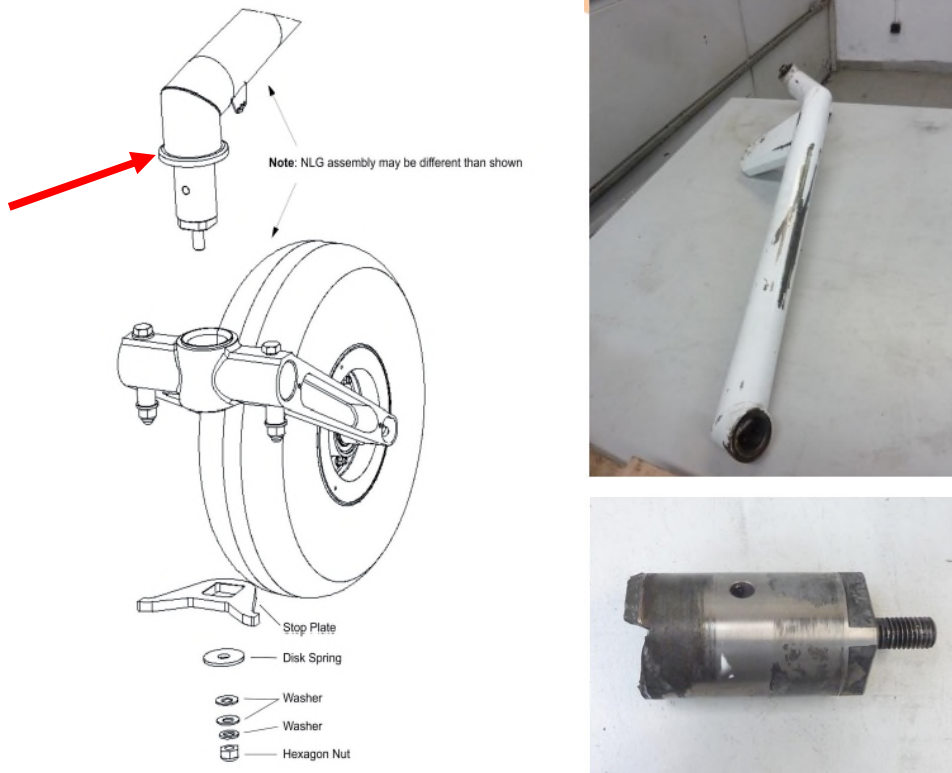
Image 4: Breakage of the nose landing gear leg parts

The damage to the landing gear nose leg was studied in detail. In the diagram below-left, the area of the breakage is marked with a red arrow. The two photographs on the right show the breakages on the tubular strut and the pivot axle, which attaches to the nose wheel support:

The fatigue fracture occurred in the upper part of the axle, at a non-smooth transition between sections that constitutes a geometric notch; in other words, a point of stress accumulation around the entire perimeter, generating the onset of the fatigue fracture and favouring its rapid progression.

The SGS laboratory determined that the pivot axle of the nose leg fork suffered an in-service failure due to fatigue. It concluded that the design of the pivot axle was inadequate because the change in section, with an abrupt transition due to the small radius, constituted a point of stress accumulation around the entire perimeter. In addition, it was noted that the chrome plating on the pivot axle was severely worn, suggesting the existence of considerable friction between the pivot axle and the fork, which would also have contributed to stresses in the area.

After an internal analysis of the incident, the aircraft operator decided to replace the nose leg with a redesigned P/N D41-3223-10-00_2 version as per the aircraft manufacturer's mandatory service bulletin MSB 40-091, which states that this is the definitive action to be taken in order to avoid this type of service failure in the future.

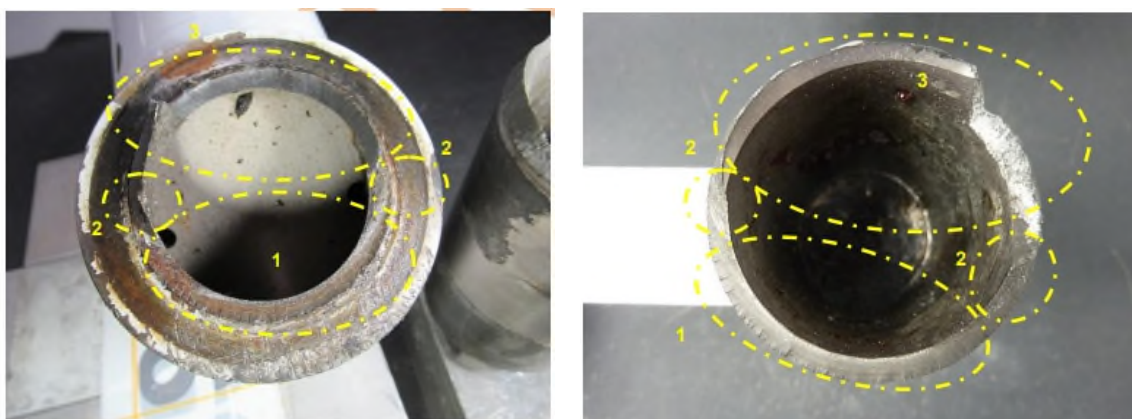
Image 5: The photograph on the left shows the breakage on the tubular strut, and the photograph on the right shows the pivot axle

On visually examining the fracture surface and fractographic features left by the failure process that led to the complete breakage, the SGS laboratory found 3 clearly distinct areas, distinguishable from one another in terms of their topography, on the fracture surface of both parts:

Zone 1 has a smooth, matt texture, with the main feature being the presence of radial marks throughout, covering approximately one-third of the section. Behind these radial marks are circumferential marks with a highly open curvature that practically follow the circumferential perimeter of the tube. These features are typical of a fatigue fracture.

The presence of numerous radial marks suggests numerous origins of the fatigue fracture via the outer surface and generally associated with elevated stress on the perimeter of the surface where they occur. Given the high level of stress present, the breakage progressed rapidly.

When the applied load exceeds the material's resistance to tearing, the fracture mechanism changes (zone 2) to a semi-fragile tear, where the surface texture is rough and with a change in the plane of the fracture progression.
