TECHNICAL REPORT

A-022/2022

Accident occurring on 26 April 2022 during disembarkation of a Boeing 737- 800 aircraft bearing the registration EL- ENK, operated by RYANAIR, at Almería Airport (Spain)

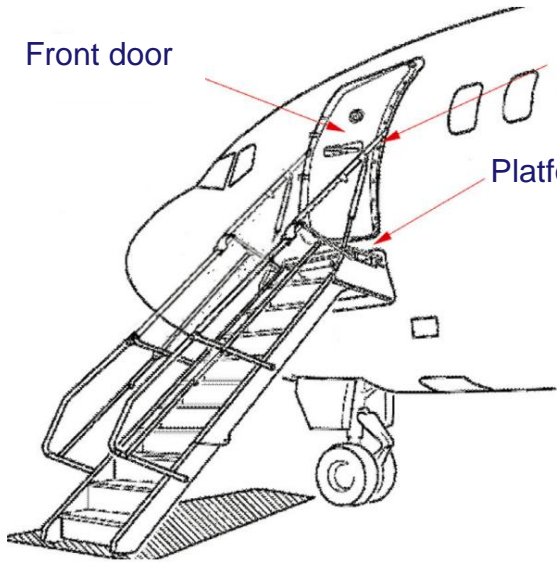
Figure 1. Extendable front stairs on the Boeing 737-8SA

These types of stairs have narrower steps and thinner and lighter handrails than the external stairs that are normally provided by airport handling services³.

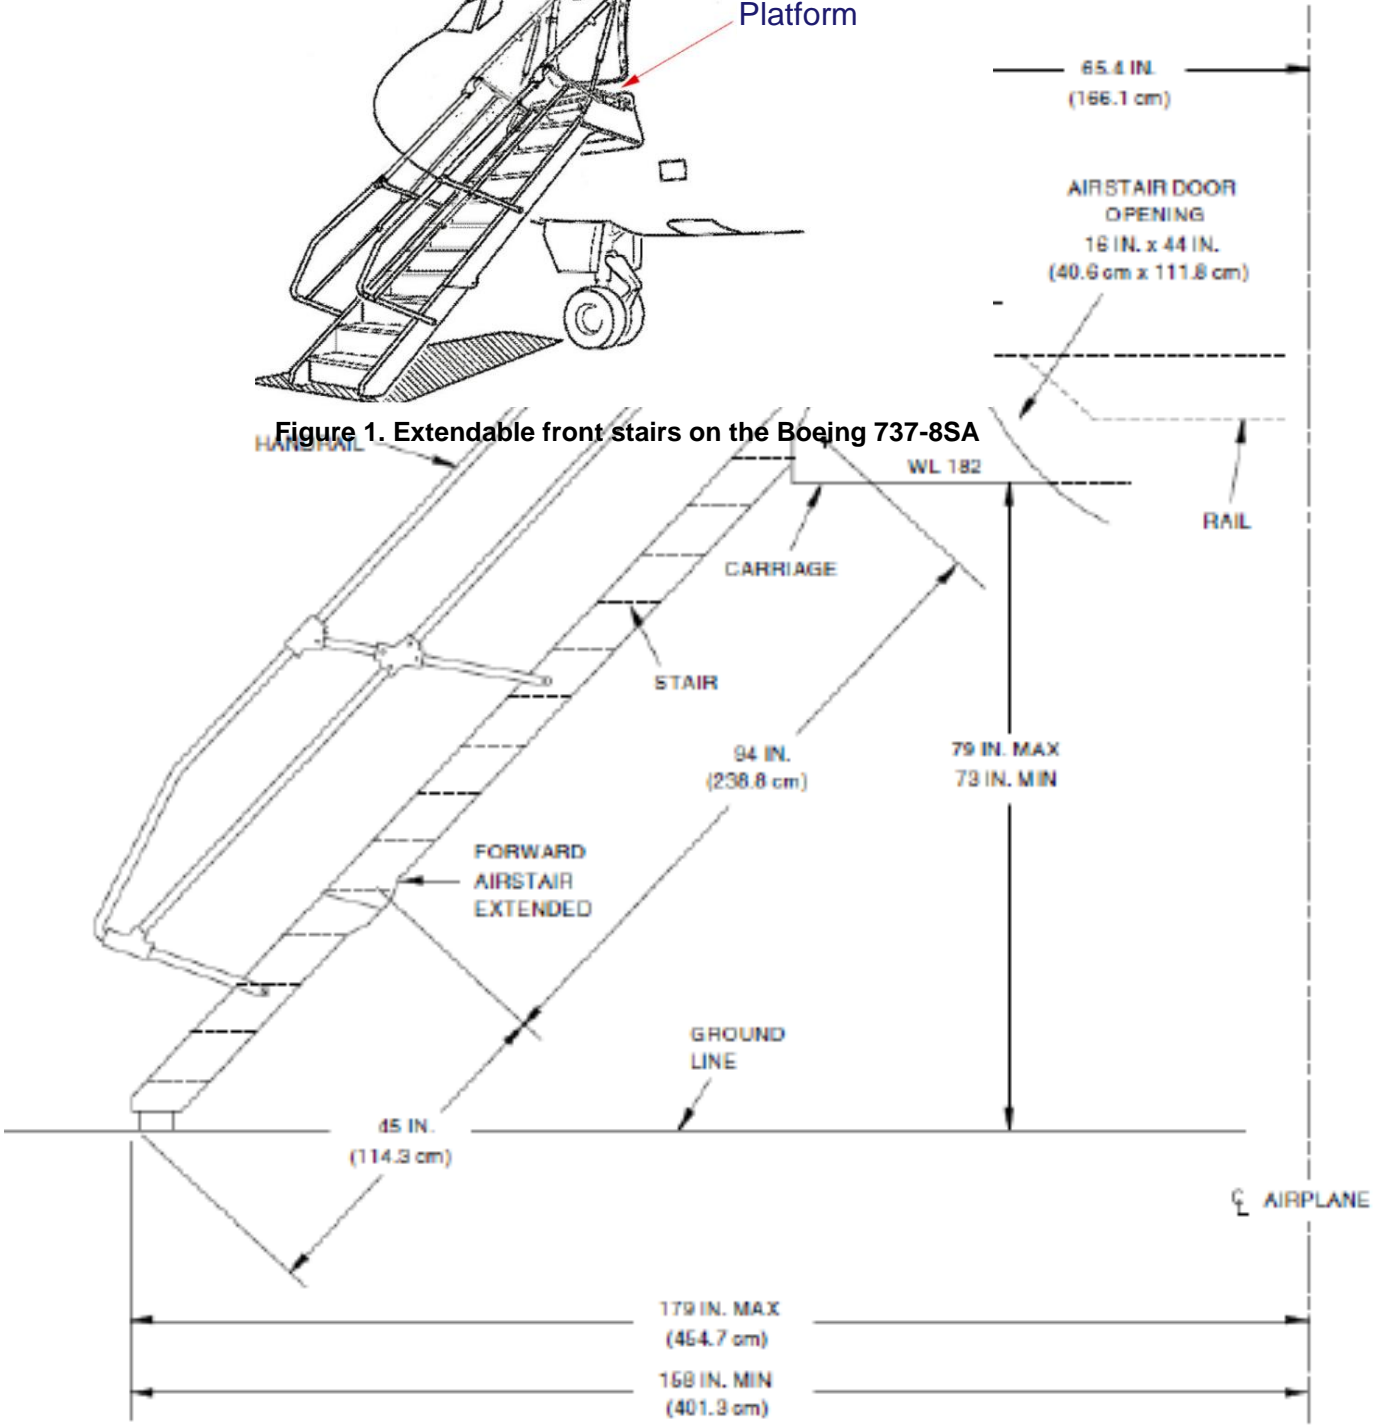
covered with non-slip material in the tread area. **Figure 2. Dimensions of the extendable front stairs on the Boeing 737-8SA**

The dimensions of the stairs are defined in the BOEING document titled "Airplane Characteristics for Airport Planning". The height of the stairs can vary, ranging from 1.85 m to 2 m, with a length of 3.53 m. Consequently, the gradient of the slope ranges from 62% to 69%, respectively.

stairs are 0.62 m total of 12 steps,
