# Technical report

## A–029/2022

### Accident on 04 June 2022 involving a TECNAM P2008 JC aircraft, registration EC- NKE, at Madrid-Cuatro Vientos Airport (Madrid, Spain)

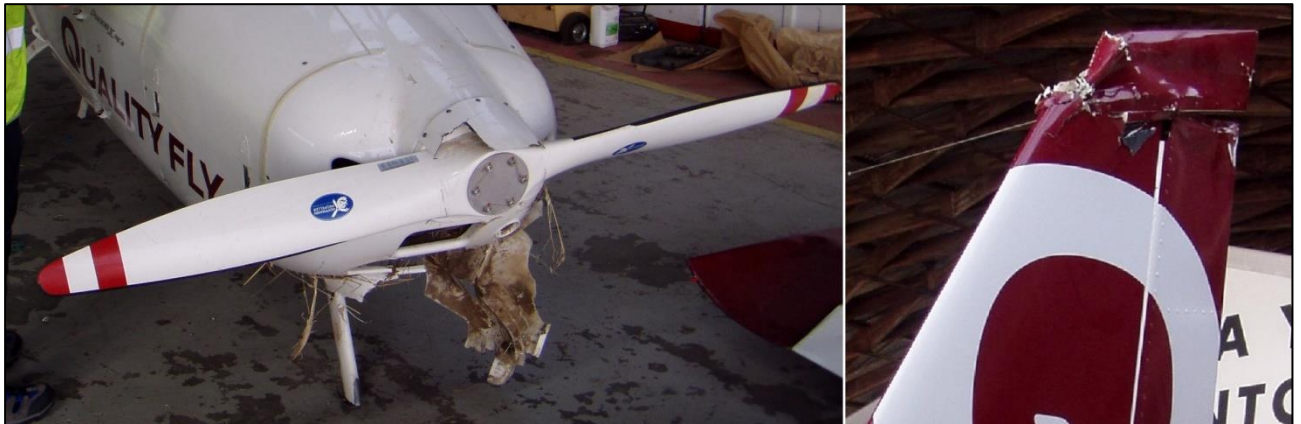
**Figure 1. Damage to the landing gear and vertical stabiliser**

The aircraft sustained damage during the landing, mainly to its fuselage, propeller and landing gear.

The image in Figure 1 shows the broken nose leg and the damage to the end of the vertical stabiliser sustained during the rollover.

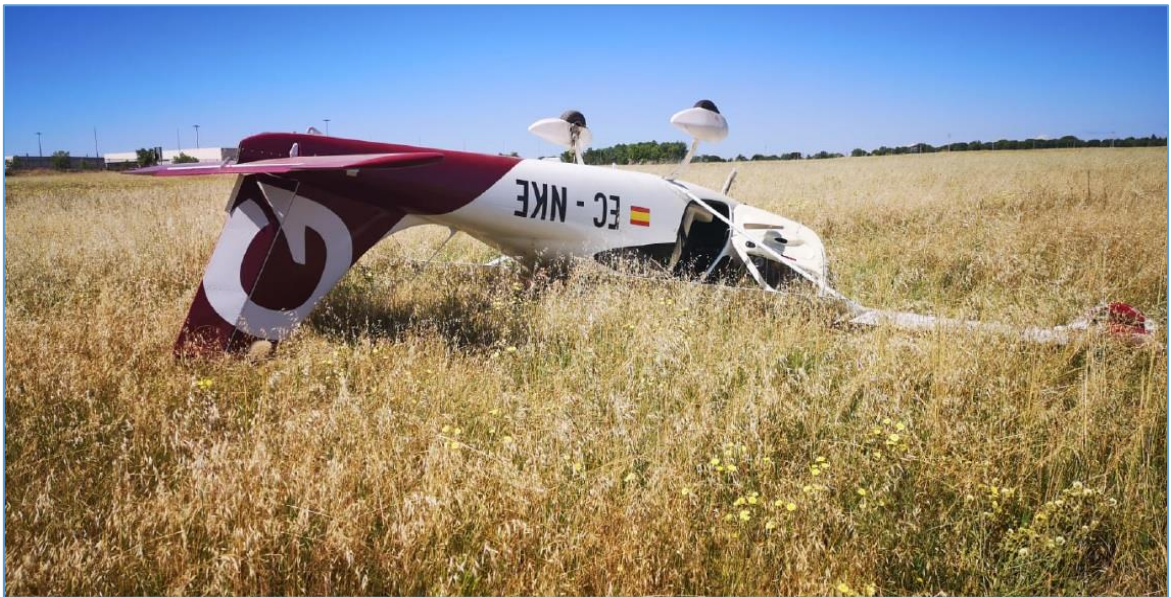
**Figure 6. Final position of aircraft EC-NKE**

The pilot performed the emergency landing on a field located to the south of the airport, about 350 m from the runway. Due to the unevenness of the terrain, the aircraft flipped over a few seconds after touching down.

The image in Figure 6 shows the aircraft in its final position.

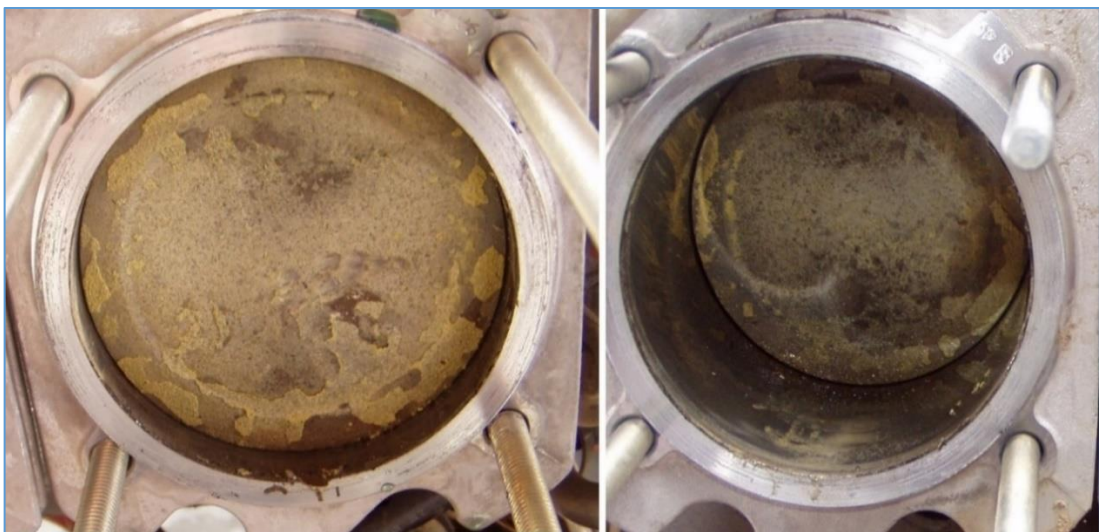
**Figure 7. Residue in cylinders 1 & 2**

The front of the aircraft was lifted onto a stand to test the engine, revealing that the crankshaft was blocked at one point and could only be partially rotated. On disassembling the cylinder heads to check whether any of the cylinders had seized, deposits of carbon residue were found inside them. The residue was worse in cylinder No. 3 than in the others.

The images in Figures 7 and 8 show the carbon deposits observed. In cylinders 1, 2 and 4, these deposits primarily constituted a layer covering the piston heads. In No. 3, however, the residue had also fallen to the bottom of the cylinder and been dragged along the wall by the piston as it moved towards top dead centre.

In terms of whether these deposits could affect the movement of the pistons and, therefore, the functioning of the engine, the manufacturer dismissed this possibility, indicating that the quantity observed was within the normal limits. As a result, a second engine inspection was carried out to try to detect any damage or evidence of failure. During this inspection, the crankshaft and connecting rods were found to be undamaged, and no other deficiencies were identified. It is possible that these deposits could have broken off from the layer formed as a consequence of the accident, and subsequently interfered with the movement of the crankshaft, but they have been ruled out as the cause of the engine failure.

The engine's online maintenance manual does not include actions to detect this type of build-up in the routine overhauls. However, based on the inspection findings, the maintainer indicated that it would include boroscopic inspections of the cylinders in the 100 h overhauls to detect potential build-ups of carbon residue.

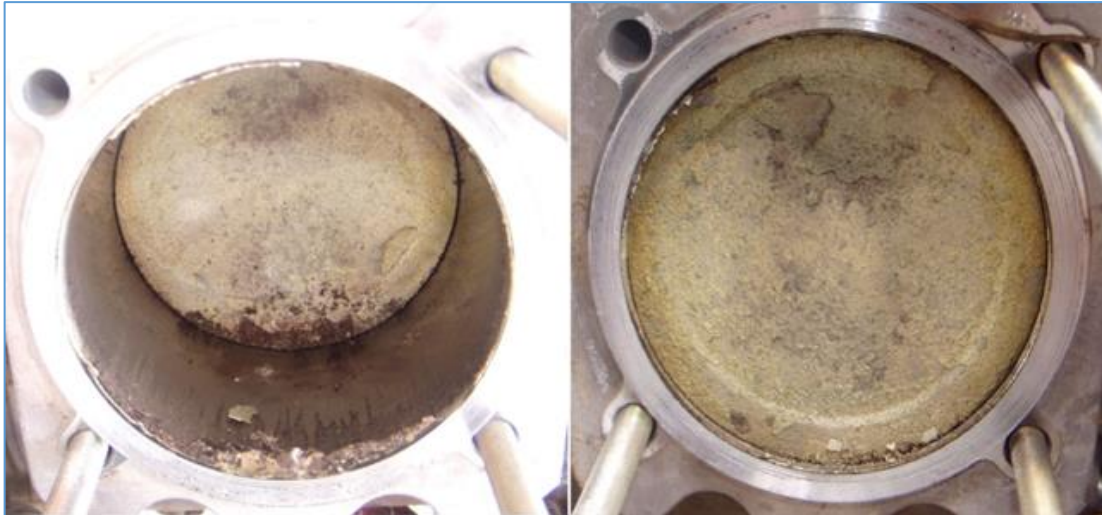
**Figure 8. Residue in cylinders 3 & 4**

It was confirmed that, after removing the cylinder head of cylinder No. 3 and making room for the debris inside it to move outwards, the crankshaft could be rotated freely, with no blockage or resistance to its rotation.

- It was noted that the crankshaft could only be partially rotated, and on removing the cylinder head of cylinder No. 3, a build-up of carbon deposits was observed, although this was ruled out as the cause of the engine failure.

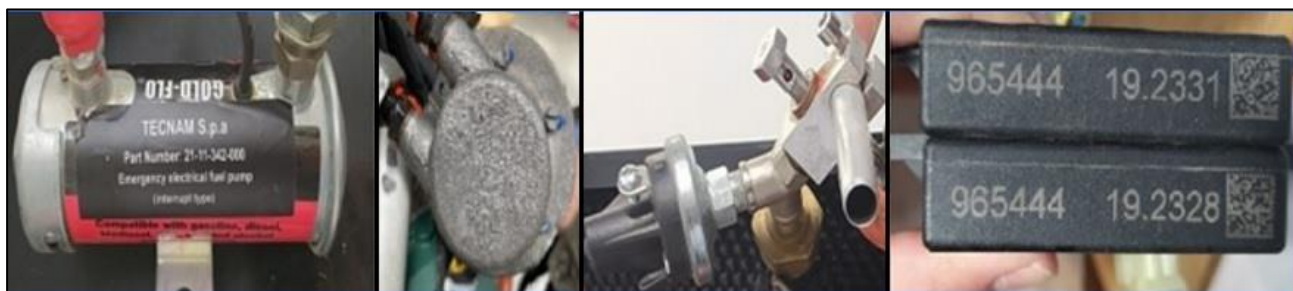
**Figure 9. Fuel pumps, sensors and ignition boxes**

No deficiencies were detected in the fuel pumps, pressure sensors and ignition boxes, which all functioned correctly when installed in a test engine.

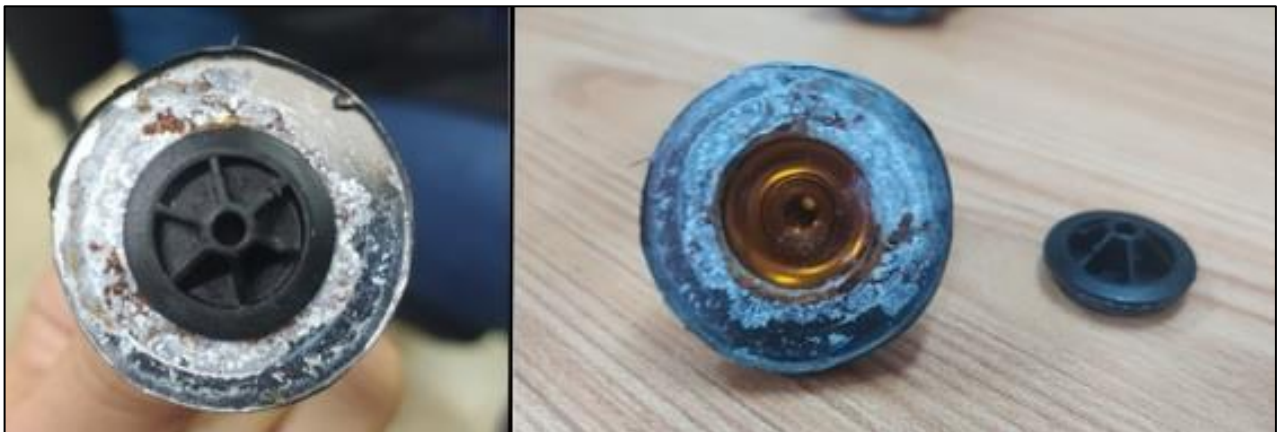
**Figure 10. Interior of the low fuel pressure warning sensor**

The sensor was opened to check its internal condition, revealing moisture, residue accumulation and corrosion inside.

The sensor was found to have a membrane which responds to pressure variations. This membrane moves a plastic actuator, which in turn slides and pushes a metal tab that acts as a switch. This plastic actuator was found to be jammed and could not be moved, leaving the warning device in an open circuit. Consequently, it was determined that the sensor had lost its seal. Cleaning spray was applied to the area around the plastic actuator, and when some of the dirt preventing it from moving was removed, the actuator was released.

With regard to the low fuel pressure warning device, although it had lost its seal and had rust and accumulated residue inside, which prevented it from working, it should be noted that on testing the fuel system in the first inspection carried out in the days following the accident, the fuel pressures were correct and no alarm sounded in the cockpit, which indicates that it was working after the accident. It is likely that the condition of the warning device, whose actuator was jammed, was caused by the rust and deposits that accumulated in the period between the accident and the time of the test, some 11 months. It is also likely that had the aircraft continued to operate, the residue would have continued to accumulate inside, and the sensor would probably have eventually failed due to the observed loss of airtightness.

- The fuel pumps and ignition boxes were tested on another engine, and no faults were found.
- The low fuel pressure warning device was found to be inoperative at the time of testing, as residue and rust had formed inside it.

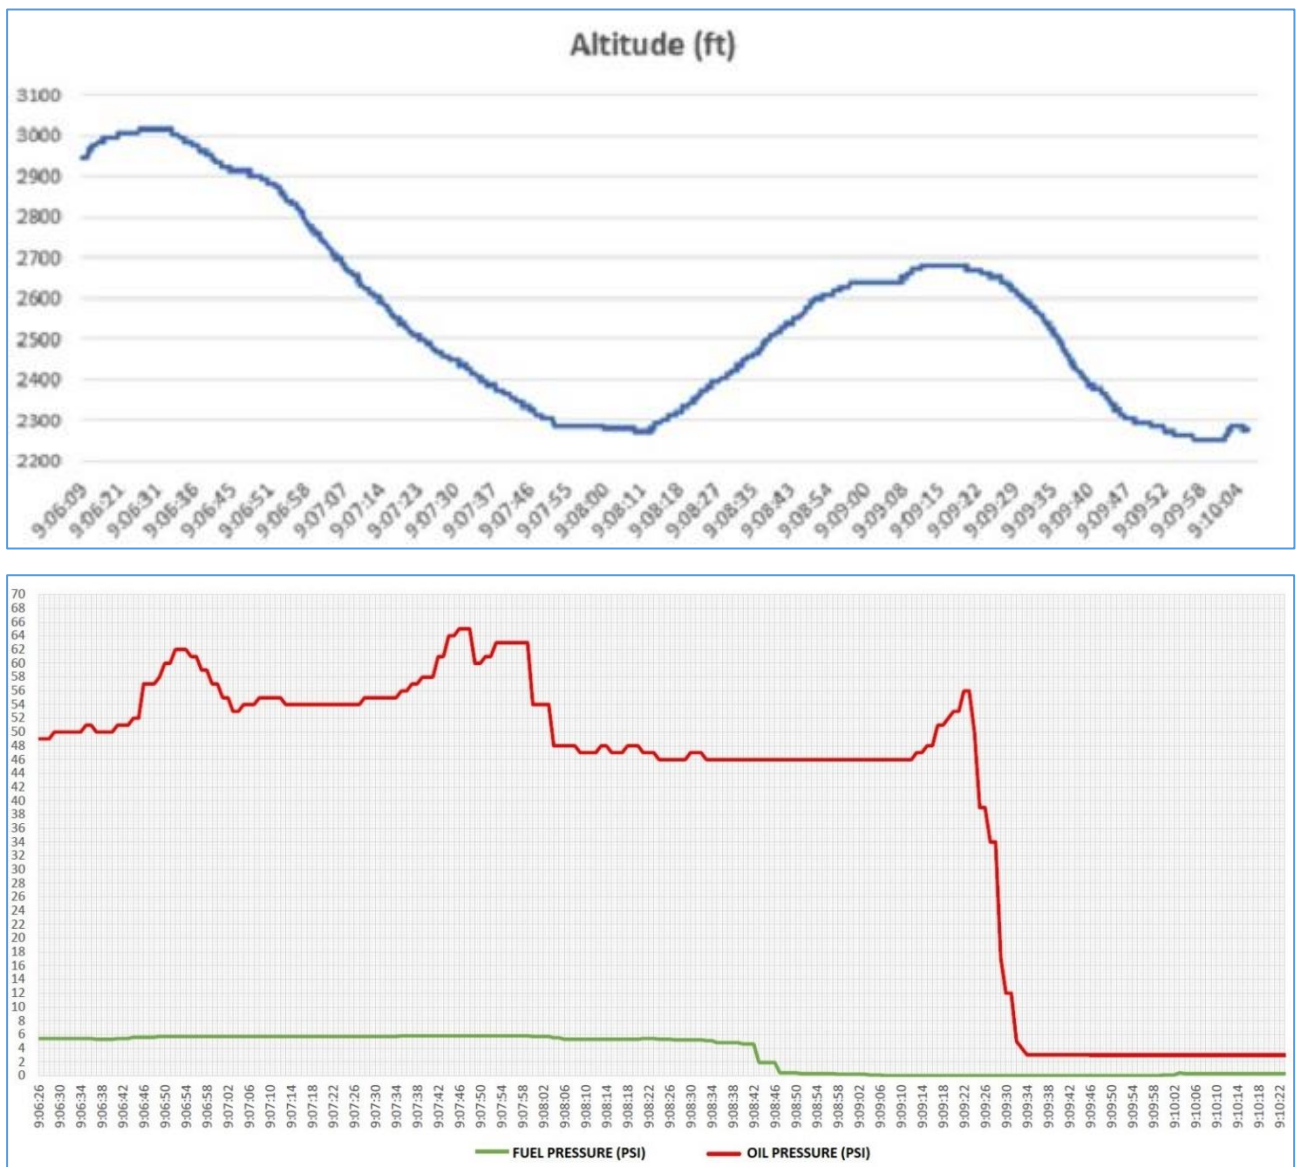
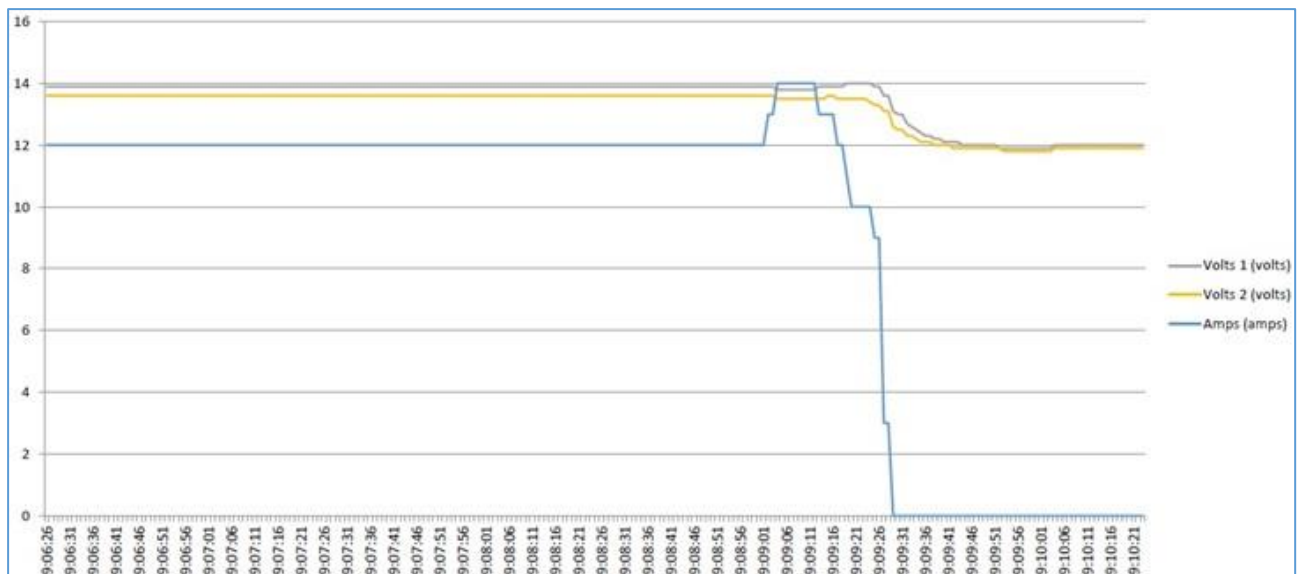
**Figure 11. Altitude, fuel and oil pressure, electrical intensity and battery voltages**

They show that at 11:08:42 h, about 20 seconds before the last communication with the tower, which was cut off, the fuel pressure began to drop to zero during the climb after take-off, and the power consumption also decreased. According to the information obtained, at 11:08:47 h, the low fuel pressure alarm was activated.
