# Technical report

## **A-031/2021**

Accident on 11 July 2021 involving a Bell412 helicopter operated by Rotorsun, registration EC-MTS, in Ejea los Caballeros (Zaragoza-Spain)

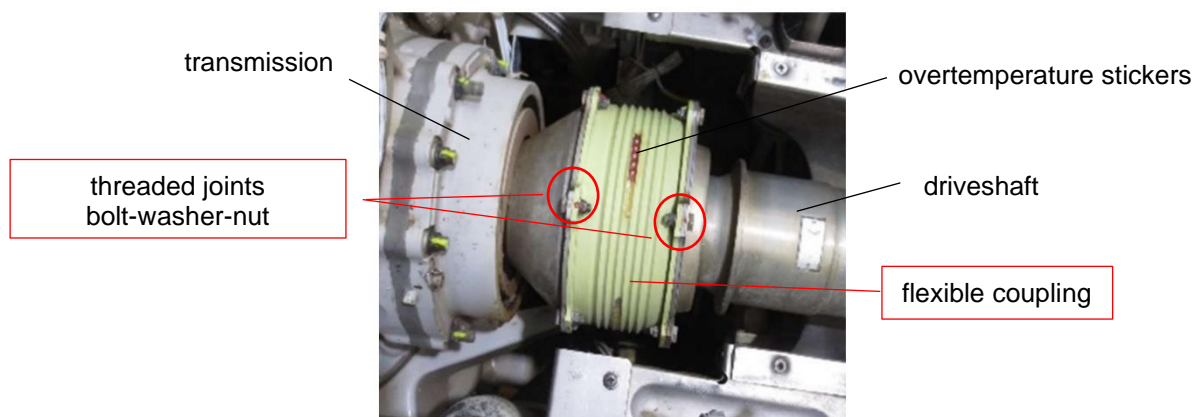
Figure 3. Flexible coupling of the main driveshaft

In the EC-MTS helicopter accident, the flexible coupling connecting the main driveshaft to the gearbox was found to be disconnected, and the 6 threaded joints on that flange had separated.

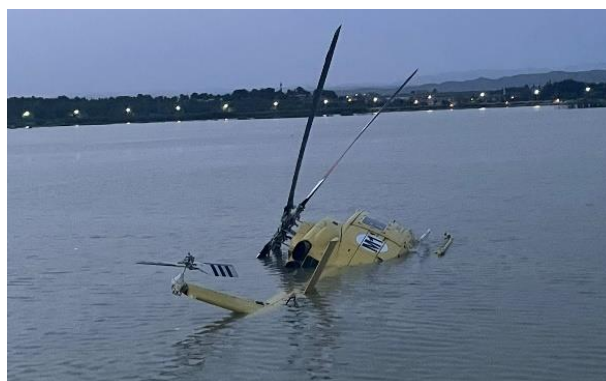
Figure 7. Aircraft EC-MTS after the accident

The aircraft had minor exterior damage:

- The most significant damage consisted of a vertical and upward compression deformation of the lower fuselage, which was more pronounced on the right side than on the left, caused by contact with the helibucket during the impact with the water.
- Deformation of a door panel on the right side, which could not be opened, as a result of the previous deformation.
- Small compression deformation on the right side of the vertical stabiliser.
- The main and tail rotor blades and skids had no visible damage.

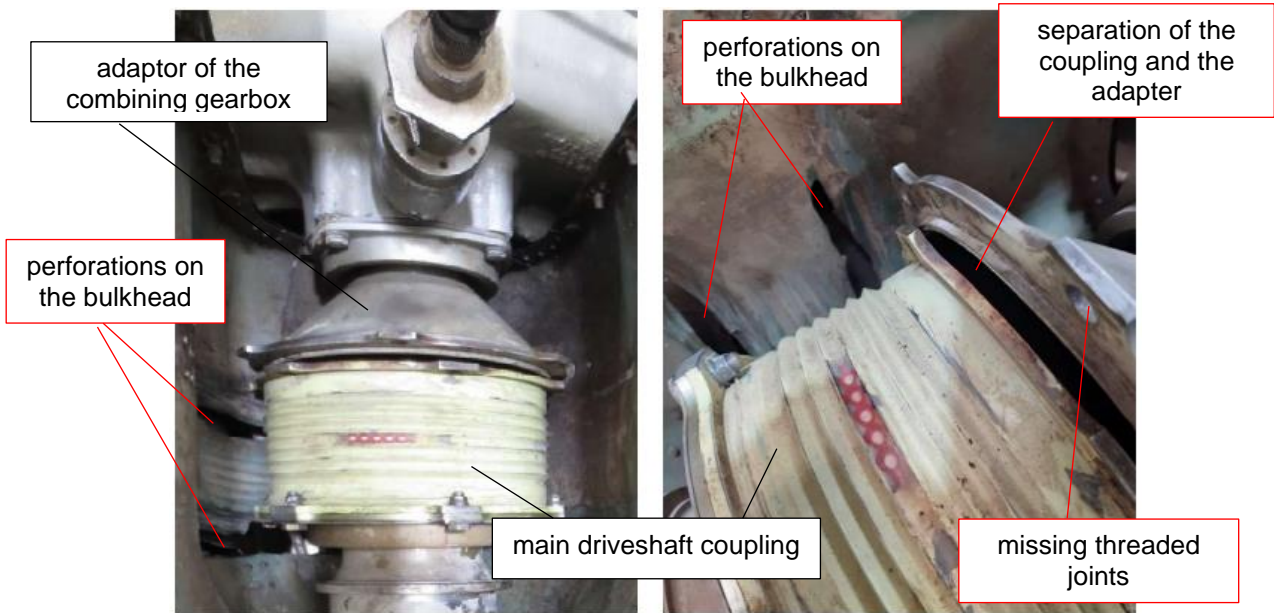
Figure 8. Separation of the shaft to gearbox coupling

The connection between the main driveshaft and the transmission was in perfect condition. However, the coupling between the main driveshaft and the gearbox was detached:

- The joint between the main driveshaft coupling and the gearbox adapter had separated, and the shaft was resting on the fire bulkhead.
- The 6 bolt-washer-self-locking nut threaded joints that held the two parts together were missing from their housings.
- Six bolts (five fragments and one whole), five washers (three whole and two fragments) and two self-locking nuts (threaded onto two bolt fragments) were recovered.
- The abrasion marks on the contact surfaces were scarce and recent.

- The temperature monitoring stickers in the gear area had not changed colour, which ruled out overheating in the coupling, both at the joint with the transmission and at the joint with the combining gearbox.
- On the fire bulkhead, where the shaft was supported, there were two parallel perforations made by the flanges of the shaft coupling after it had disconnected. These perforations were located above engine 2. There were two parallel abrasion marks on the side of engine 1, but they had not perforated.
- The perforations had reached the exhaust nozzle of engine 2.
- Check of the free and frictionless rotation of the power transmission shaft.

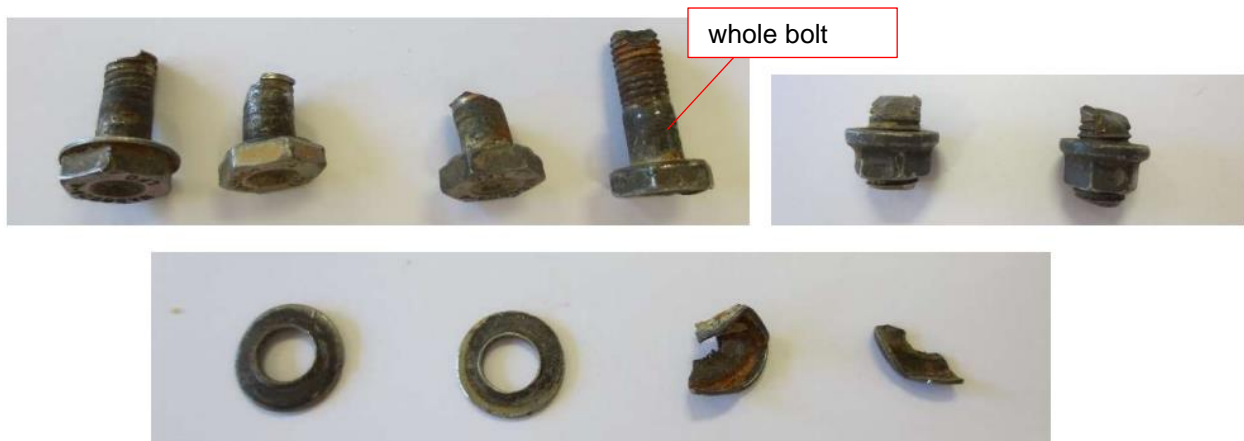
Figure 9. Recovered bolts, nuts and washers

- Bolts: 3 fragments from the head area, 2 fragments from the end with screwed-on nuts and 1 whole bolt without the nut or washer.
- Washers: 2 loose whole washers, 1 whole washer attached to the head of a bolt fragment and 2 fragments.
- Self-locking nuts: 2 screwed onto the two bolt fragments.

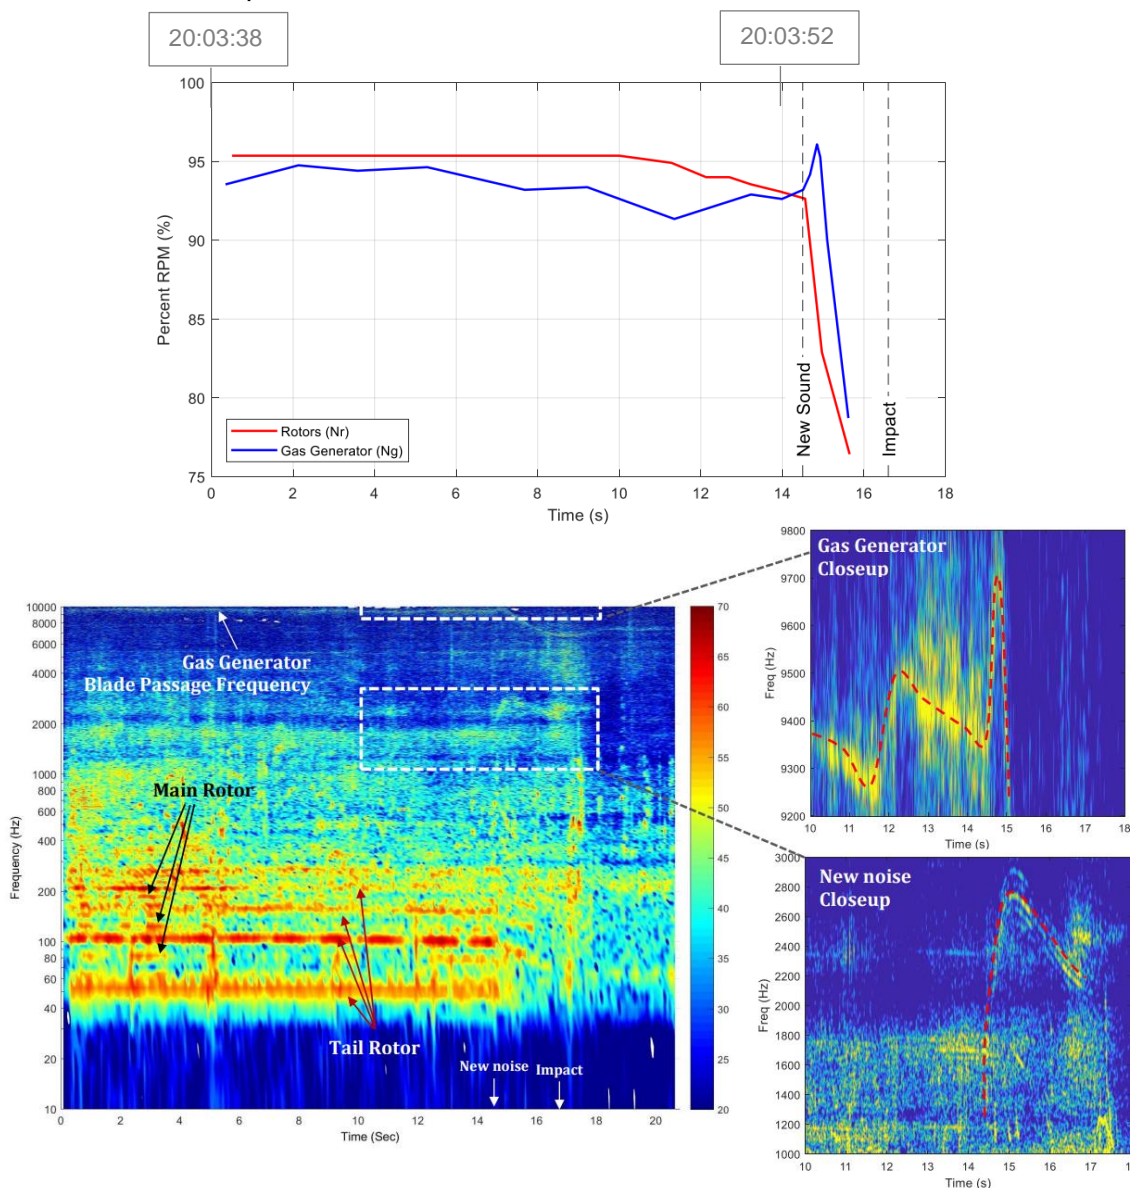
Figure 10. Acoustic analysis of the flight between 20:03:38 and 20:03:54

- In the last half of second 20:03:52, a high amplitude sound can be heard, which is not associated with any component under normal operating conditions. The frequency of this sound rapidly increases and then decreases, and its appearance coincides with the helicopter's descent at 690 fpm until it hits the water.
- Within one second of the onset of the sound, the NR decreases instantaneously, and the N1 of both engines momentarily increases and then decreases drastically.

Figure 10 shows the acoustic analysis. Graphs showing the percentage rotational speeds of the main rotor, the compressor turbines and other elements with frequencies have been included. The time references of the graphs have been marked with respect to the beginning of the video taken from the southern part of the reservoir.

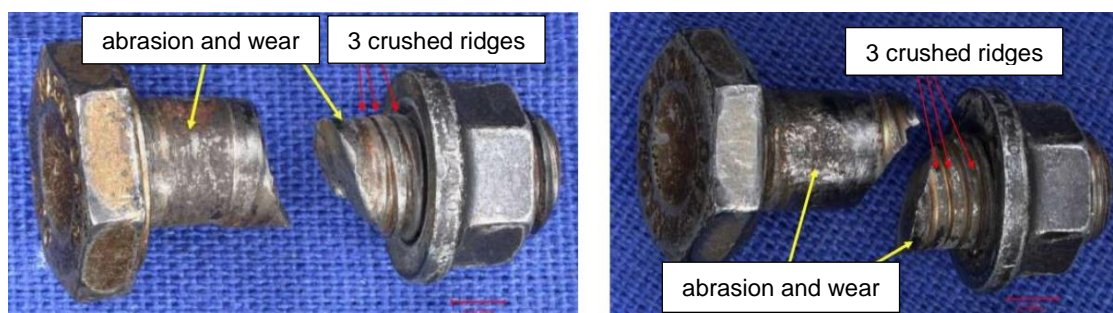
Figure 11. Bolt fragments

The three bolt fragments that included the head also had the non-threaded (grip) area. The heads were engraved with "NAS6604-4 LFC". The fracture surfaces were examined with a stereo-microscope and scanning electron microscopy (SEM), confirming breakage due to overload on the fracture surfaces. With regard to material and hardness specifications, all three fragments met the specifications of the NAS6604 standard, but the diameters of the non-threaded areas at some points were below the design minimum. The non-threaded areas of the bolt showed signs of wear and abrasion.

The two nuts that remained screwed onto the bolt fragments were engraved "90-132", indicating compliance with the manufacturer's service bulletin ASB412-14-160 and EASA directive AD2014-0118. The fracture surfaces of the bolts were examined with a stereo-microscope and scanning electron microscope, also confirming breakage due to overload. It was also confirmed that these fragments completed two of the three bolt heads that had been found.

In addition to abrasion and wear on the non-threaded section of the bolt, the fragments exhibited crushing of the first three thread ridges (the ones closest to the head). In the case of the bolt that

was found with the washer installed, the washer was completely warped and deformed towards the bolt head.

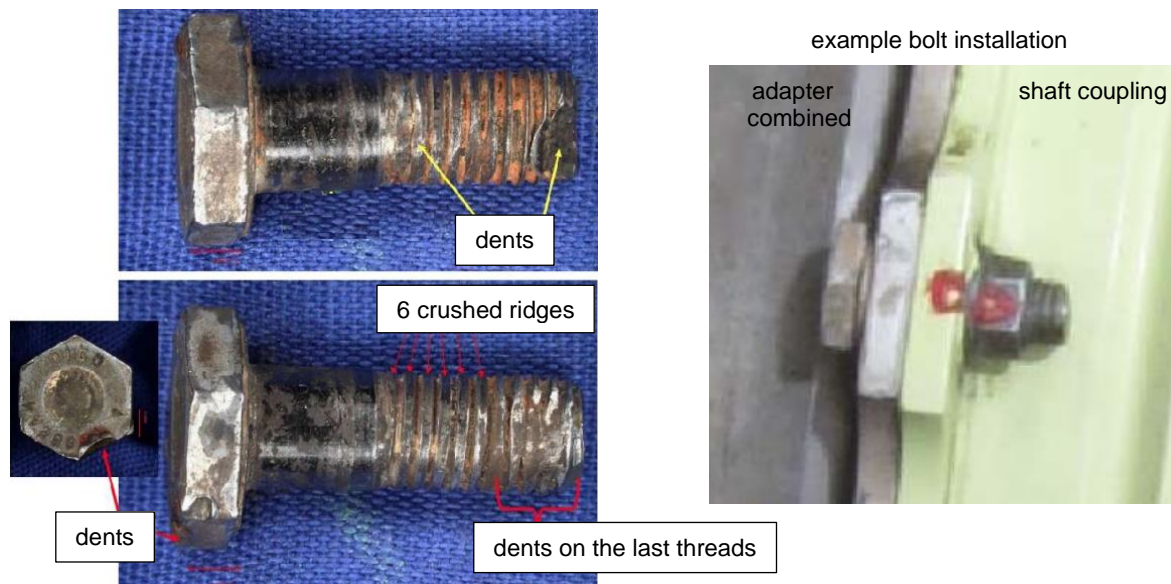
Figure 12. Whole bolt and example of contact areas

The bolt exhibited three types of damage:

- Impact dents in some areas of the last threads, which is where the nut should be, as well as on the head.
- Crushing of the first 6 thread ridges, corresponding to the area where the bolt passes through the main driveshaft coupling.
- Abrasion and wear on the non-threaded area of the bolt, the area where the bolt passes through the gearbox adapter.
- The last threads had no signs of crushing or shearing on their ridges, although they did exhibit contact marks (the dents mentioned previously).

These damages confirmed that the threaded joint to which it belonged had no counterweight installed to balance the shaft.
