Report A-037/2018

Accident involving a Piper PA-28R-200,
registration EC-HSZ, at the Cuatro
Vientos Airport (Madrid)
on 4 September 2018.

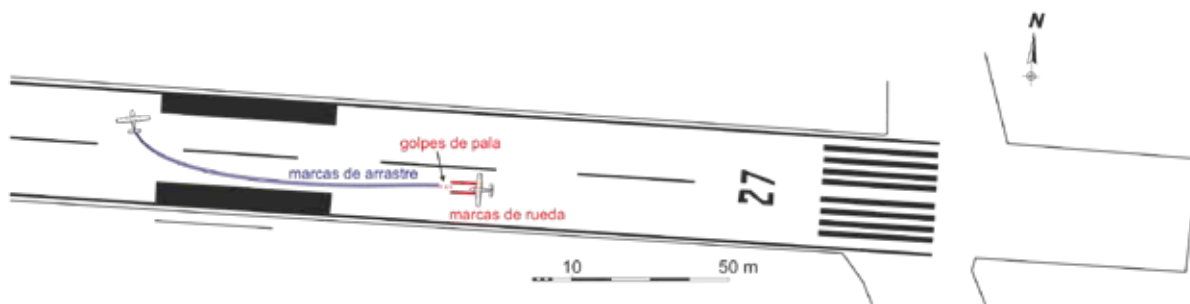
Fig. 4.- Diagram of the marks and location of aircraft

The aircraft touched down at the start of the runway, approximately 87 m past the threshold markings and slightly left of the centerline. After this point, for a length of about 10 m, there were tire marks on the runway, along with contact marks left by the tips of the propeller blades. Next, over an 80-m length, there was a mark, initially in a straight line that later veered to the right, compatible with the skidding of the underside of the fuselage that led to where the aircraft came to a stop on the right side of the runway with the nose pointing north.

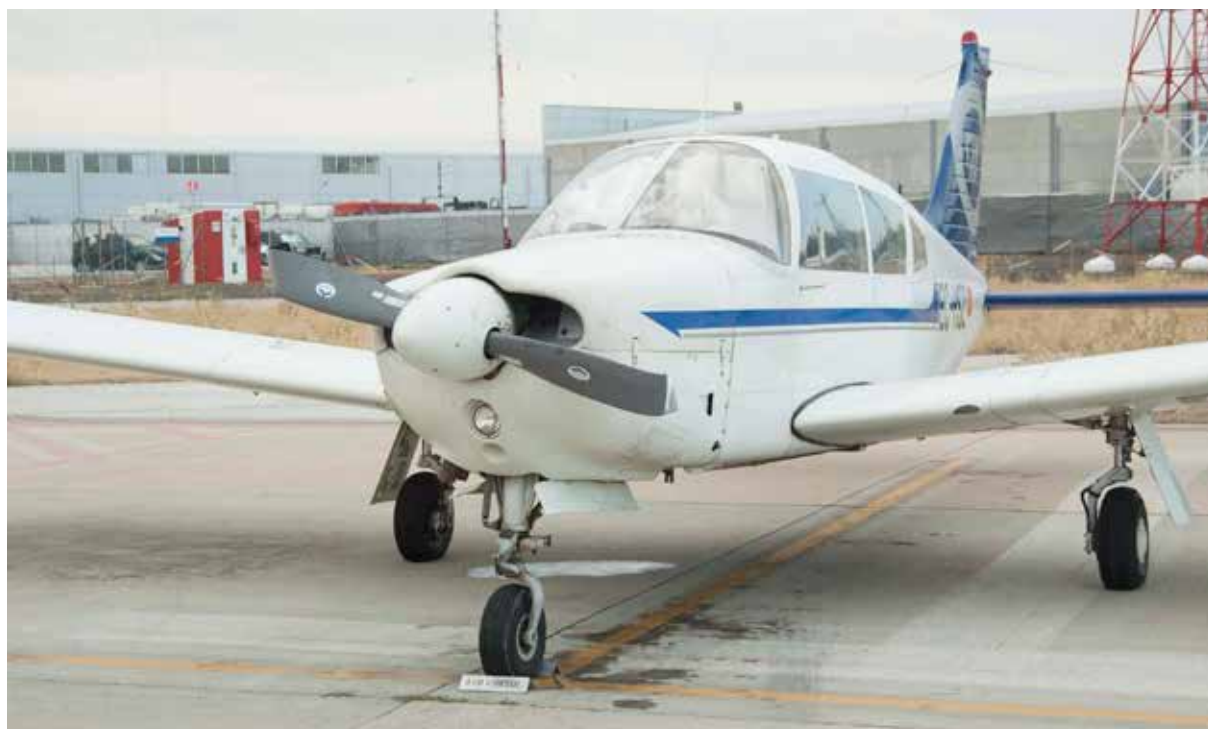
Fig. 5.- Condition of the aircraft

As a result of the landing, the aircraft sustained significant damage to the propeller as well as fractures and scraping in the landing gear and underside of the fuselage.

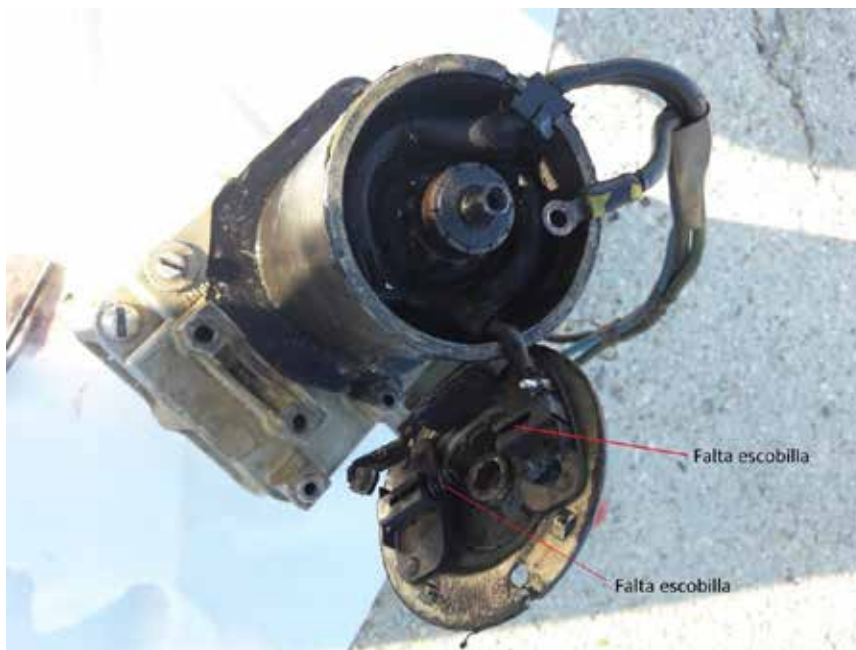
Fig. 6.- Condition of the electric pump

The electric motor was noticed to be missing one of the two screws that attaches the brush holder cover to the body of the motor. Once the brush holder cover was removed, both holders were verified to be excessively worn and outside their housings. One brush was detached from its connecting cable and was resting on the top part of the motor winding. The rotor on the electric motor turned freely, and there were traces of worn brushes and hydraulic fluid. It was determined that the electric motor had not been maintained properly.

The inspection of the electric pump revealed that it had been improperly maintained; specifically, the brushes showed excessive wear and had been dislodged. According to the pilot, he did not pull the fuse during the flight, so it is possible that the motor was running the entire time, which contributed to the poor condition of the brushes.

Even so, the overall condition of the pump is indicative of a lack of proper maintenance and is sufficient reason for the inability to change the position of the landing gear.

The electric pump stopped working because of its defective maintenance condition.

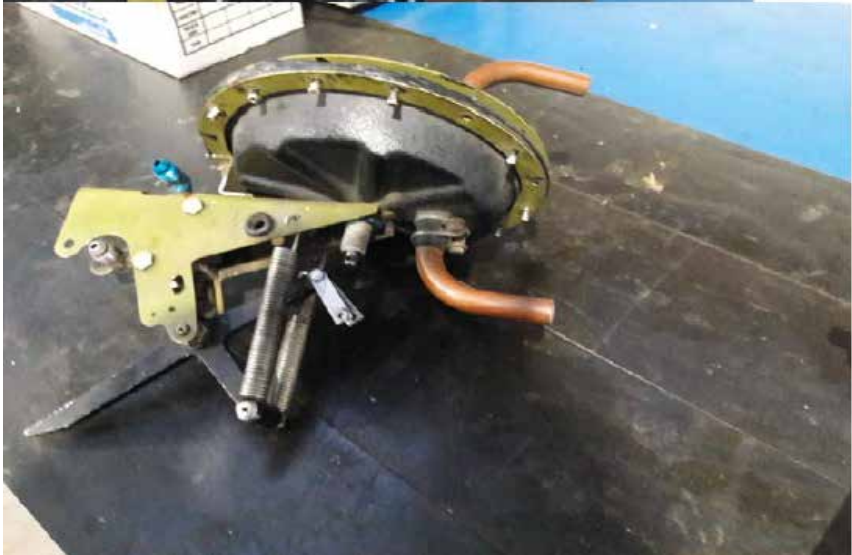
Fig. 7.- External appearance of the pressure sensing mechanism

As for the pressure sensor mechanism, once opened it was found to be blocked because the diaphragm assembly, consisting of a membrane and circular metal supports, was stuck to one of the sides of the casing that housed it, which prevented it from moving.

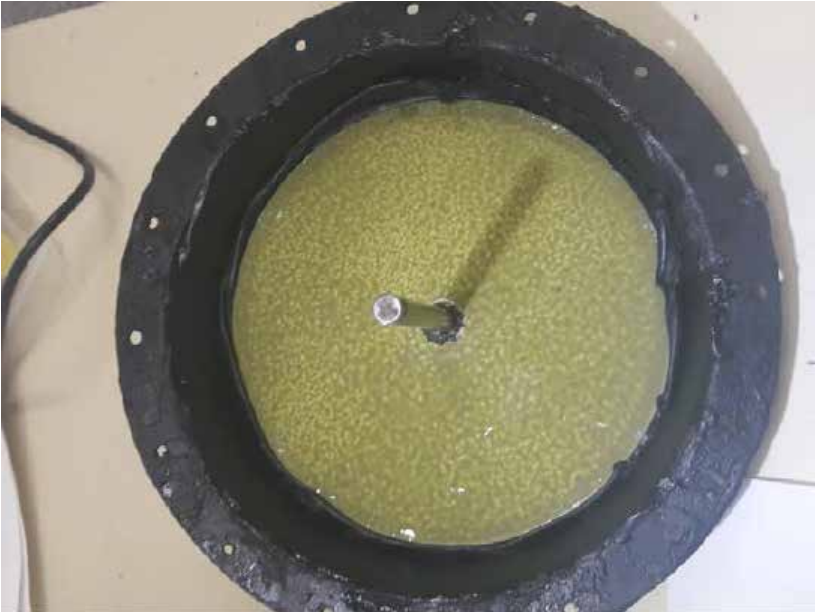
Fig. 8.- Diaphragm assembly stuck to the casing

Opening the casing that contained the diaphragm revealed that the membrane had deteriorated and stuck to one side of the casing (see Fig. 8), precisely in the position where it would be when the lever is in the topmost, or override, position, which disarms the automatic gear extension system. As a result, the rod was only able to move as far as the distance between its two tabs – which push the diaphragm – a distance that, as the diagram/photo show, is insufficient to change the condition of the landing gear mechanism (see Fig. 3).

The casing and diaphragm system is arranged vertically. It is located underneath the rear left seat and is not directly exposed to sunlight or to hot engine components. It therefore seems unlikely that the material could have degraded – practically melted – to the point where it could accidentally adhere to the casing. Even if it could, this condition would only have affected the lower half of the diaphragm; instead, the diaphragm was affected around its entire perimeter (see Figs. 10 and 11). It is more likely, therefore, the result of a conscious action to seal the piston to the casing in the position associated with the removal of the automatic system without realizing that this would disable the manual emergency gear extension system.

The diaphragm was worn and stuck to one of the halves of the housing, which prevented the rod from moving.

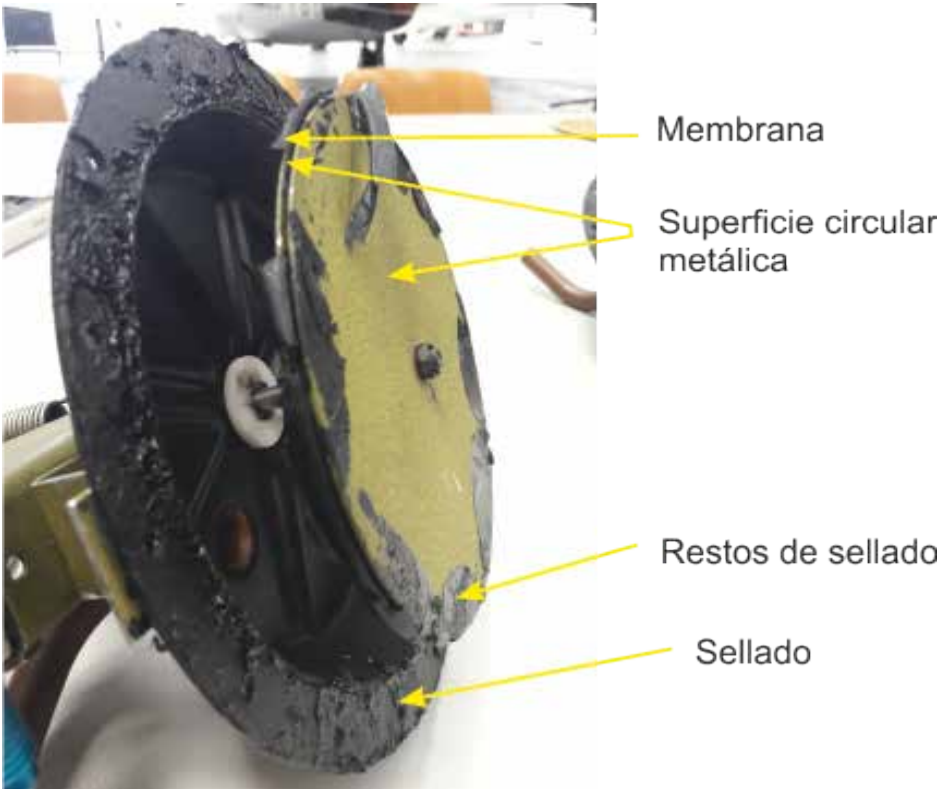
Fig. 10.- Diaphragm assembly detached from the casing

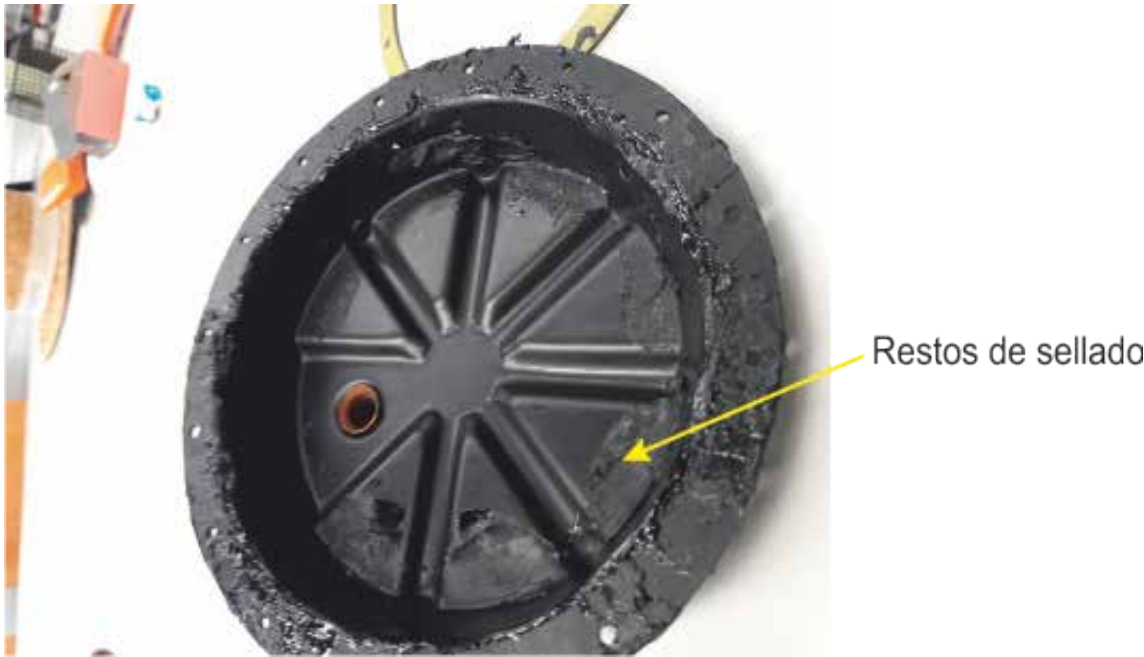
Fig. 11.- Half of casing to which diaphragm assembly had adhered
