Technical report

A-042/2019

Accident involving the aircraft SPORTINÉ AVIACIJA LAK 17B FES 18M, registration D-KSEO, on 11 August 2019 at the Garray aerodrome (Soria)

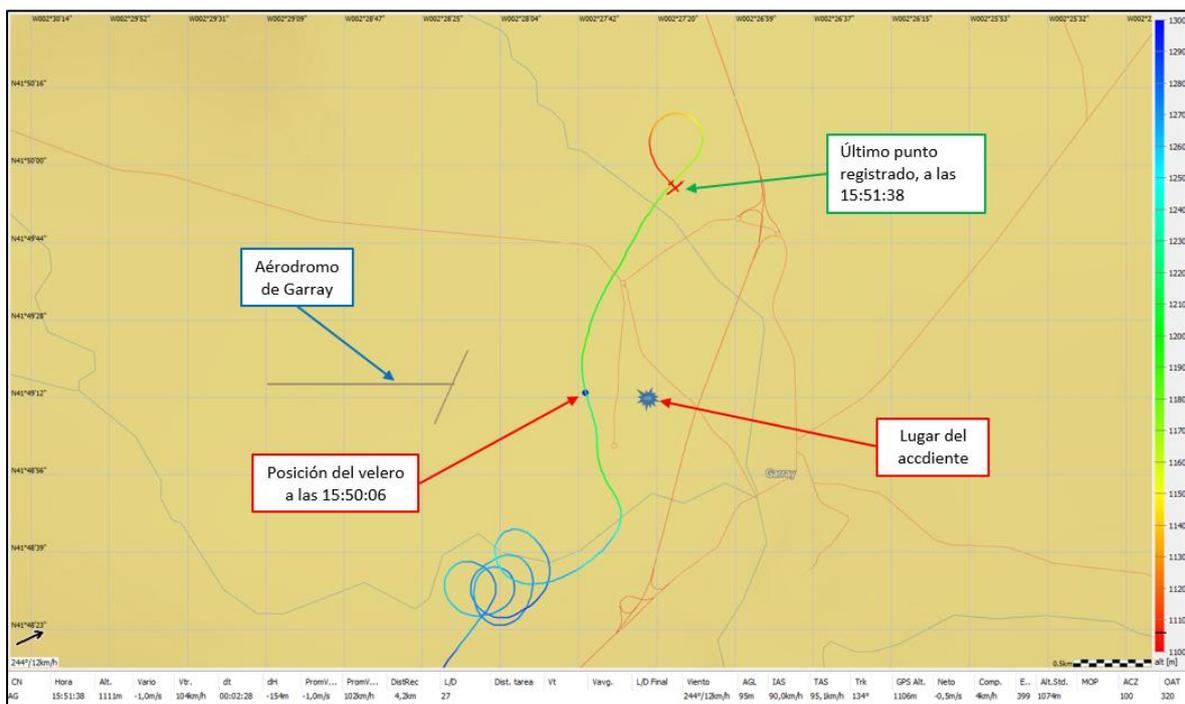
Illustration 4: Illustration depicting the last movements recorded by the aircraft's avionics

- At 15:50, the glider crossed the extension of the runway centreline at a distance of 800 m horizontally and about 200 m above it (See Illustration 4). At 15:51:38, when the information from the aircraft's recorder was lost, it was located north of the town of Tardesillas, 1,875 m in a straight line from the head of runway 27 and 86 m above it. At that point, it had travelled 275 km in a total time of 2 hours and 26 minutes.

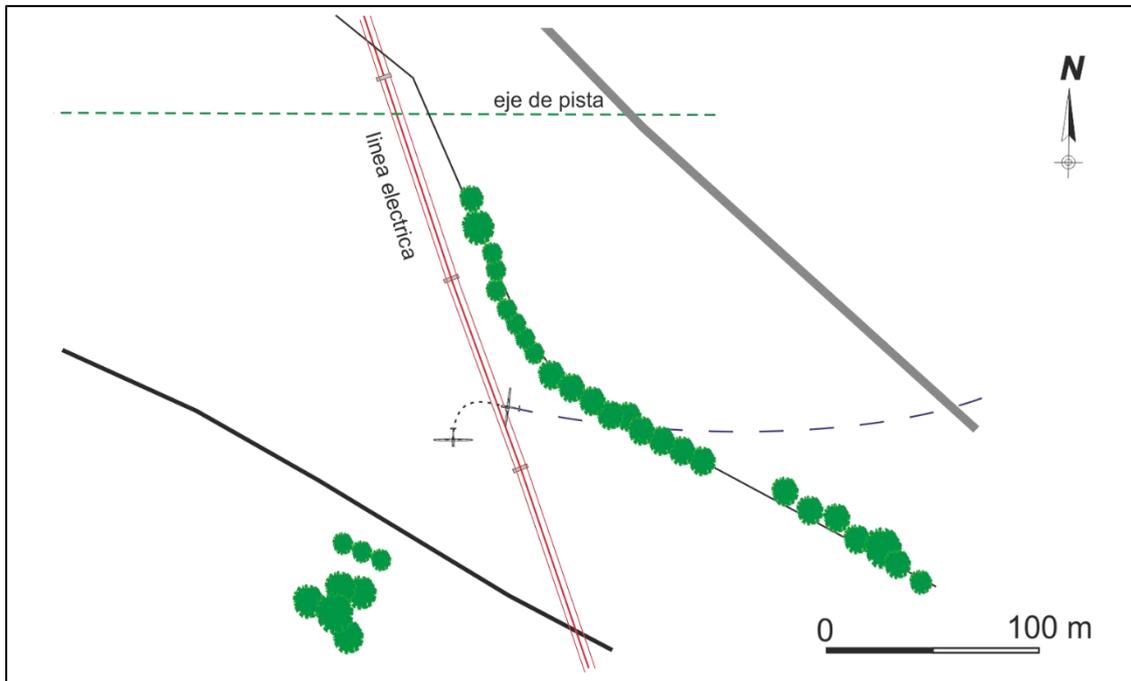
Illustration 5: Manoeuvres and final position of the aircraft

nearby field. When he was a few meters from the ground, the left wing caught the power line, and the aircraft struck and slid along the ground, having turned 180° by the time it came to a halt. It's estimated trajectory before coming to a halt is shown in the following diagram:

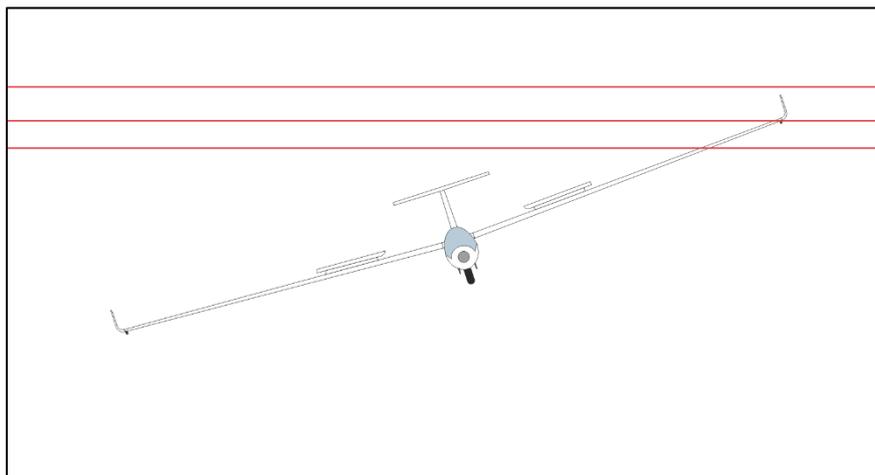
The estimated angle of the aircraft at the moment of impact is shown in Illustration 6: Estimated angle of the aircraft at the moment of impact

Based on the pilot's testimony that he attempted to dive the aircraft under the cables when he saw them, and the damage to the left wing which is compatible with striking the cables, we conclude that the aircraft was banking to the right at the time of the impact (shown in Illustration 6). The cable dragged along the leading edge of the left wing until at one point it snagged, causing the aircraft to pivot, yawing to the left. This is consistent with the marks on the ground, which suggest the aircraft slid to the right.

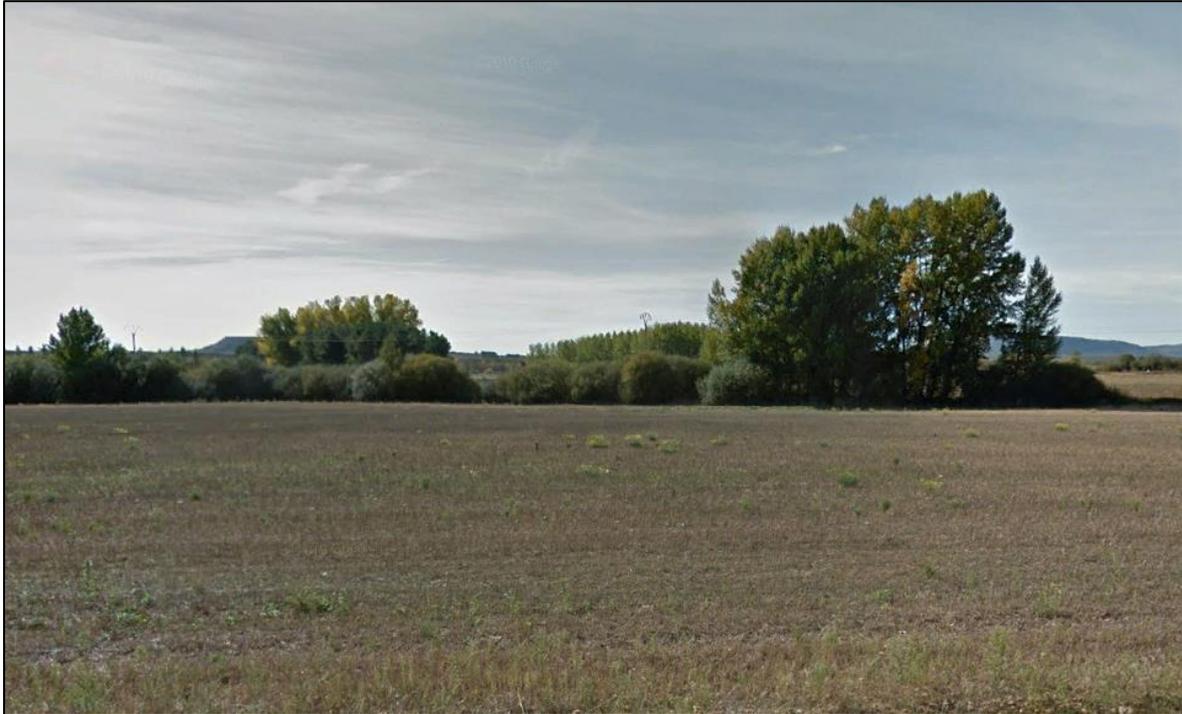
Illustration 7: View of the line of trees and the power line poles behind them, from the northeast

The pilot declared he didn't see the power lines until he passed the line of trees partially obscuring it. The line of trees was lower than the height of the poles in several sections but

also higher in others, as can be seen in Illustration 7, which is the view from the estimated trajectory of the aircraft (northeast), at ground level.

REC 06/21 It is recommended that details of nearby power lines be included in the Garray aerodrome information.

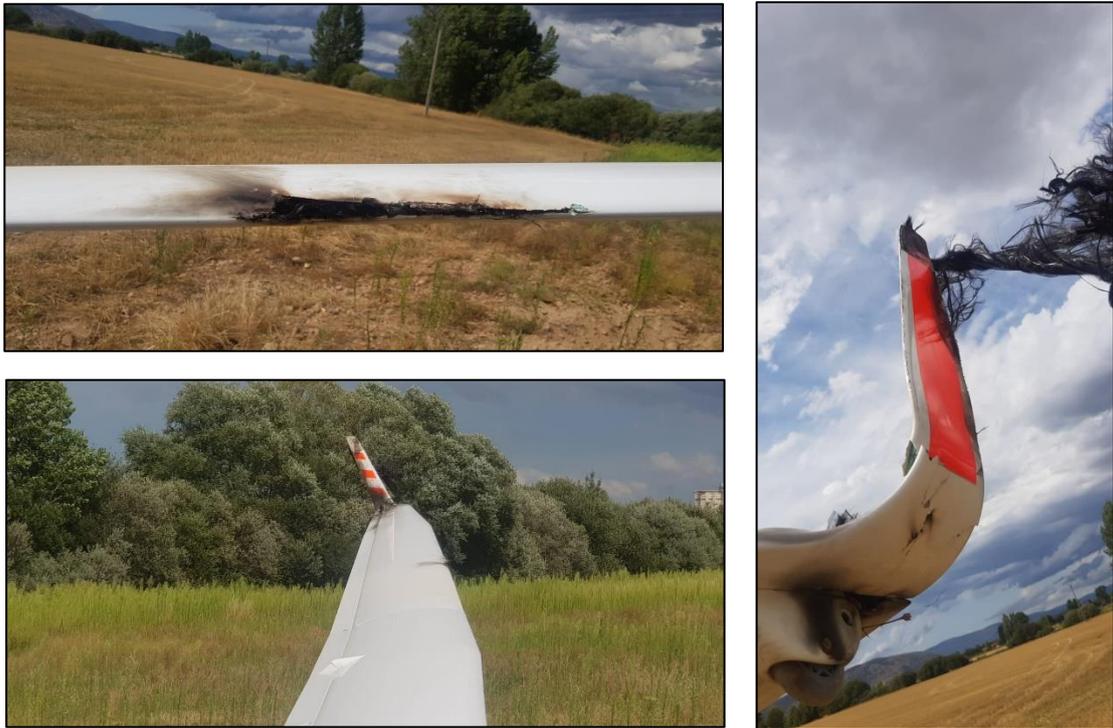
Illustration 8: Evidence of striking the cable and the resulting electric arc

The aircraft's left wing was lacerated and burnt at both the tip and approximately three-quarters of the way along the wingspan. (See Illustration 8). The damage was compatible with having made contact with at least two different cables of the medium-voltage line and the electric arc that would have been produced as a result.

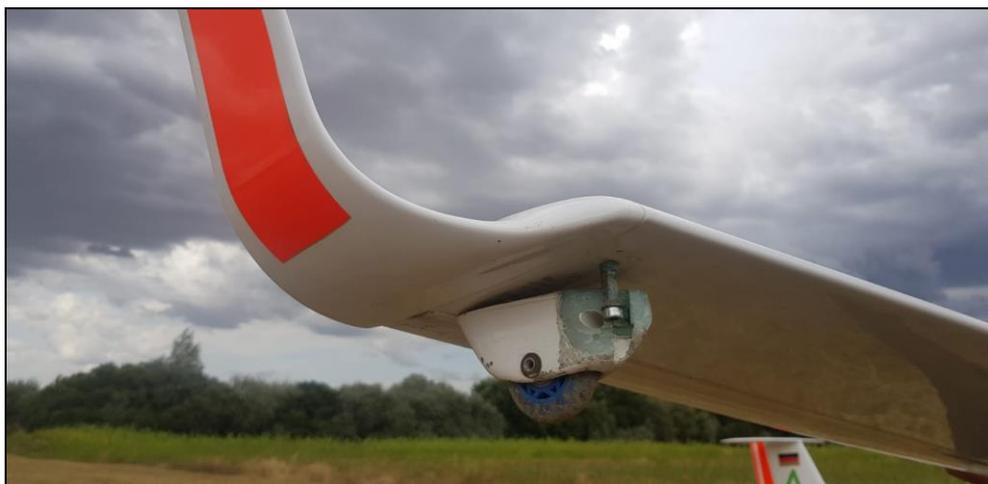
Illustration 9: Damage to the wheel at the tip of the right wing

The right wing had scratches along the leading edge, and the wheel fairing at the end of the wingspan was split around one of the wing's anchor bolts (See Illustration 9).

The wheel at the end of the right wing was split around one of the wing anchor bolts (See Illustration 9). Given that it would have taken a considerable amount of force to split it, we can conclude that the tip of the right wing was probably the first part of the aircraft to make contact with the ground. Furthermore, based on the orientation of the fracture surface, the impact came from the right as the aircraft was travelling sideways. This is compatible with the aircraft yawing to the left when snagged on the cables and, through inertia, continuing to move forward while yawing. For these reasons, we estimate the aircraft had an orientation of approximately 270° when it hit the cables (shown in Illustration 5), almost in alignment with runway 27 of the Garray aerodrome.

Because the significant damage at the end of the right wing was concentrated in the wheel, it's probable the roll angle and dive position of the aircraft on impact was not especially pronounced. If it had been, considering the small size of the wheel, the tip of the wing would also have hit the ground and incurred damage.

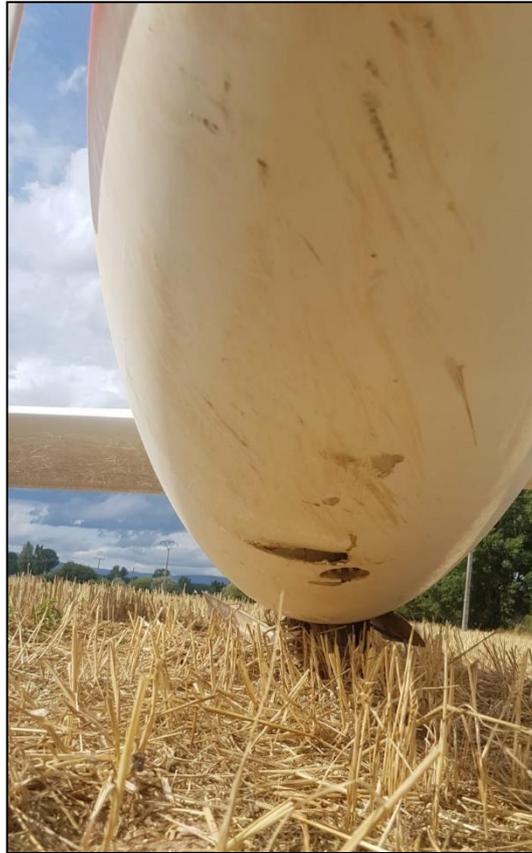
Illustration 10: Front underside view of the fuselage

The undercarriage of the fuselage was dented in some places and had scratches compatible with a short forward-right drag along the ground (relative to the aircraft).

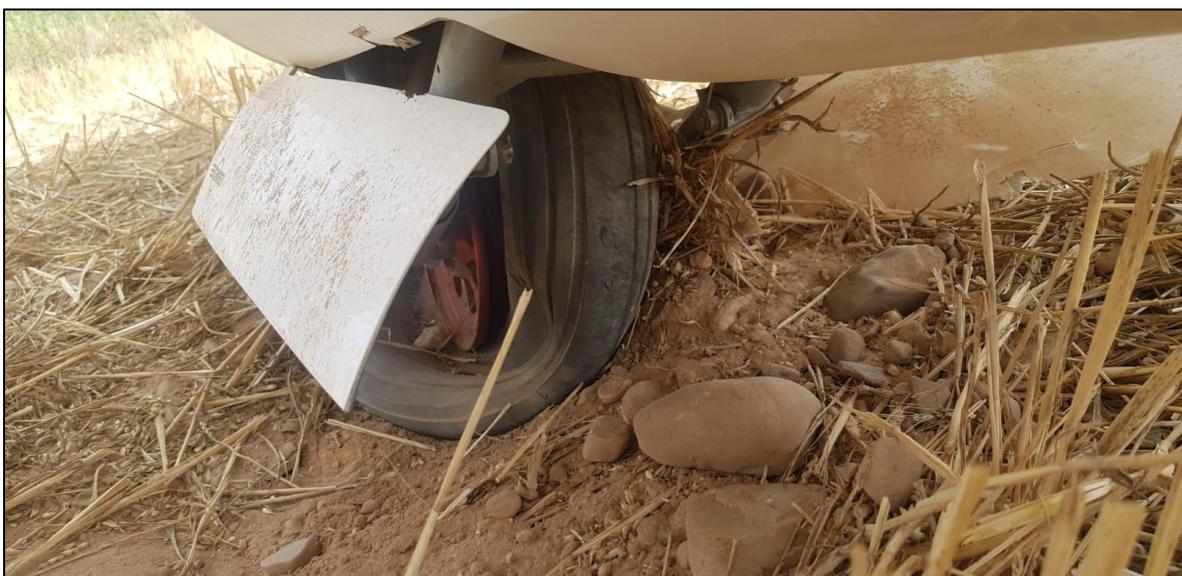
Illustration 11: Main landing gear

The damage to the main landing gear and its cover, as well as the marks left on the field, confirm that the aircraft slid to its right once on the ground (See Illustration 11).
