CIAIAC

Report A-046/2018

Accident involving a Cessna
310-R aircraft, registration
EC-EQK, at the Cuatro Vientos
Airport on 30 November 2018

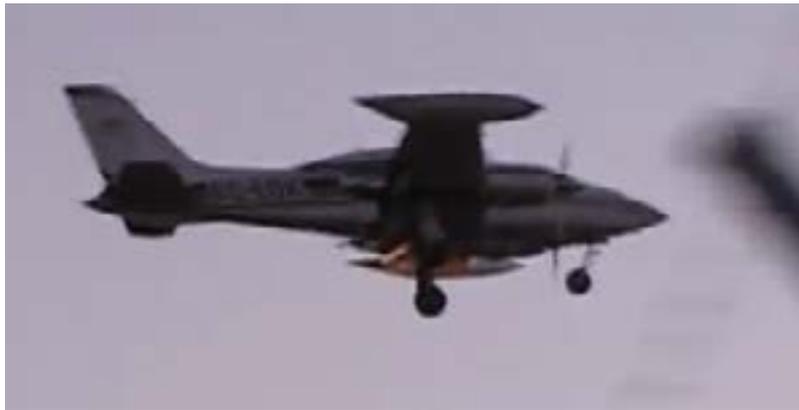
After flying for 35 minutes, they executed a touch and go. Upon reaching an altitude of 700 ft, they attempted to raise the landing gear and some 25 seconds later, according to the pilot, they heard a loud mechanical sound and smelled smoke. The aircraft has a mirror, which allowed them to see that the front landing gear leg was not fully lowered.

Figure 1: View of the aircraft's landing gear seconds before landing at the Cuatro Vientos Airport

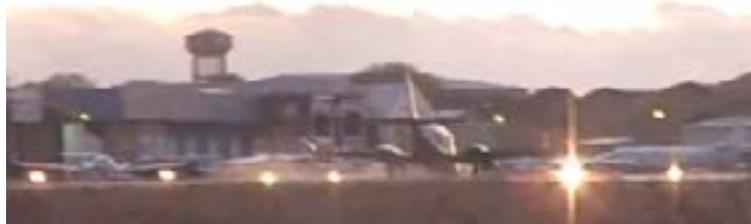
Figure 2: Aircraft landing at the Cuatro Vientos Airport

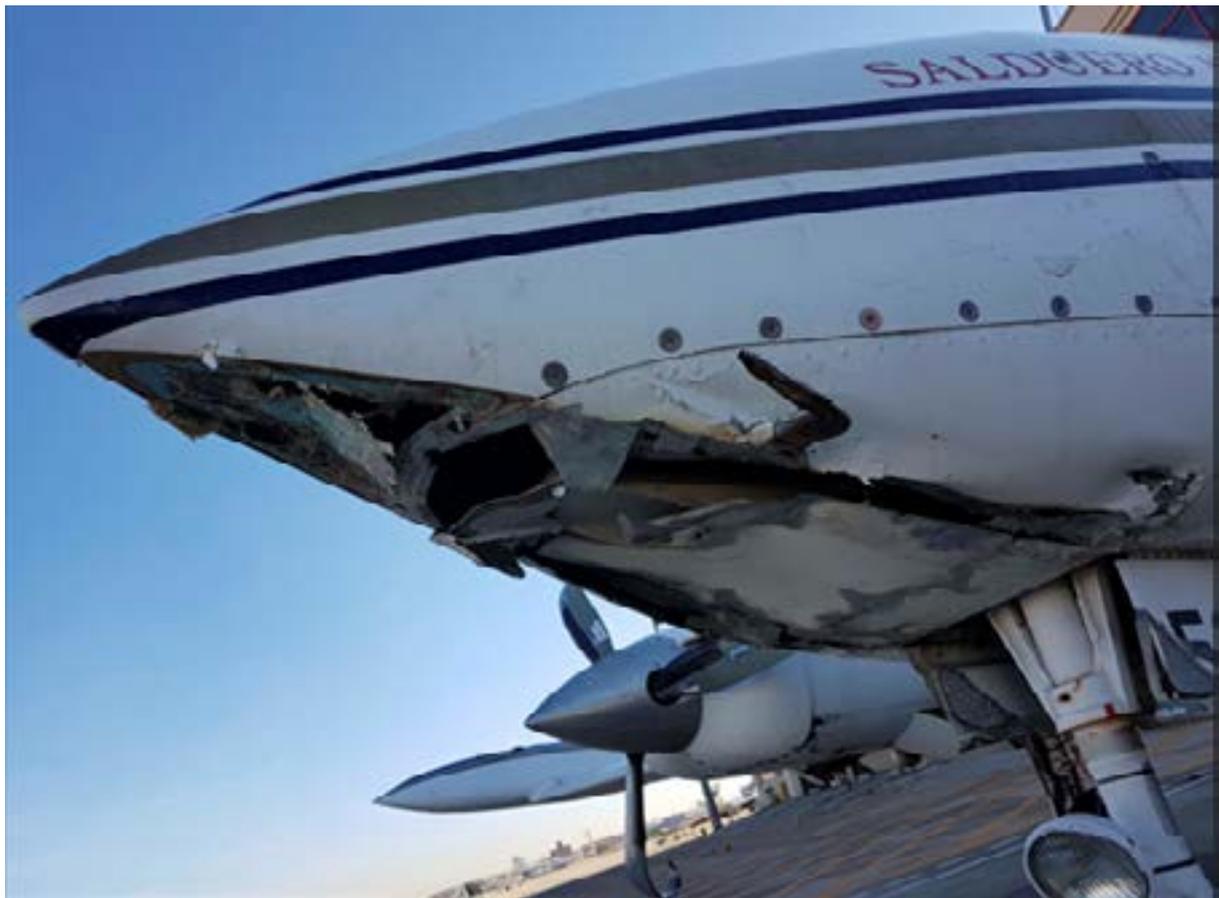
As a result of landing with the front landing gear leg not being locked, the propellers and the underside of the fuselage were damaged.

Figure 3: Close-up of the damage to the underside of the fuselage and one of the propellers

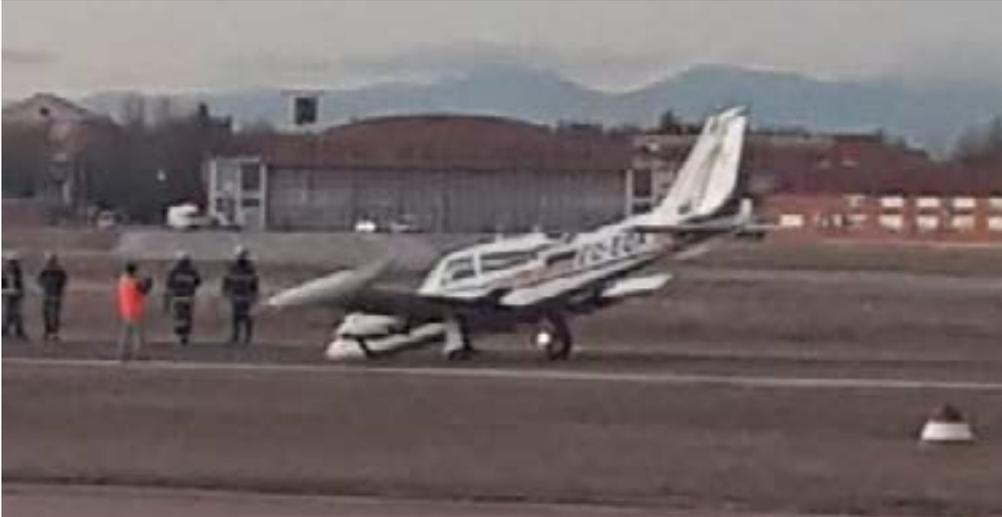
The propellers and underside of the fuselage were damaged during the landing run due to the failure of the front landing gear leg to lock.

Figure 10: Final position of the aircraft after stopping

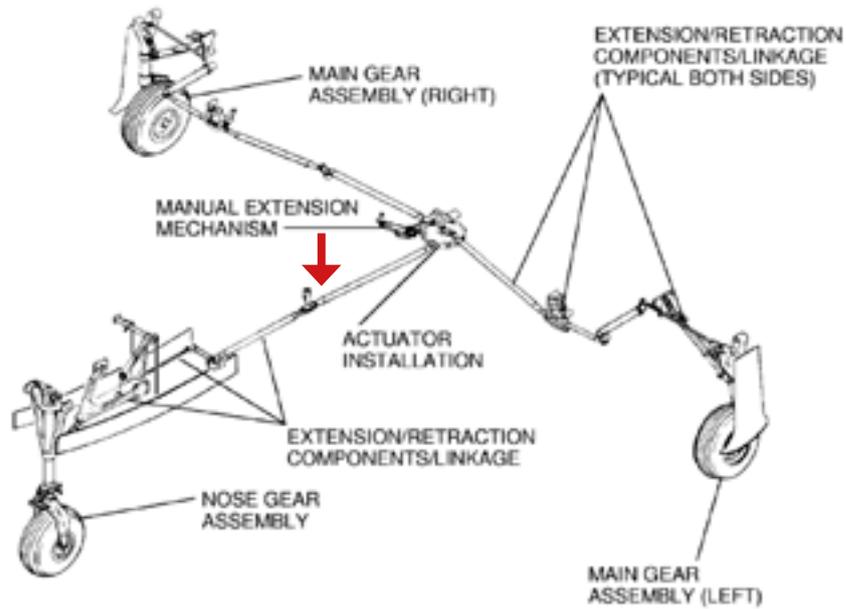
After the accident, the front landing gear leg was disassembled. This revealed that one of the tubes that moves to actuate the front leg was broken. The red arrow in the image below indicates the tube that was found broken when the front landing gear leg was disassembled.

Figure 11: Identification of the broken tube

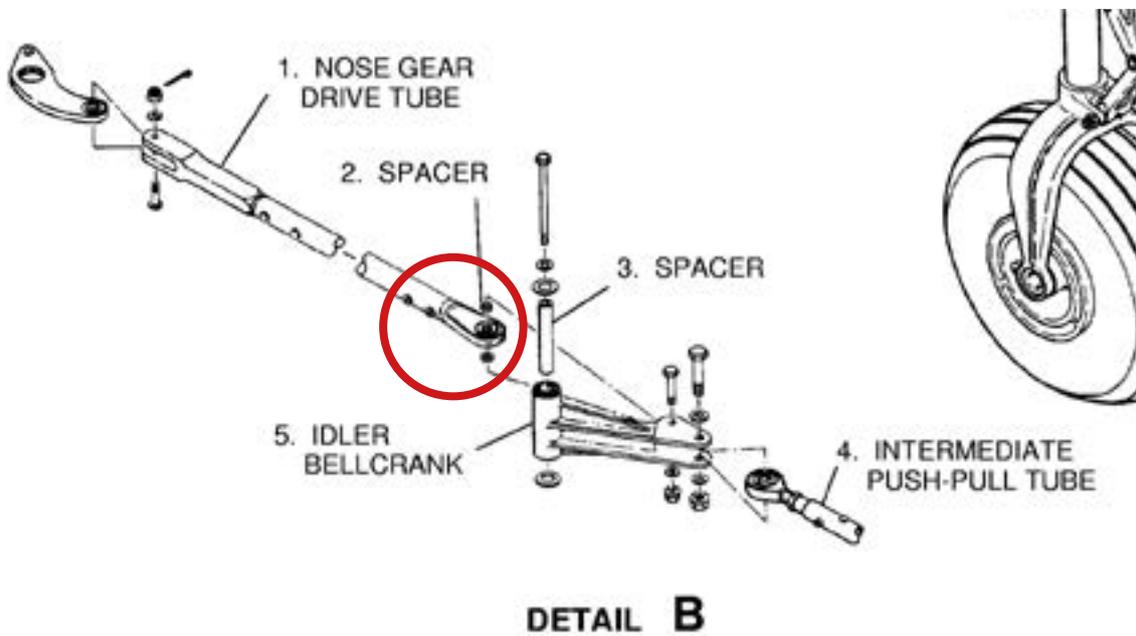
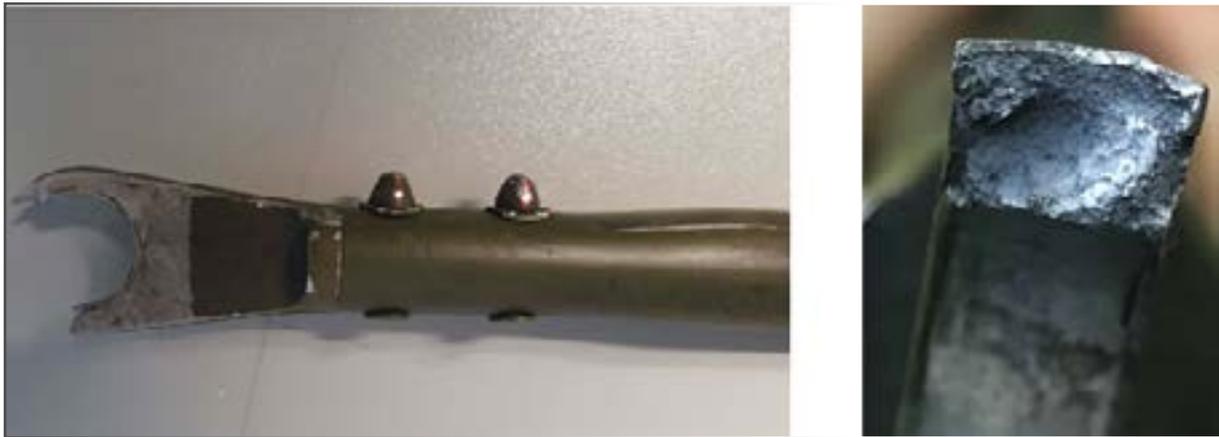
Detail of the tube that was found broken.

Figure 12: Close-up of the fracture on the drive tube in the front landing gear leg

This laboratory concluded that the tube exhibited a complete fracture of a lug located at one of its ends. The visual inspection conducted revealed that the inner diameter of the lug had very noticeably deformed and elongated during the failure process. It also showed that the parts of the lug close to the fracture had undergone significant thinning due to plastic deformation.

All the findings point to an in-service fracture process of the lug that was instantaneous and caused by a ductile overload.

There were no indications of fatigue or corrosion that could have weakened this part.

The most likely cause is that a slight misalignment in the tubes of the extension and retraction system mechanically obstructed the retraction of the landing gear. The attempt to retract a slightly misaligned landing gear could have created overloads that ended up breaking said tube. Once this happened, the nose leg could not be moved either electrically or mechanically.

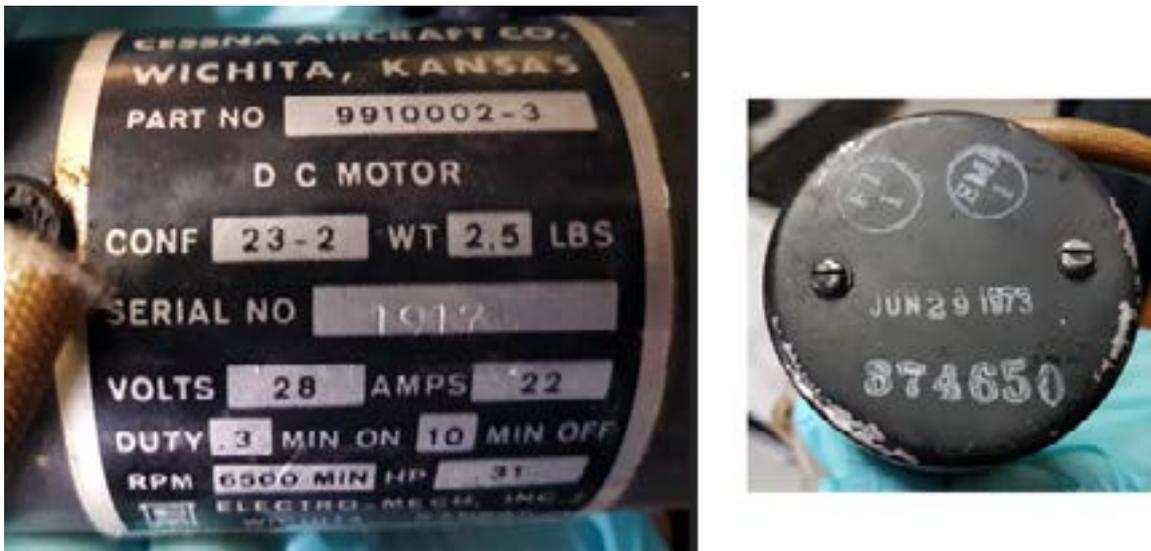
However, the electric motor that extends and retracts the landing gear did not rotate in the up direction. It did work in the down direction.

Figure 13: Views of the electric landing gear motor on the accident aircraft

The electric landing gear motor had been working correctly until that point, but its operating time was exceeded during this accident. As noted above, the landing gear actuator was mechanically obstructed, which prevented its proper operation, and the up-limit switch that signals that the gear is up never activated, and thus the electric motor was not deenergized. The duty cycle of the motor is 20 seconds on followed by 10 minutes off, even though, according to the manufacturer's Maintenance Manual, only 10 to 14 seconds is needed to raise the gear. According to the pilot's statement, he heard a loud mechanical noise some 25 seconds after commanding the gear up. This means that the motor must have been damaged after it exceeded its duty time, at which point it stopped turning in the up direction. The burning odor smelled by the pilot undoubtedly originated in the electric motor.
