Report A-047/2019

Accident involving a Cirrus SR22
aircraft, registration F-HAMP, in
the municipality of Pedreguer
(Alicante) on 15 September 2019

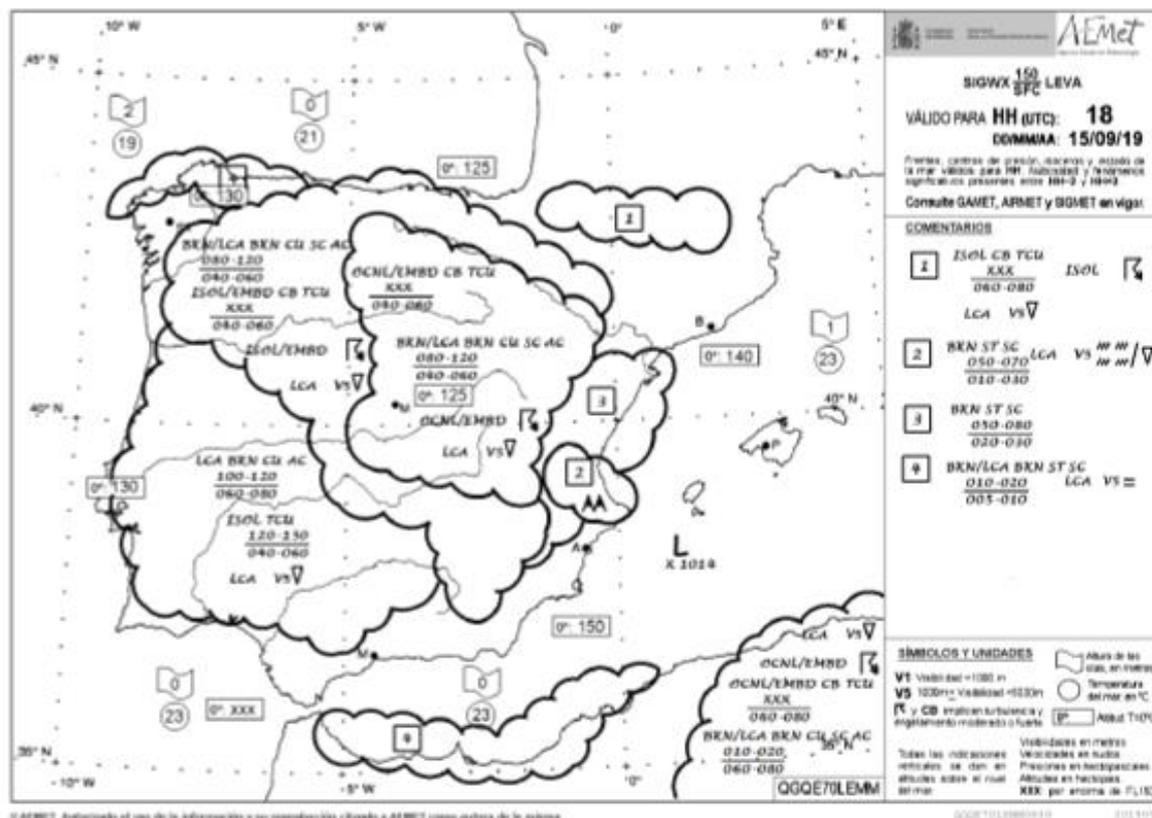
Illustration2 : Significant low level chart for 18:00 UTC

In conclusion, according to AEMET, the situation was favorable to persistent low clouds in mountain summits and significantly reduced visibility caused by stratiform clouds touching the ground at high elevations, which very likely contributed to the accident.

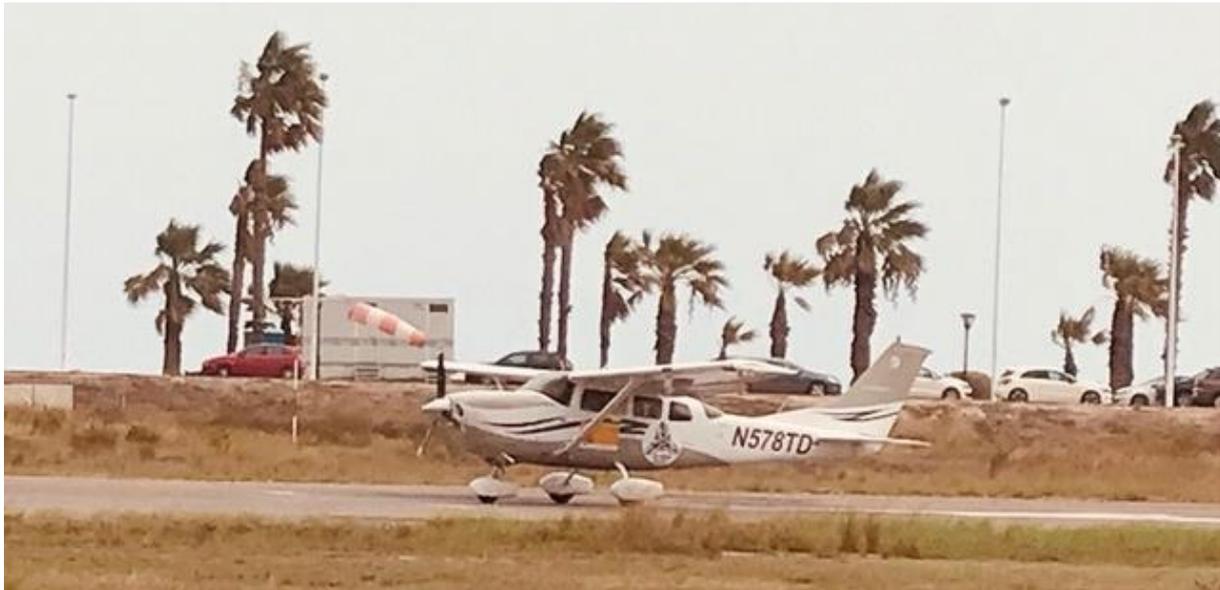
Illustration 3 : Wind at the Pinar de Castellón aerodrome as one of the aircraft takes off

The photo below, taken by an aircraft taking part in the air rally, shows the takeoff of aircraft N-578TD, which took off after the accident aircraft, and the wind that was present at the time.

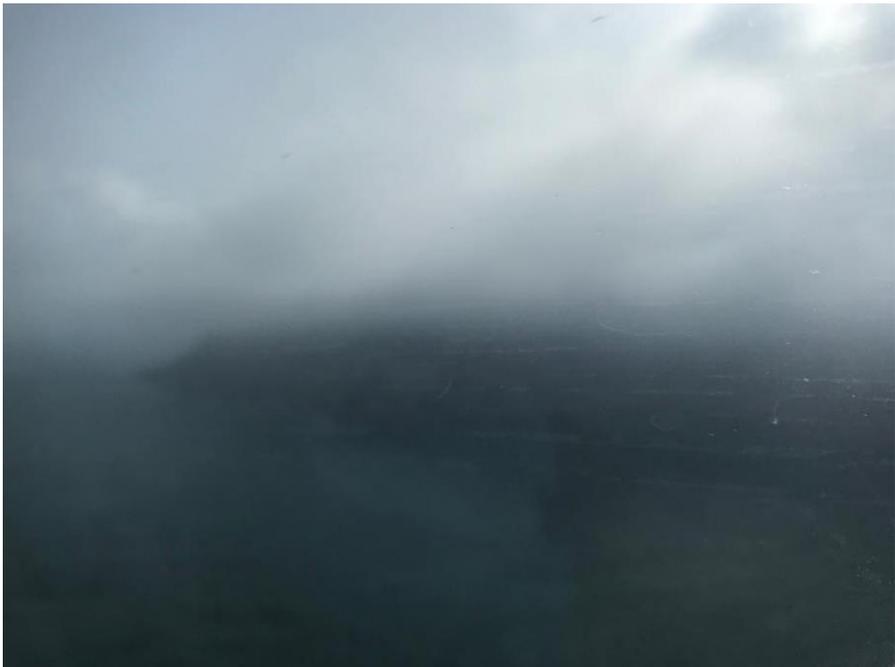
Illustration 4: Photo of Cape Nao taken by one of the crews

Also included is another photograph, taken by the one flying behind the accident aircraft, of the weather conditions in Cape Nao, near the accident site.

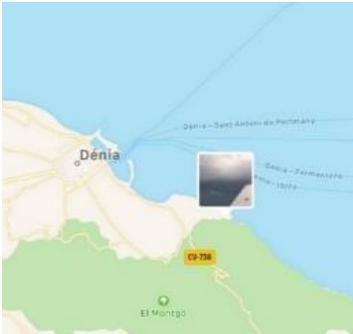
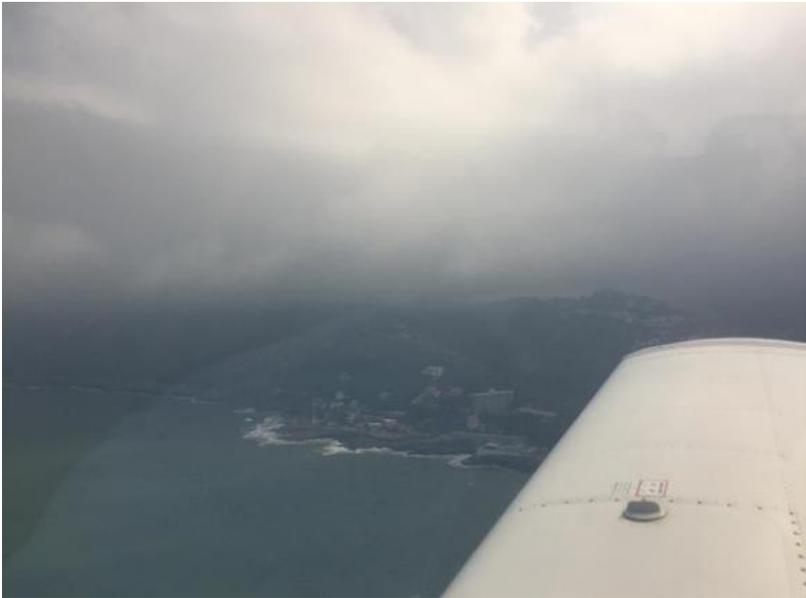
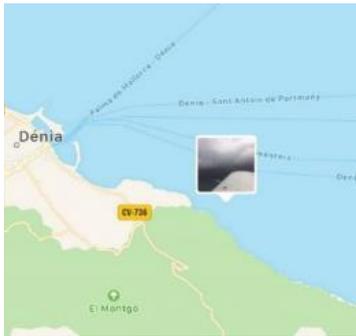
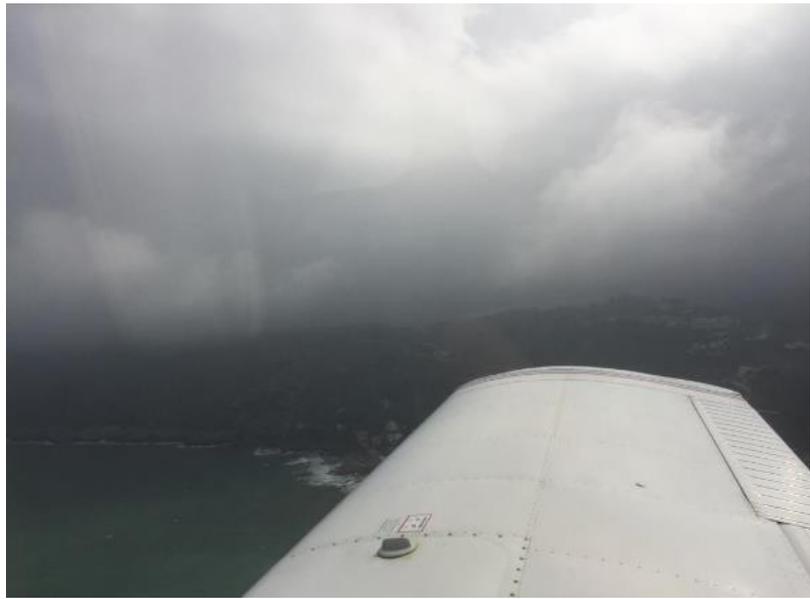
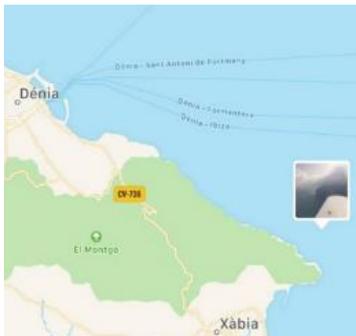
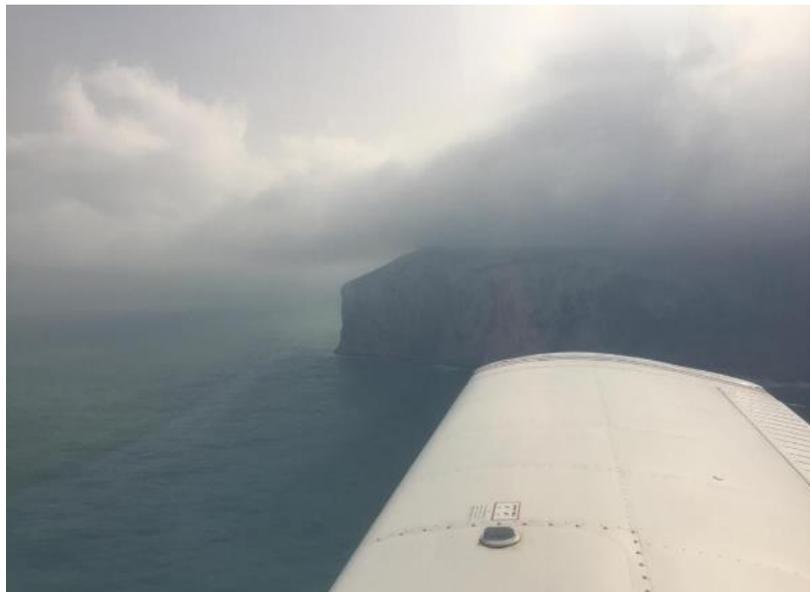
These other photographs were taken by a passenger onboard HB-OQN aircraft. This aircraft took off 27 minutes later than the accident aircraft. The left figure shows the aircraft position when the right photograph was taken.

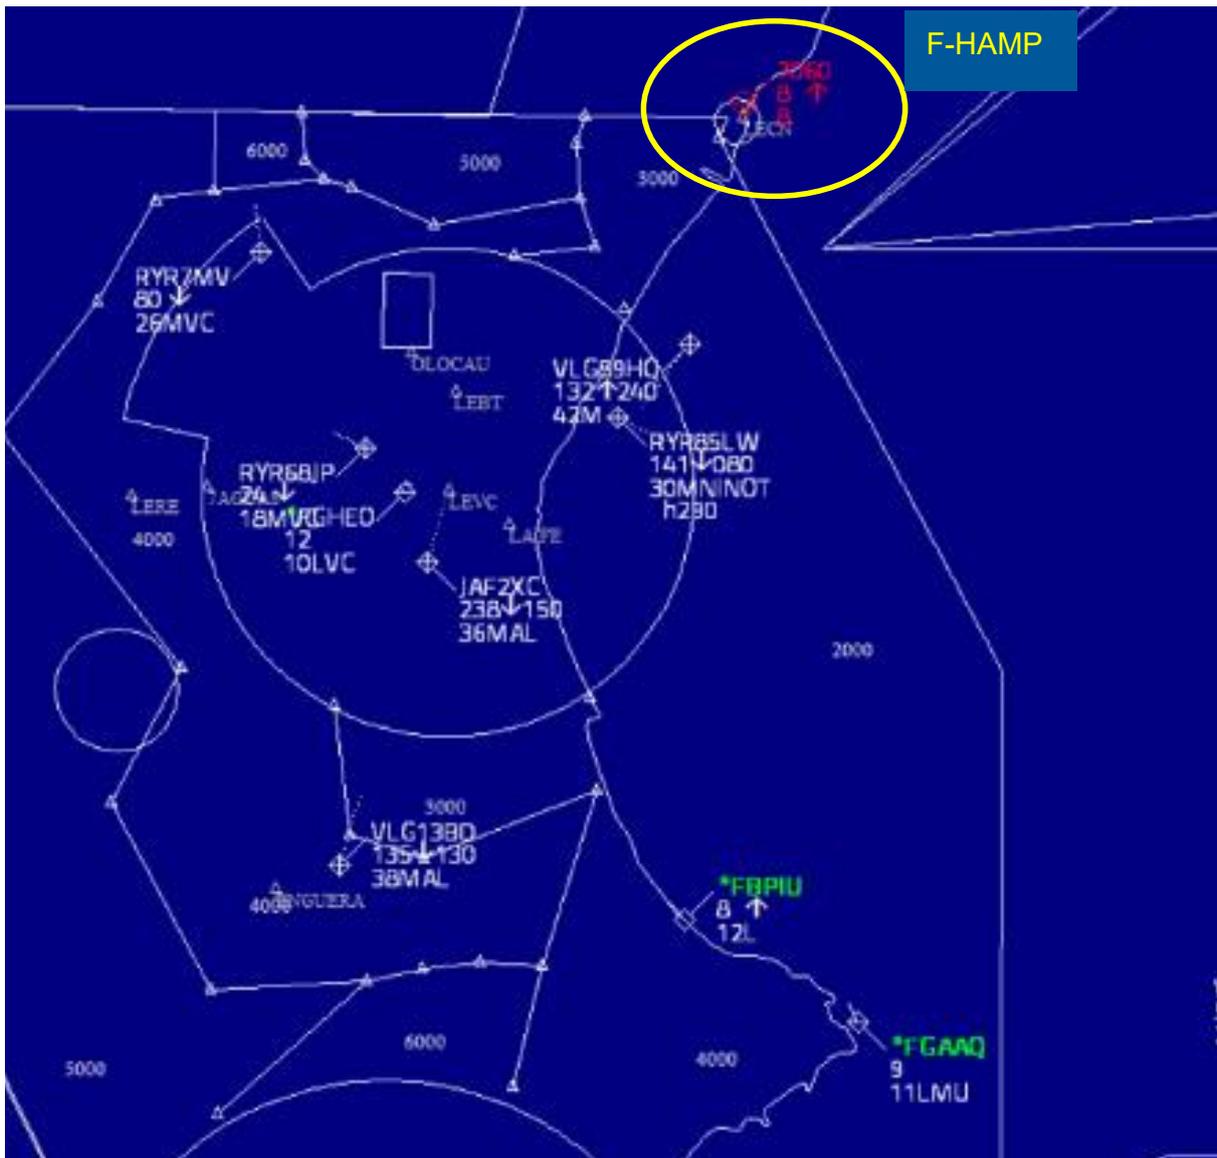
Illustration 5: Positions of F-HAMP, F-BPIU and F-GAAQ at 15:18

At 15:18 (13:18 UTC), the accident aircraft had just taken off from the aerodrome of Pinar de Castellon and was climbing. Aircraft F-GAAQ (which took off half an hour before the accident aircraft en route to Mutxamel) and F-BPIU (lead aircraft, which took off from the Requena aerodrome) were near Cape Nao.

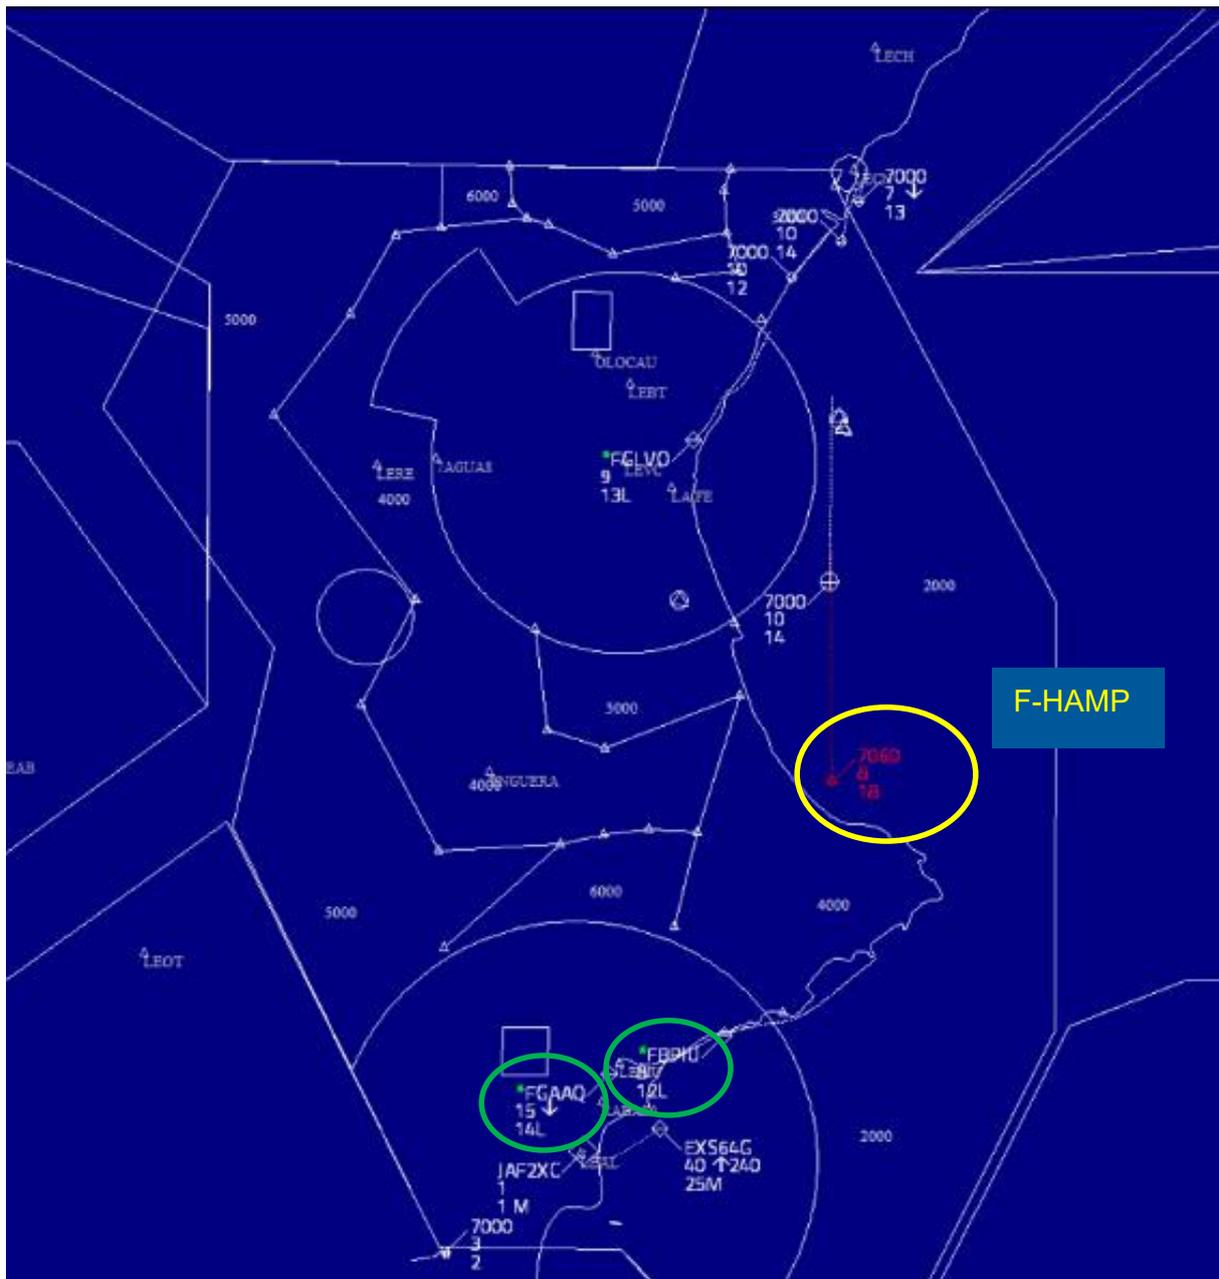
Illustration 6: Positions of F-HAMP, F-BPIU and F-GAAQ at 15:41

At 15:41:13 (13:41:13 UTC), the aircraft was at an altitude of 800 ft and flying at 180 knots. At that moment, the aircraft was flying in a straight path over the Mediterranean. The aircraft ahead of it, F-GAAQ and F-BPIU, were near the Mutxamel aerodrome.

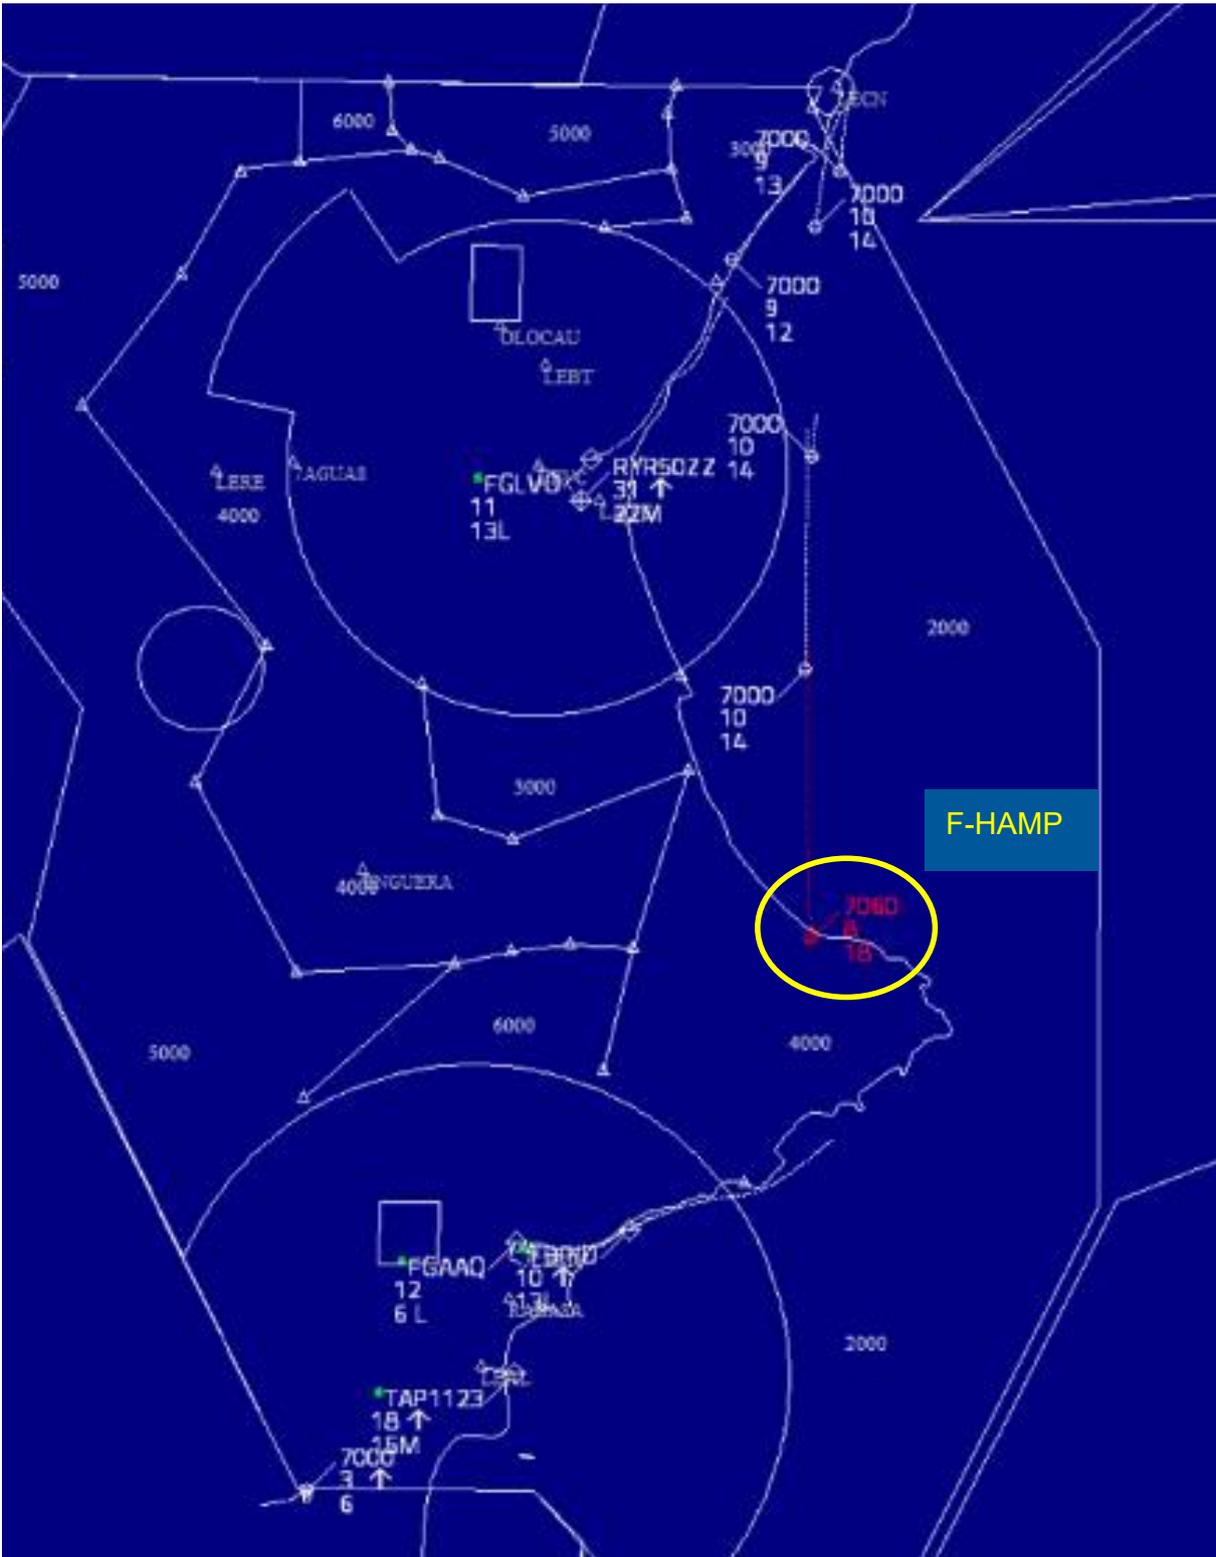
Illustration 7: Position of F-HAMP at 15:42:49

By 15:42:49 (13:42:49 UTC), the aircraft was flying inland. It was still at an altitude of 800 ft, meaning it did not increase its altitude to clear potential obstacles, and on the same heading. The speed was also the same at 180 knots.

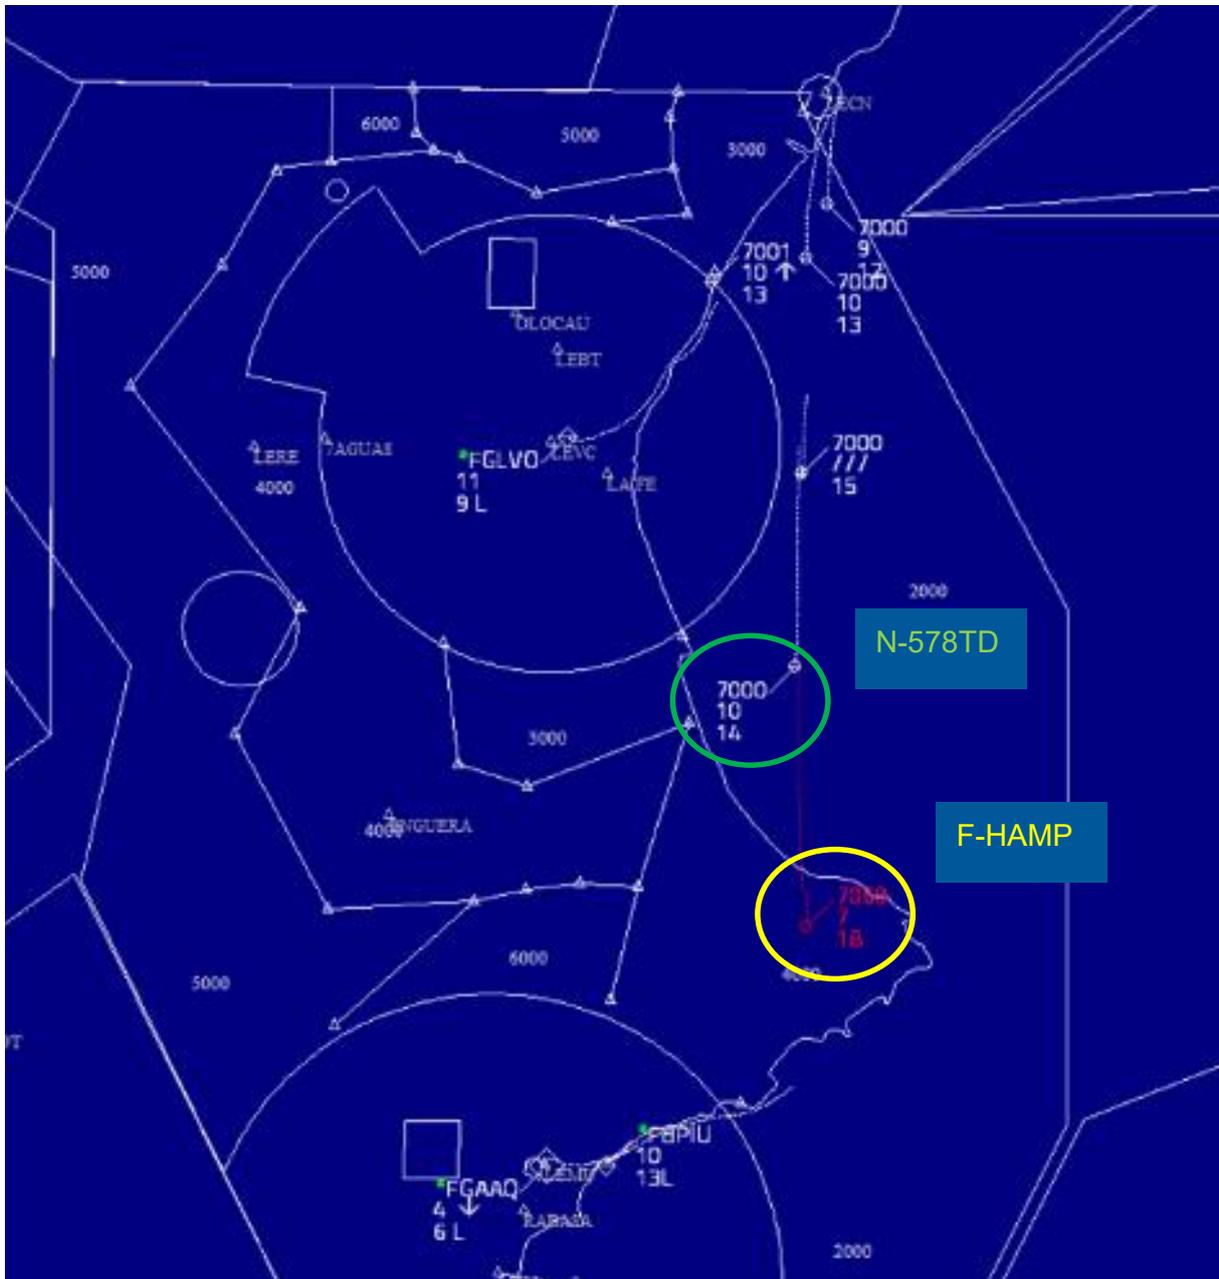
Illustration 8: Positions of F-HAMP and N-578TD at 15:44:14

At 15:44:14 (13:44:14 UTC), the position of the accident aircraft and of the aircraft that had taken off after it (N-578TD) were:

Eight seconds later, while at coordinates 38° 47' 08" N and 00° 00' 04" E, the aircraft was lost from radar.

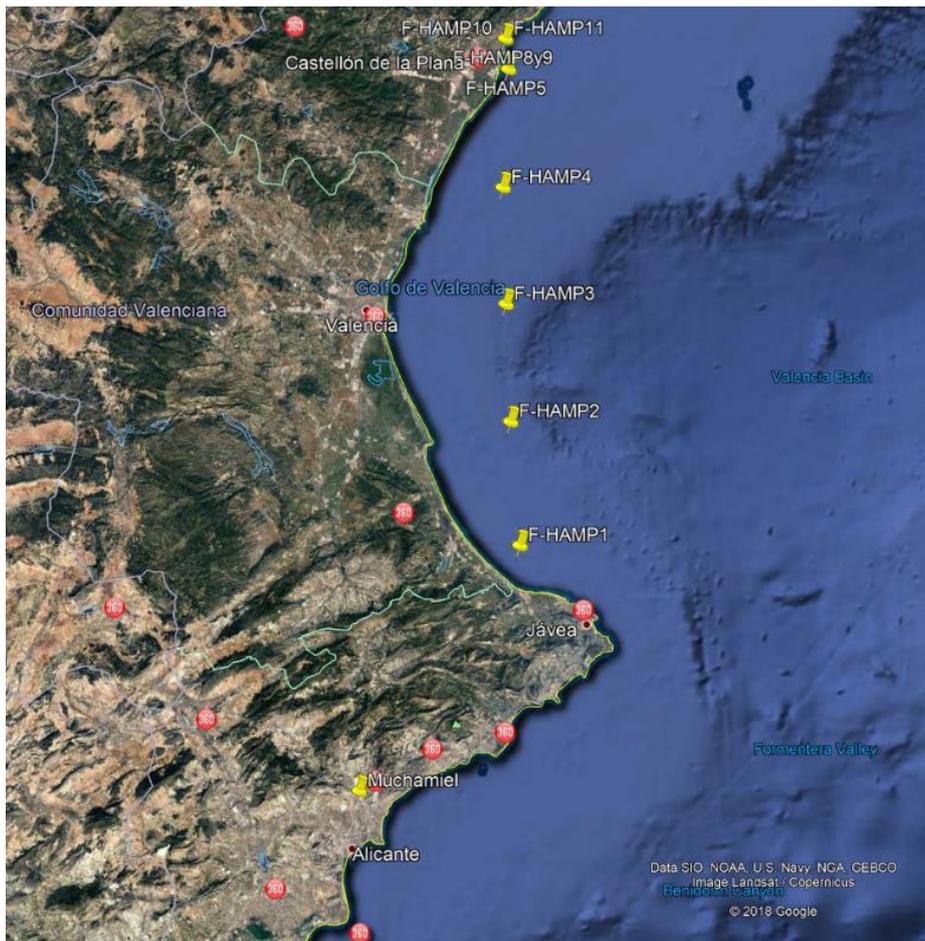
Illustration 9: Aircraft's position at various time during the flight

The positions transmitted until 15:41 are shown in the image below:

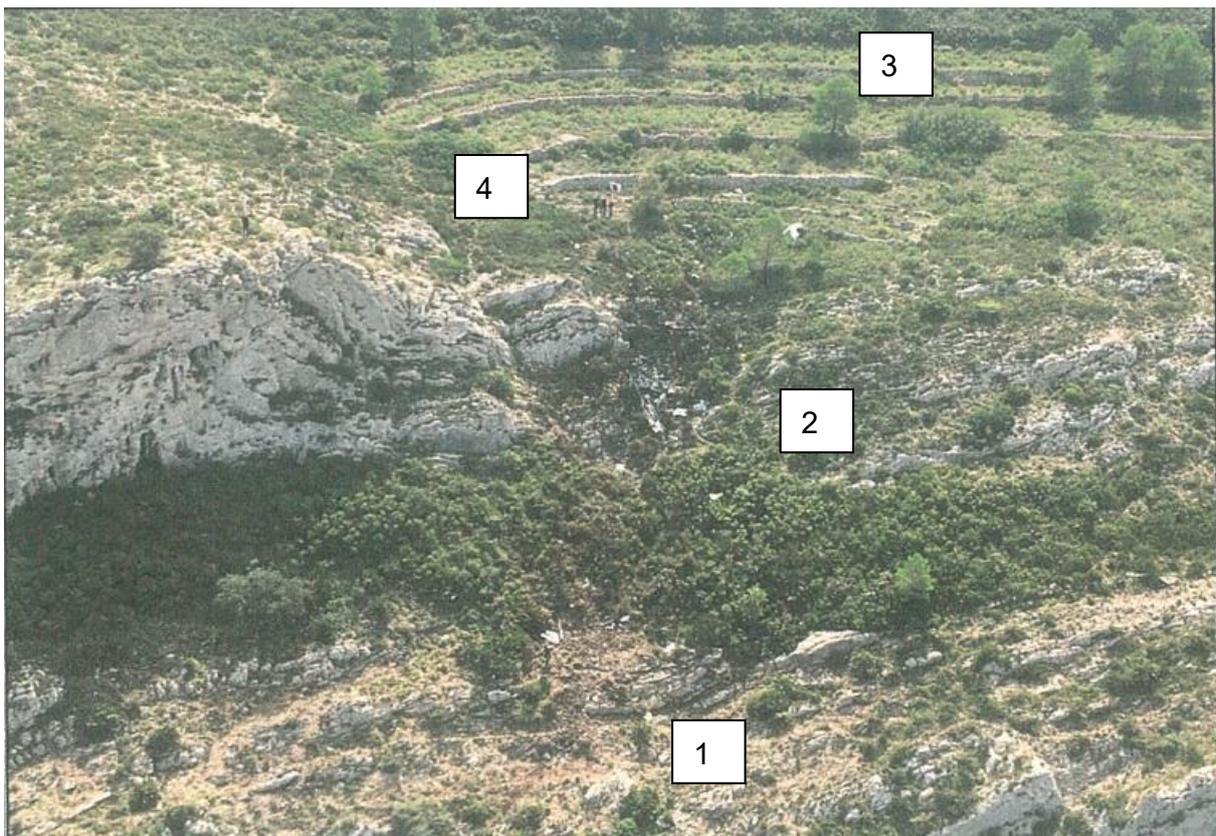
Illustration 10: Location of the main aircraft wreckage and the bodies of the crew members

The aircraft impacted the mountain side, leaving an uphill trail of debris and fire, scattered within a radius of approximately 150 meters. The terrain impacted by the aircraft is rugged and stepped. It is very steep and contains various terraces that are surrounded by stone walls, resulting in plots where the land is farmed.

The bodies of the pilot and the passenger were separated by about 50 meters. The pilot's body was in the seat with the seat belt fastened. The passenger's body was found separated from the seat, at a higher elevation.

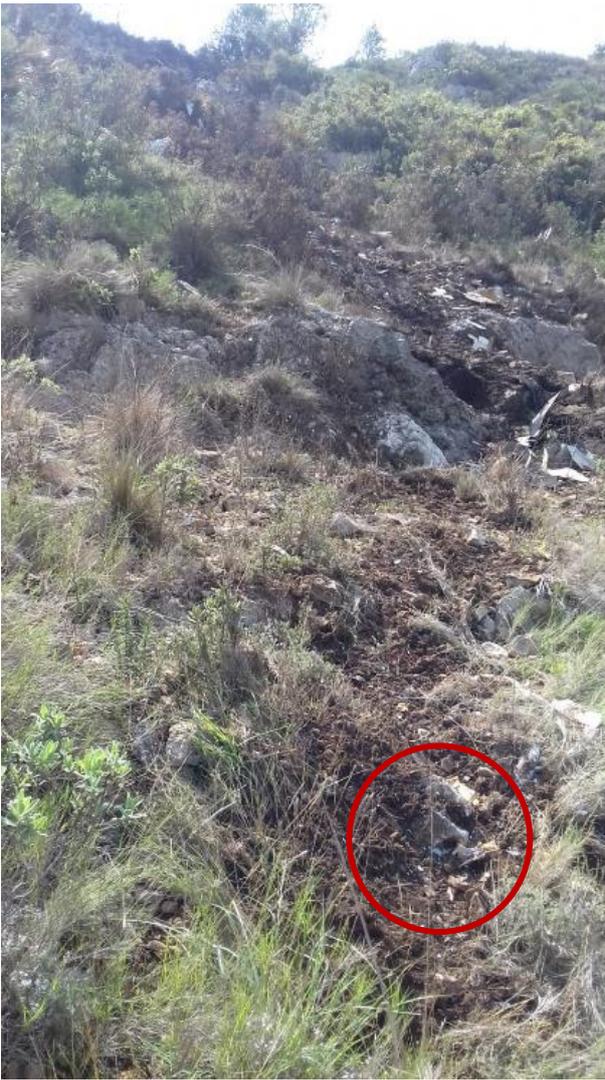
The first debris found, lowest on the hillside, was the aircraft's propeller.

The photograph on the right shows the propeller (marked in red). The mark behind it was left by the aircraft as it moved up the hillside.

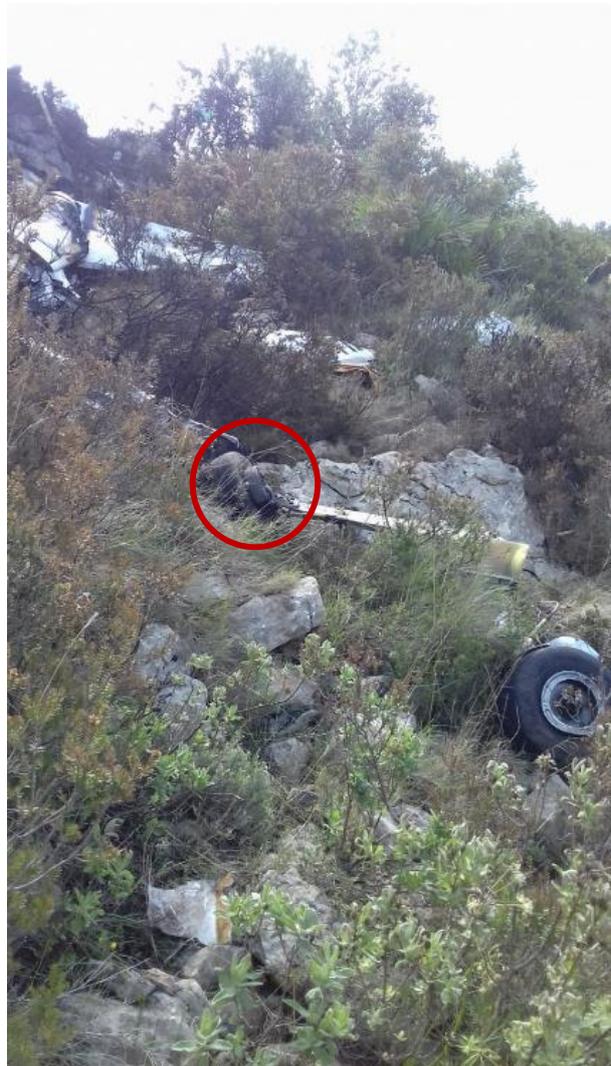
Further up there were the tires from the main gear (one of them circled in red), and further up still there were the fuselage and the wings of the aircraft.

The debris from the fuselage and wings, as well as the surrounding area, had been affected by the fire that broke out after the impact.

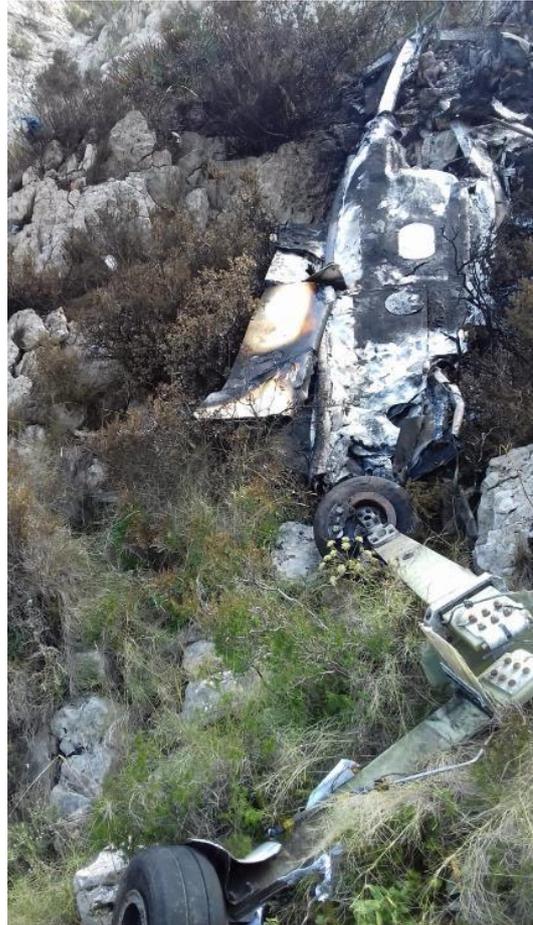
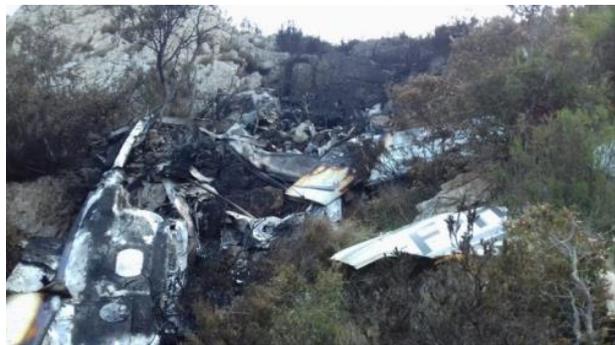
The top image shows the nose gear and parts of the fuselage, and the bottom image the same debris from the fuselage and debris from the wings.

The aircraft debris and the surrounding area had been affected by the fire that broke out after the impact, as the photographs show.

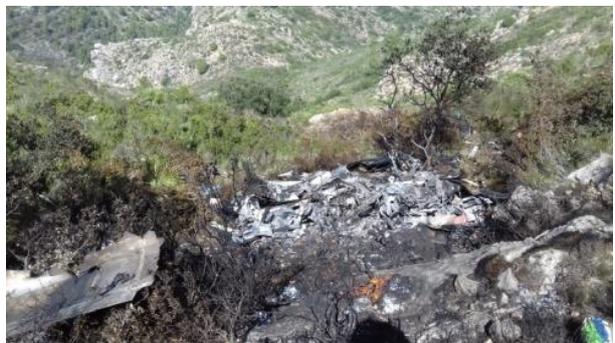
The photograph taken from the highest part of the hillside shows the main aircraft wreckage in the foreground, and the area where the aircraft impacted the slope in the background.

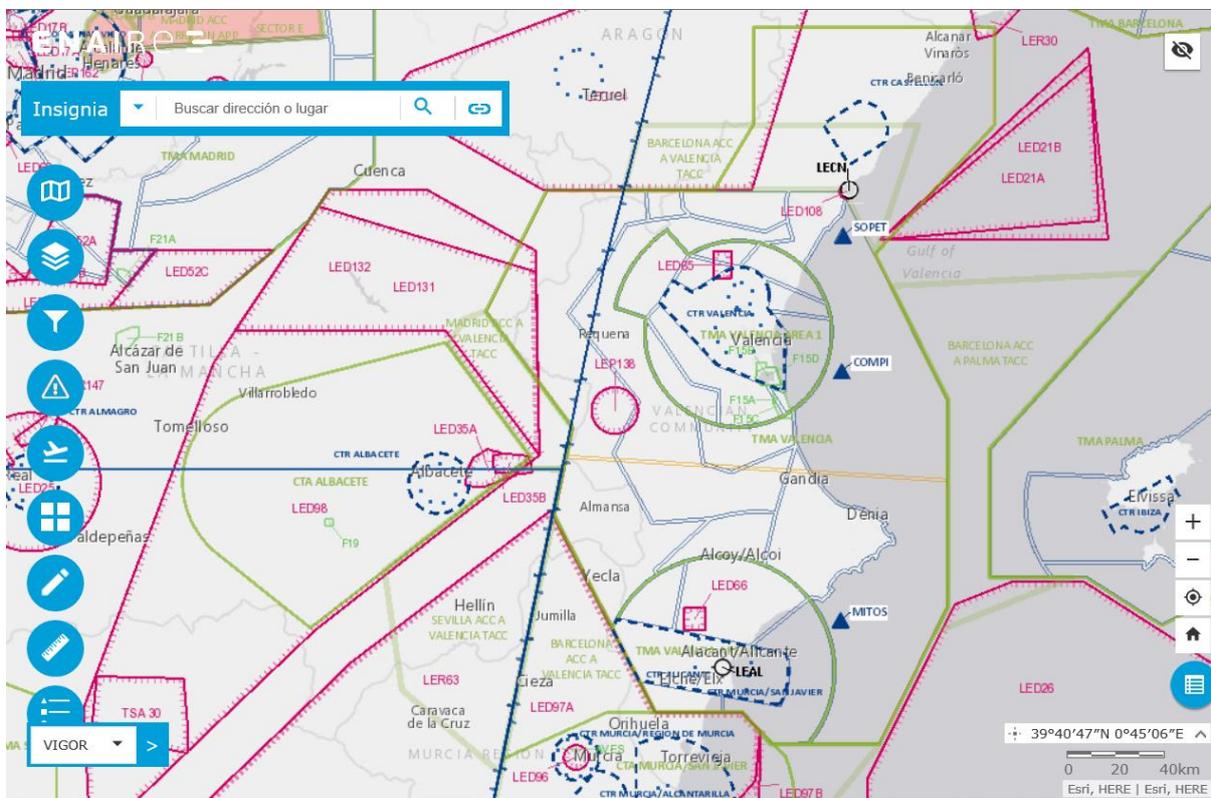
Illustration 12: Location of reporting points flown over by the accident aircraft

According to the final flight plan, the aircraft left from the aerodrome of Pinar de Castellon at 15:15 (13:15 UTC) and would fly over reporting points SOPET, COMPI and MITOS en route to the aerodrome of Mutxamel.

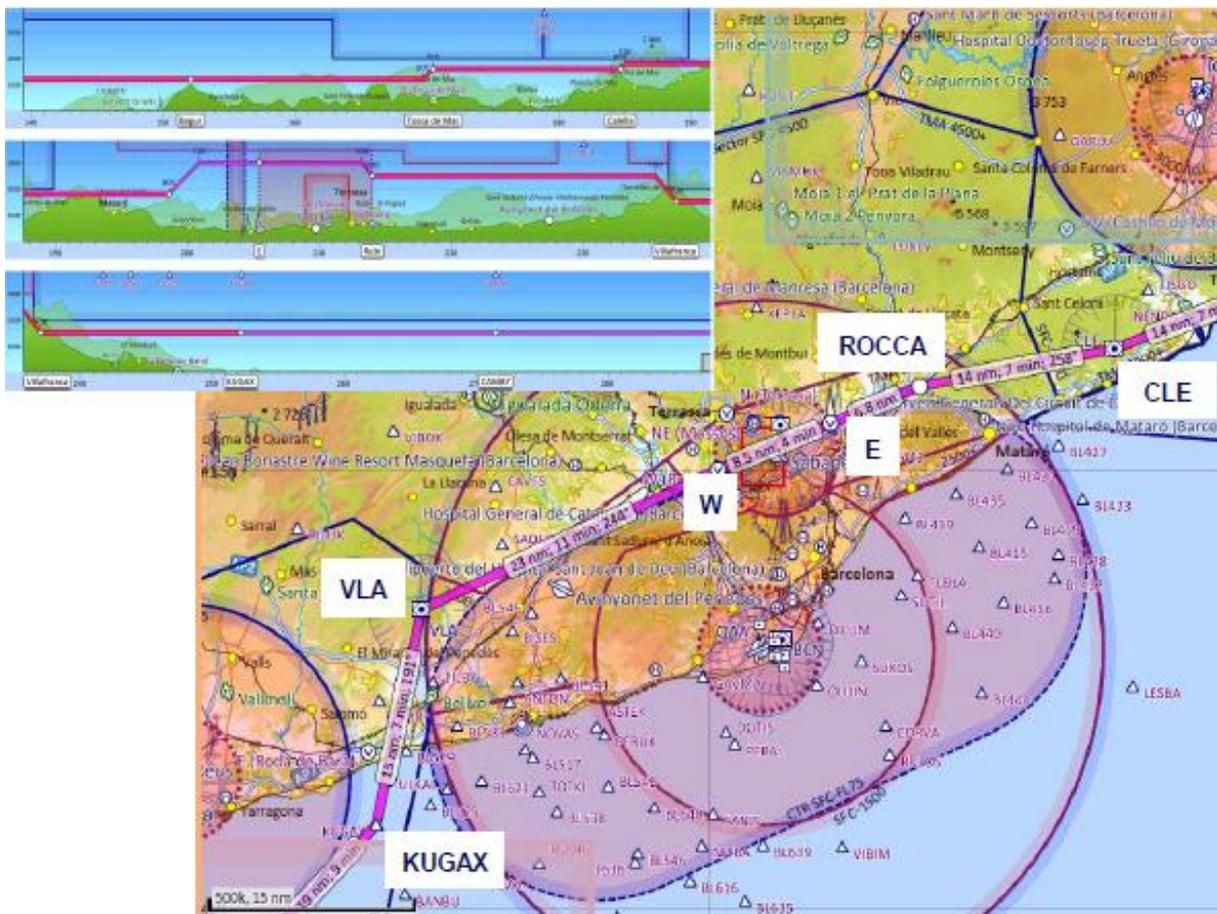
Illustration 13: Close up of the route proposed for 14 September

On 14 September, the first stage of the air rally was held between the aerodromes of Perpignan and Pinar de Castellon. The planned route was to go through the ATZ of the Sabadell airport, entering it via reporting point E and exiting it via W at an altitude of 3000 ft. The documentation from the organizers specified that after crossing the border, crews were to tune into the Barcelona frequency (INFO 127.70 MHz) until reporting point VLA (Villafranca VOR).

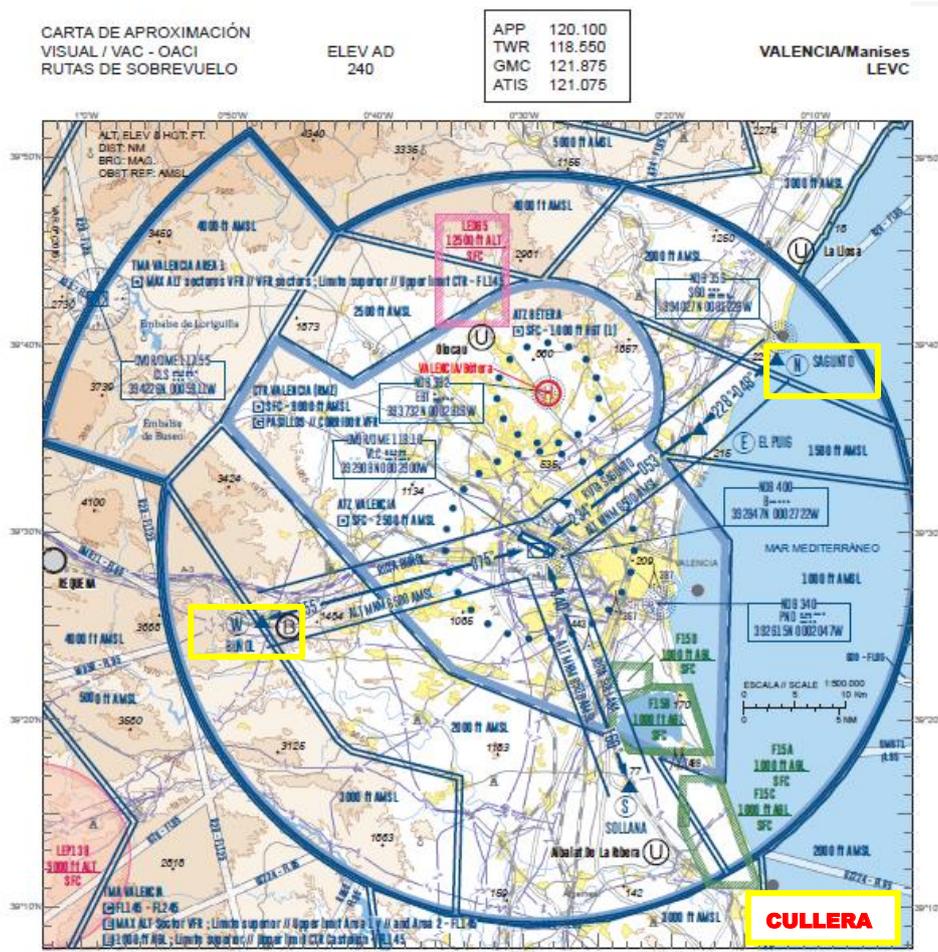
Attached is the visual approach chart for routes flying through the Valencia CTR, which includes the uncontrolled visual sectors, defined as class-G airspace, through which the participants in the air rally traveled on the day of the accident.

Indicated on the chart are reporting points N (Sagunto), W (Buñol) and the town of Cullera.
