# Report A-047/2019

Accident involving a Cirrus SR22 aircraft,  
registration F-HAMP, in the municipality of  
Pedreguer (Alicante) on 15 September 2019

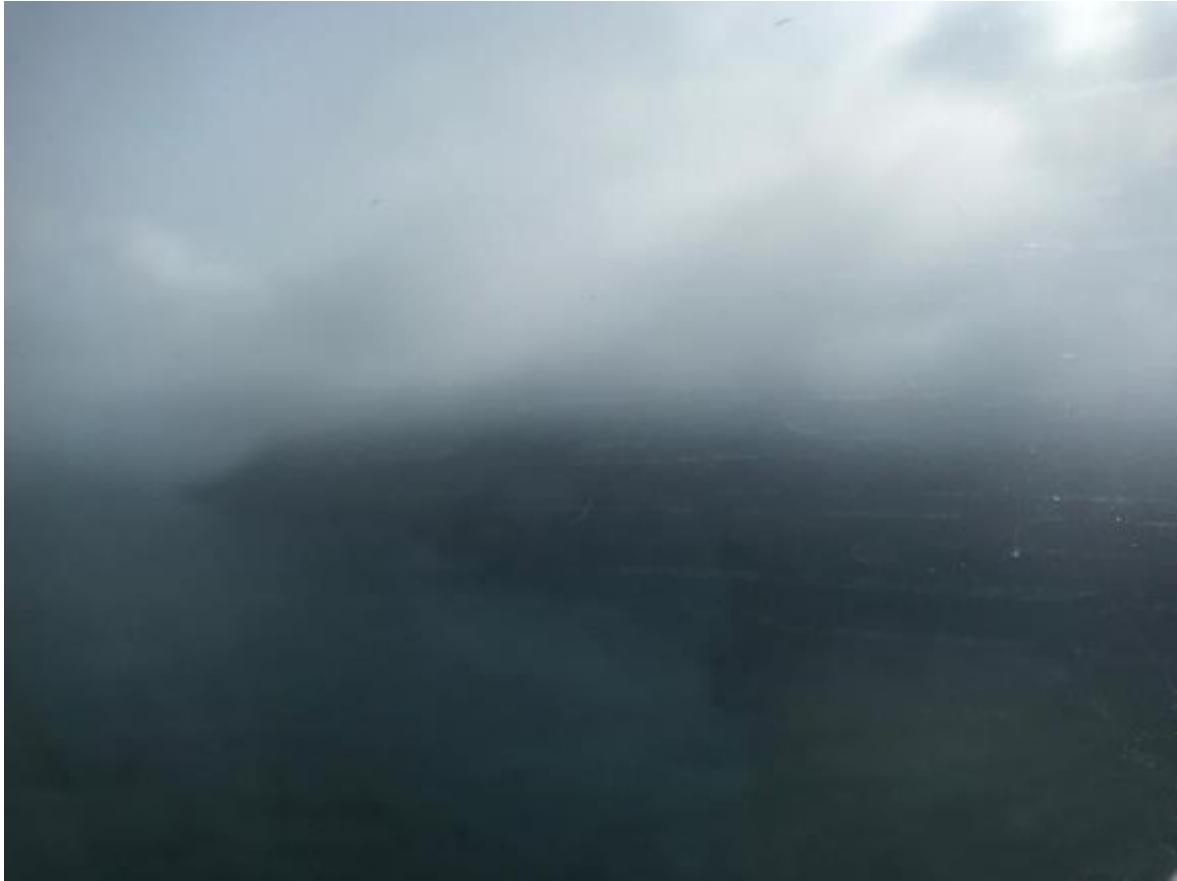
*Illustration 4: Photo of Cape Nao taken by one of the crews*

Also included is another photograph, taken by the one flying behind the accident aircraft, of the weather conditions in Cape Nao, near the accident site:

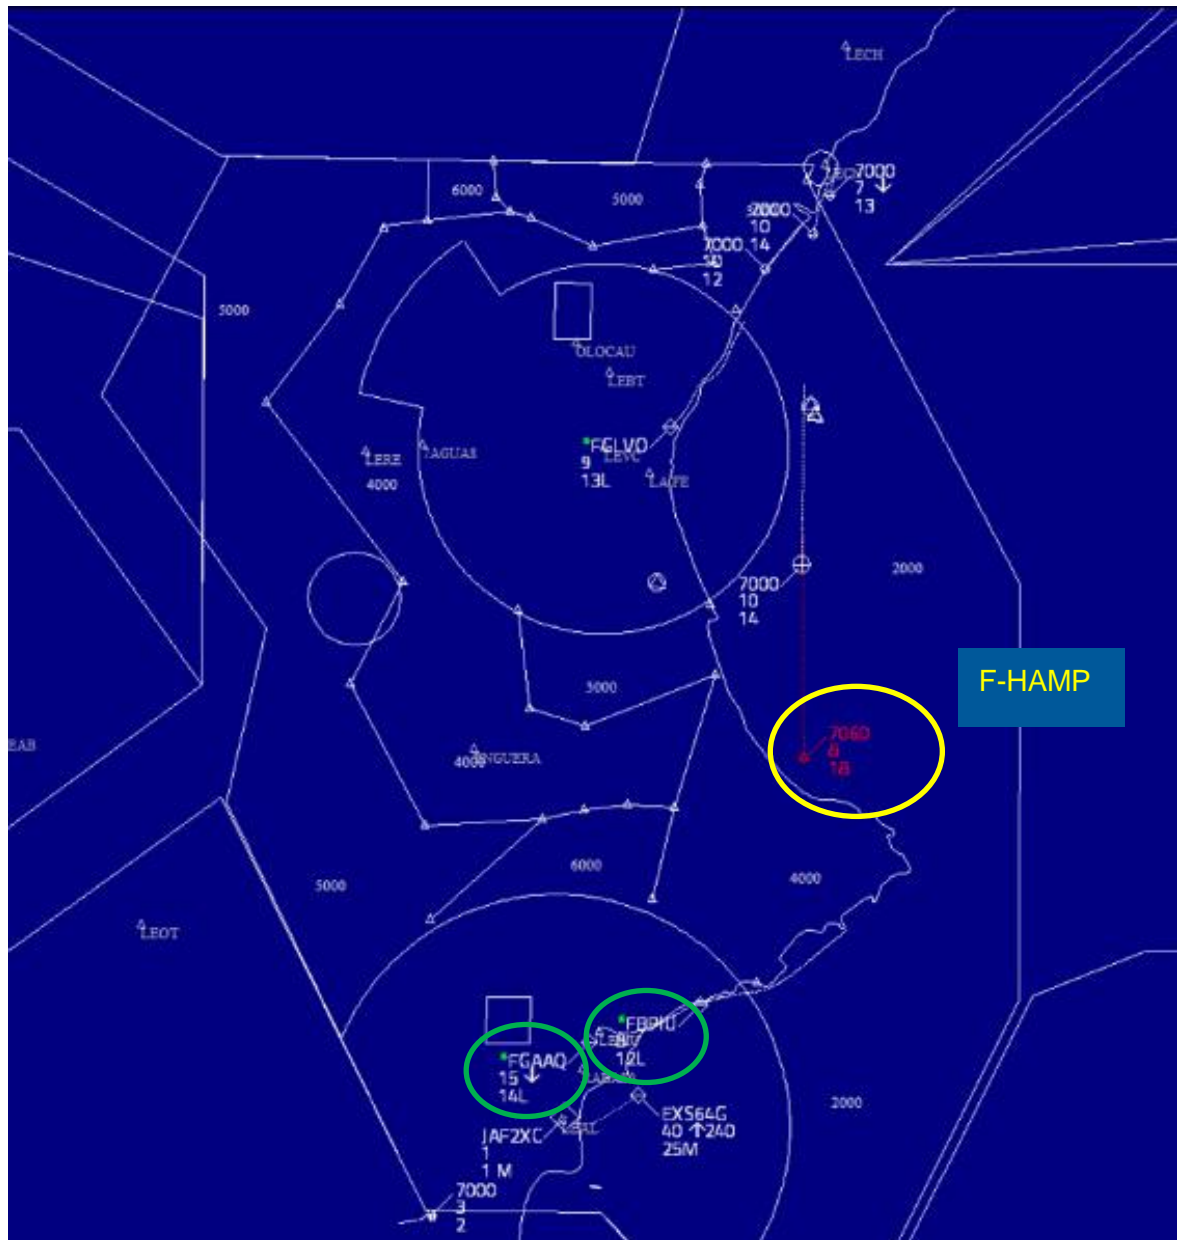
Illustration 6: Positions of F-HAMP, F-BPIU and F-GAAQ at 15:41

At 15:41:13 (13:41:13 UTC), the aircraft was at an altitude of 800 ft and flying at 180 knots. At that moment, the aircraft was flying in a straight path over the Mediterranean. The aircraft ahead of it, F-GAAQ and F-BPIU, were near the Mutxamel aerodrome.

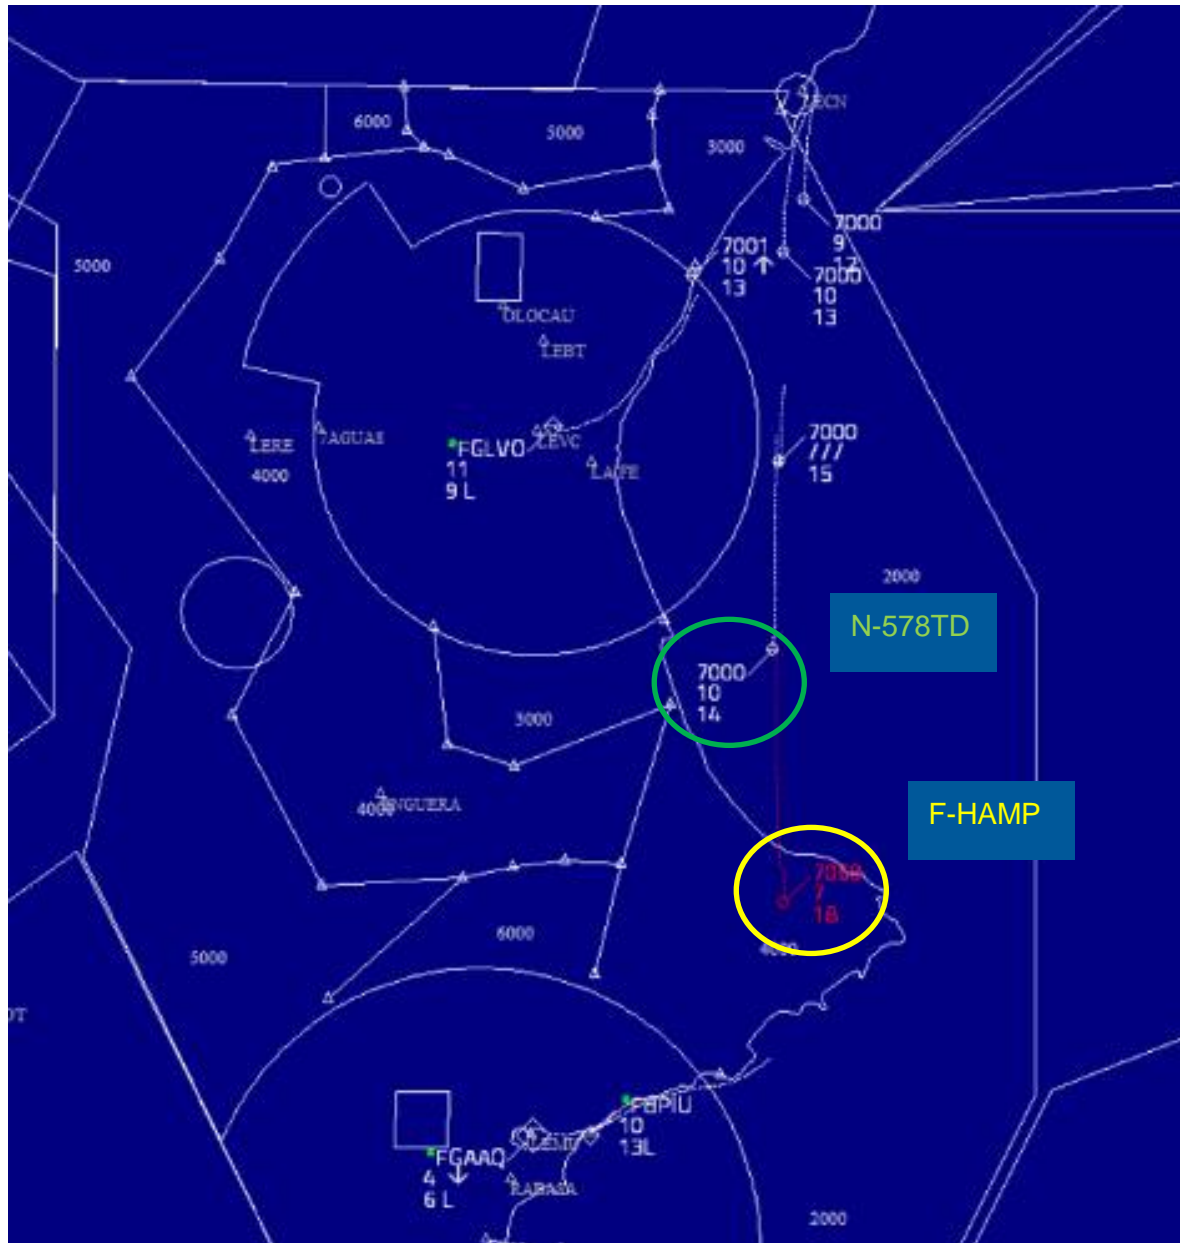
Illustration 8: Positions of F-HAMP and N-578TD at 15:44:14

By 15:42:49 (13:42:49 UTC), the aircraft was flying inland. It was still at an altitude of 800 ft, meaning it did not increase its altitude to clear potential obstacles, and on the same heading. The speed was also the same at 180 knots.

Seconds later, the aircraft made a left turn and changed its altitude slightly.

Eight seconds later, while at coordinates  $38^{\circ} 47' 08''$  N and  $00^{\circ} 00' 04''$  E, the aircraft was lost from radar.

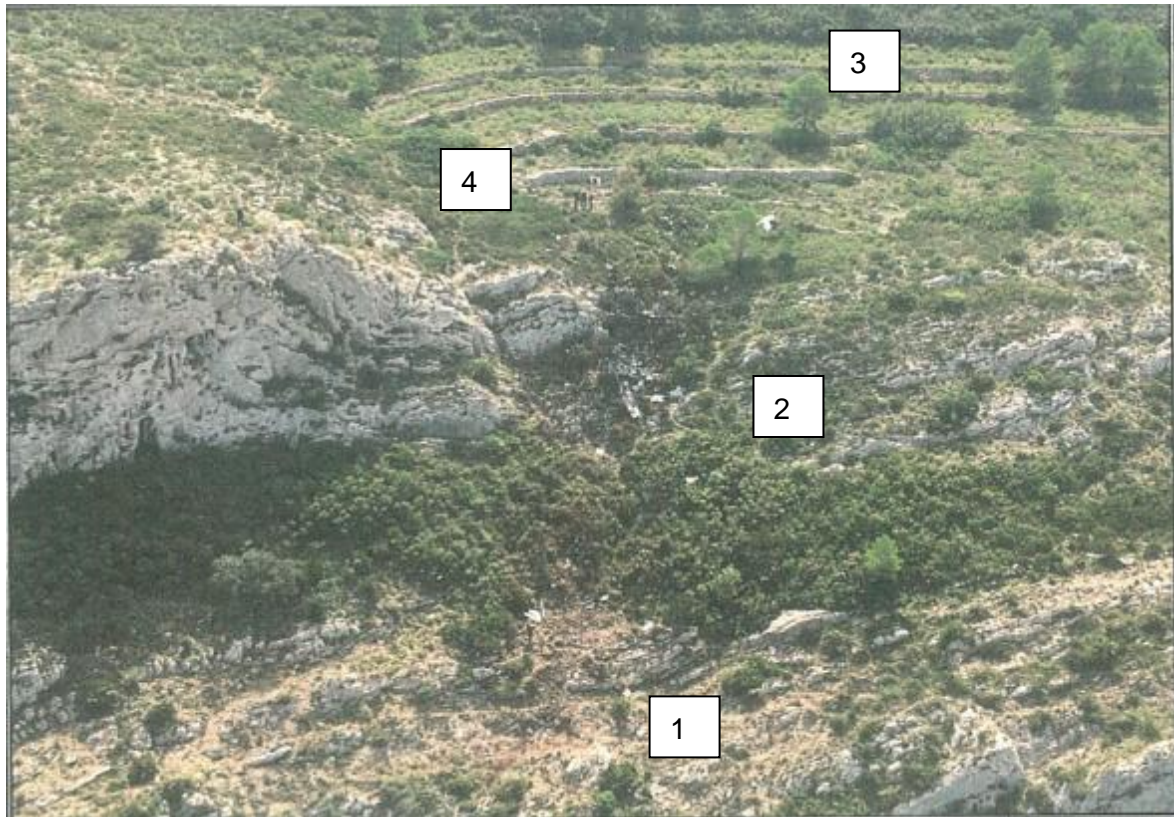
*Illustration 10: Location of the main aircraft wreckage and the bodies of the crew members*

The aircraft impacted the mountain side, leaving an uphill trail of debris and fire, scattered within a radius of approximately 150 meters. The terrain impacted by the aircraft is rugged and stepped. It is very steep and contains various terraces that are surrounded by stone walls, resulting in plots where the land is farmed.

The bodies of the pilot and the passenger were separated by about 50 meters. The pilot's body was in the seat with the seat belt fastened. The passenger's body was found separated from the seat, at a higher elevation.

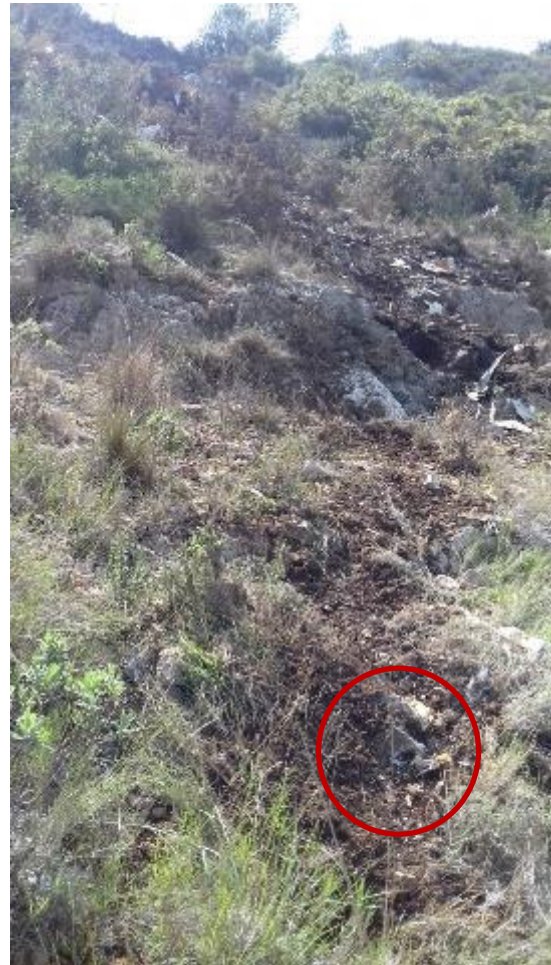
The first debris found, lowest on the hillside, was the aircraft's propeller.

The photograph on the right shows the propeller (marked in red). The mark behind it was left by the aircraft as it moved up the hillside.

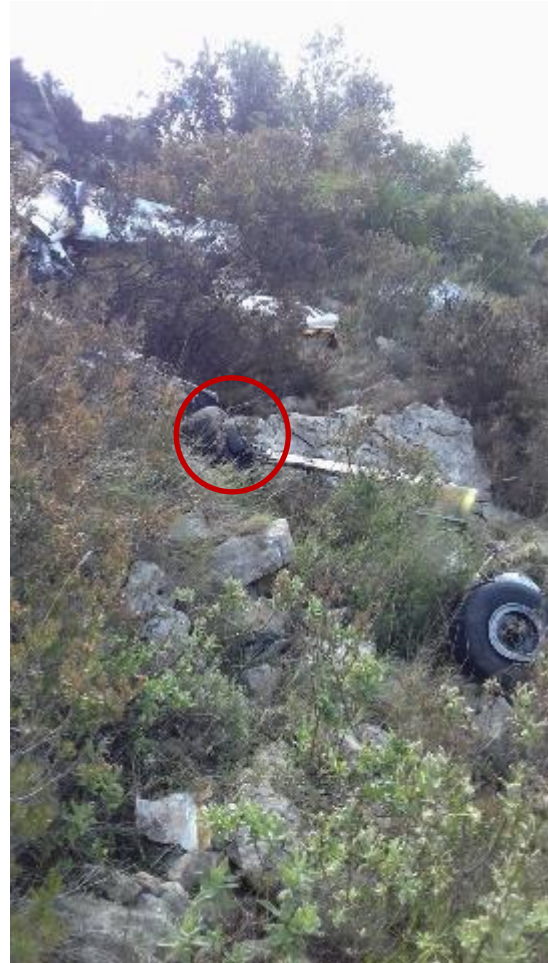
Further up there were the tires from the main gear (one of them circled in red), and further up still there were the fuselage and the wings of the aircraft.

The debris from the fuselage and wings, as well as the surrounding area, had been affected by the fire that broke out after the impact.

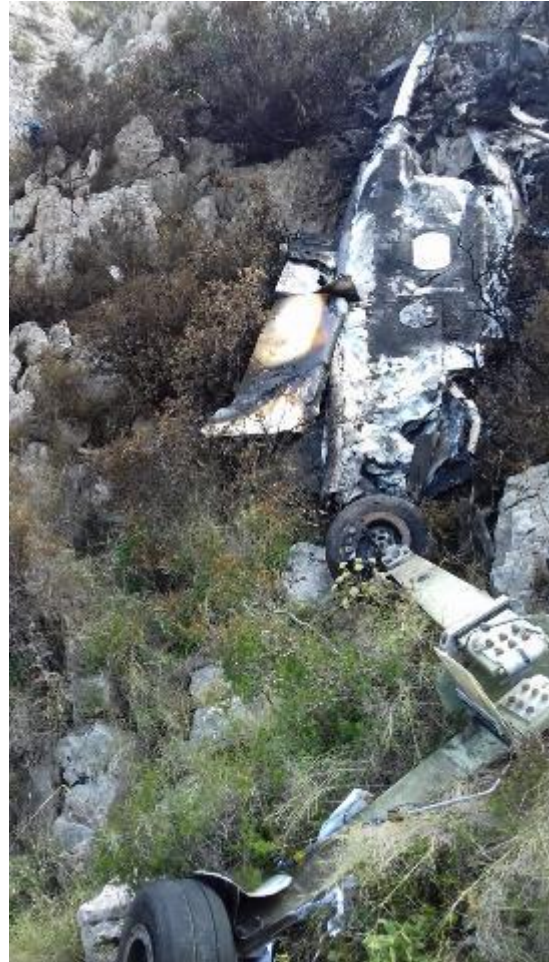
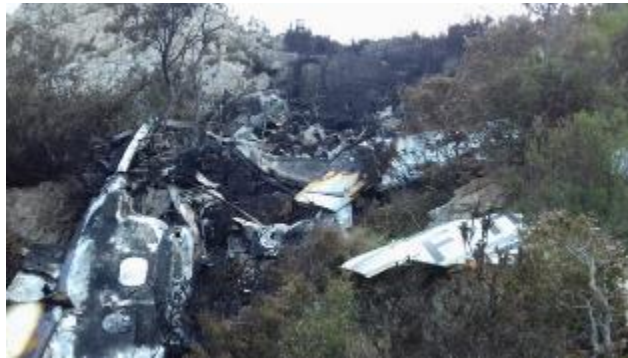
The top image shows the nose gear and parts of the fuselage, and the bottom image the same debris from the fuselage and debris from the wings.

The aircraft debris and the surrounding area had been affected by the fire that broke out after the impact, as the photographs show.

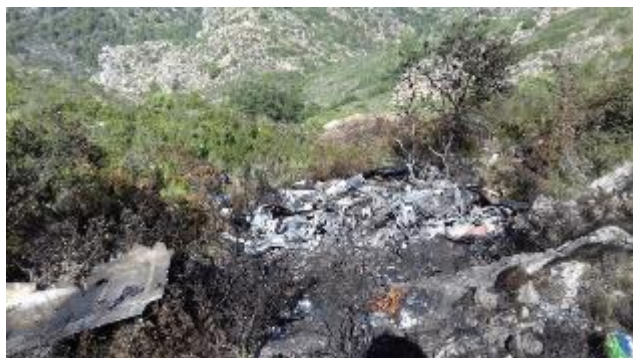
The photograph taken from the highest part of the hillside shows the main aircraft wreckage in the foreground, and the area where the aircraft impacted the slope in the background.
