Technical report

A-049/2021

Accident on 22 October 2021, involving a
Eurocopter AS-350-B3 aircraft,
registration EC-JEA, operated by Eliance, in the
Vall d'Arán, Lérida (Spain)

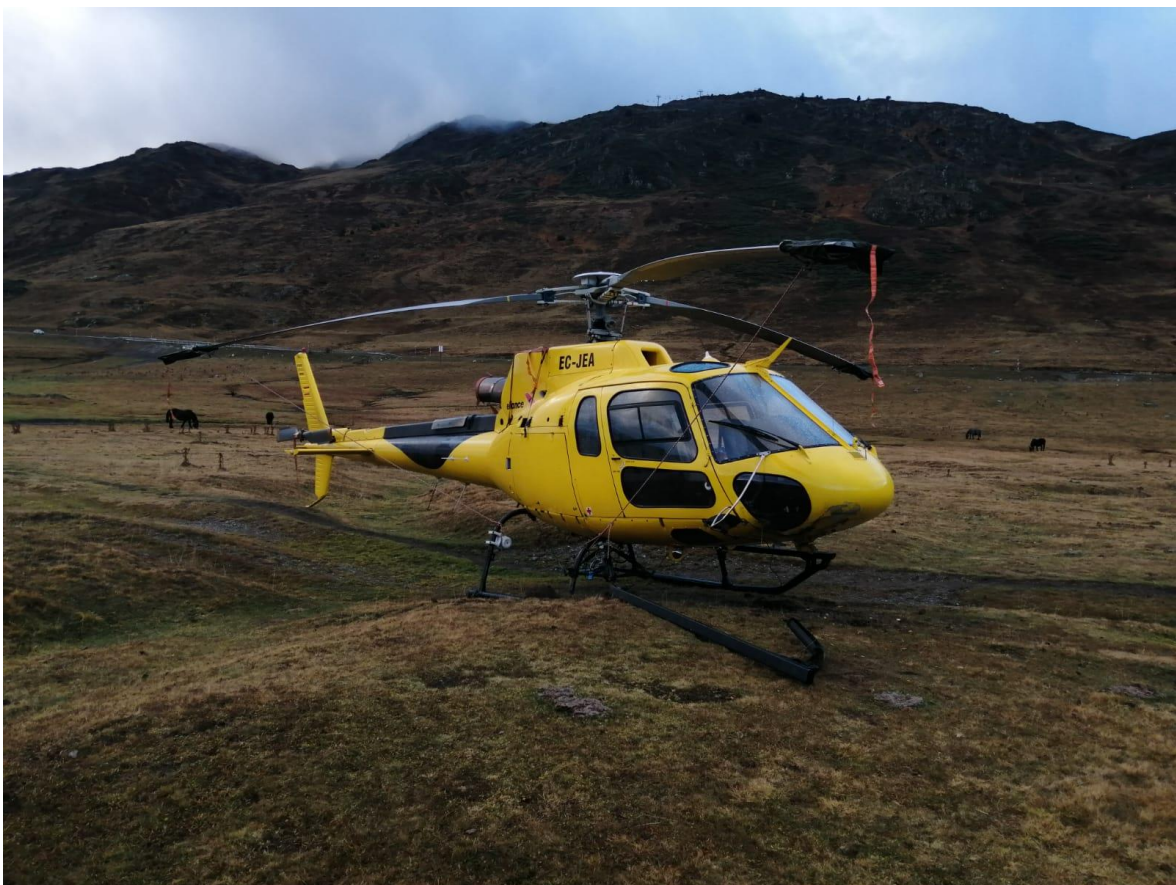
Photograph 1: Aircraft at the site of event

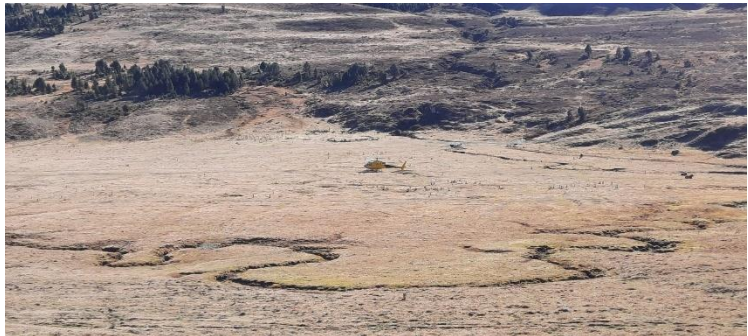
Photograph 10. Helicopter at the accident site

After two successive impacts with the ground, the aircraft came to rest at 42° 43' 8.09" N - 0° 57' 33.14" E, with its longitudinal axis oriented on an easterly heading, resting on the damaged landing gear. As a result of the accident, the helicopter suffered significant damage that rendered it unairworthy. Consequently, it was withdrawn from service and transferred to the operator's maintenance centre in Sabadell.

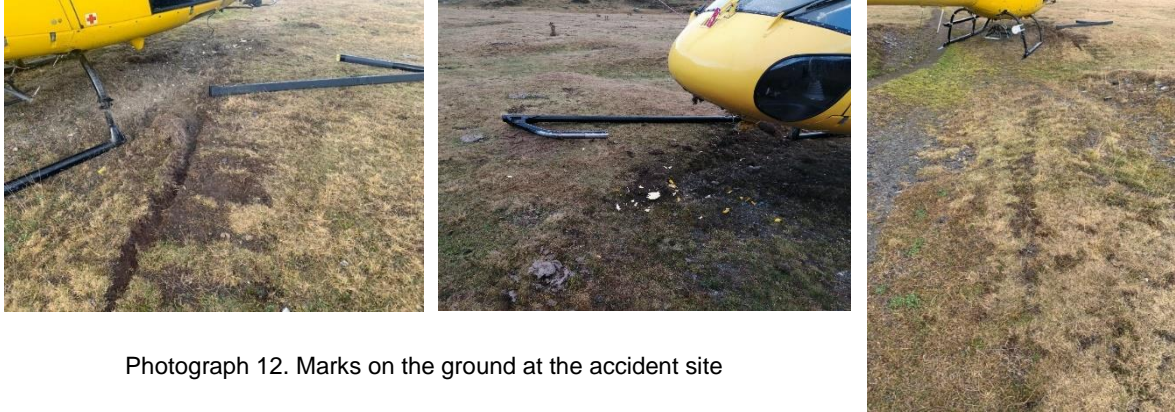
Due to the unevenness of the terrain, the aircraft lifted and then fell again, this time onto an upward incline, again resulting in a negative pitch attitude which caused the right skid (level with the front crosstube) and the right-hand underside of the nose to collapse, broke the lower cable cutter and caused the aircraft to rotate 45°, which brought it to an abrupt halt. The impact triggered the ELT, and Palma SAR contacted the operator to confirm the emergency situation.

Photograph 12. Marks on the ground at the accident site

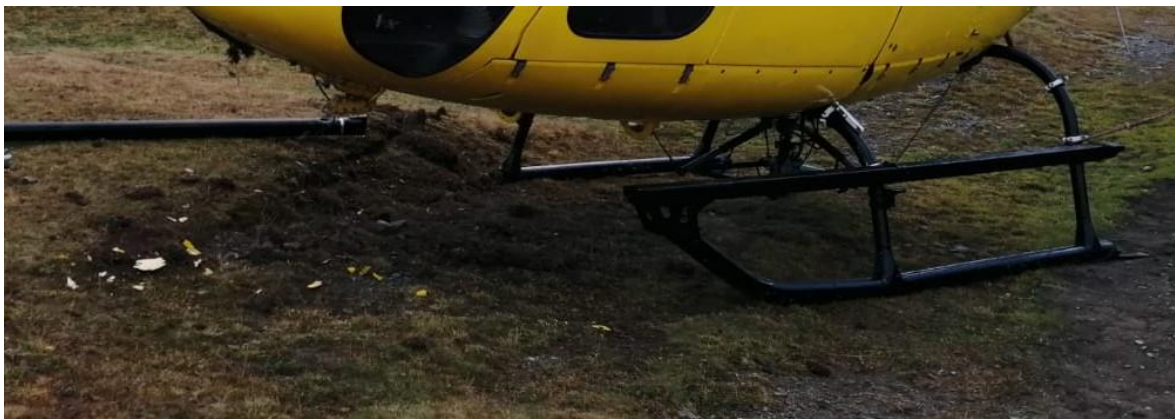
- Rupture of the right skid where it meets the crosstube.
- Deformation of the left skid.

Photograph 13. Helicopter at the accident site - Landing gear

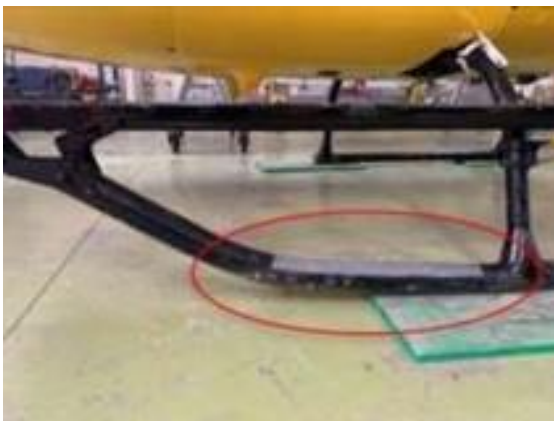
Photograph 14. Left skid

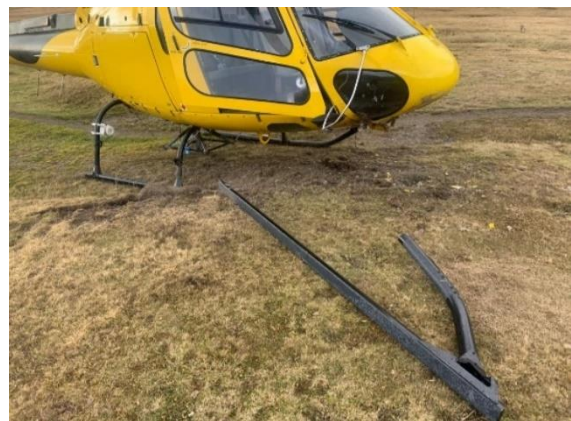
The aircraft sustained damage to the right skid, which collapsed and broke where it meets the front crosstube; the lower front window and mirror attachment were deformed; the lower cable cutter was severed, and the upper one was damaged. It also sustained cuts to its tail rotor drive shaft fairing, and the shaft itself was damaged.

Photograph 15. Right skid

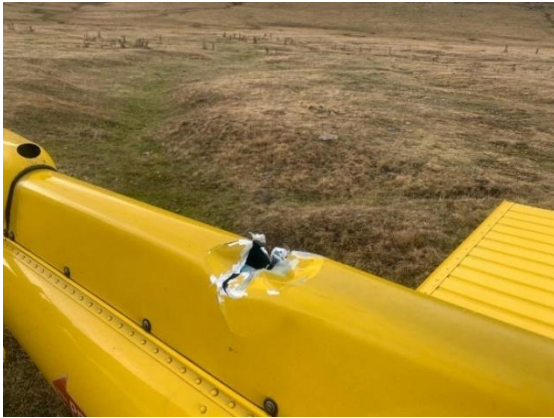
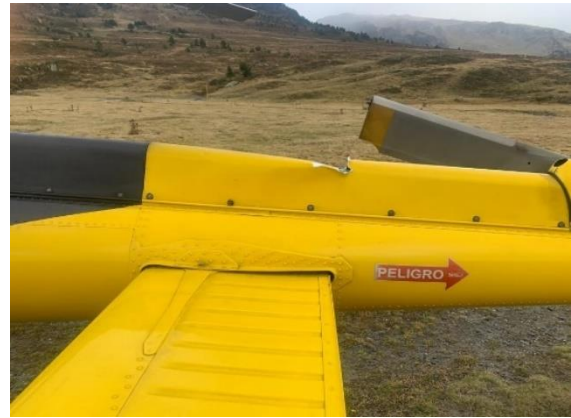
- Cuts to the tail rotor drive shaft fairing.
- Deformed tail rotor drive shaft.

Photograph 16. Tail rotor drive shaft fairing

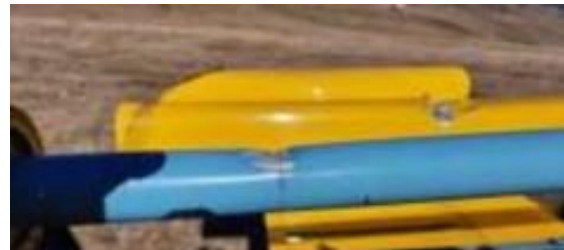
Photograph 17. Tail rotor drive shaft

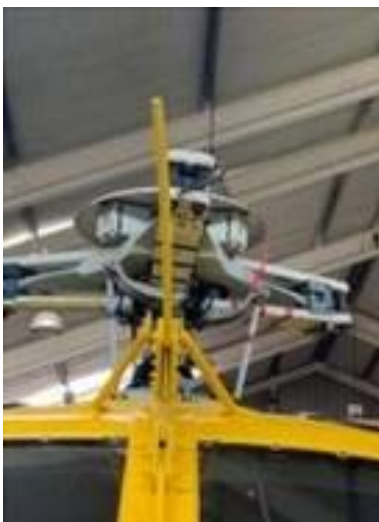
- Deformed upper cable cutter.
- Breakage of the lower cable cutter.
- Damaged lower-right front fairing.
- Mirror support.
- Damage to the tips of two of the three main rotor blades (red and blue).
- Structure reinforcement bar left side transmission area damaged.

Photograph 18. Left, upper cable cutter

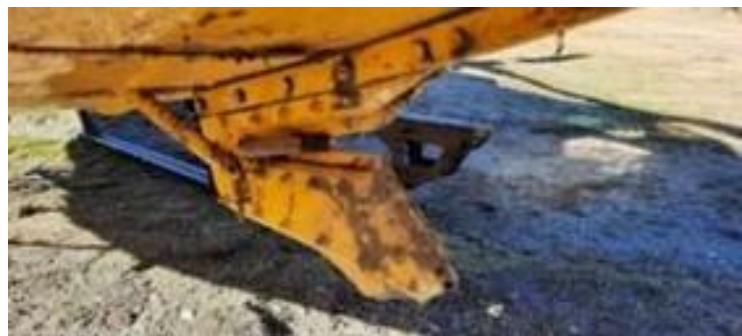
Photograph 19. Right, lower cable cutter

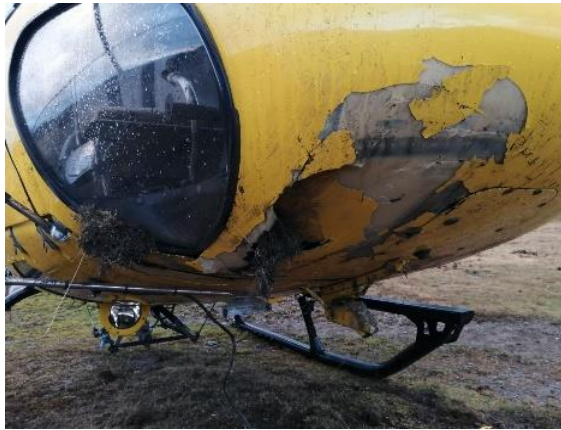
Photograph 20. Lower right fairing

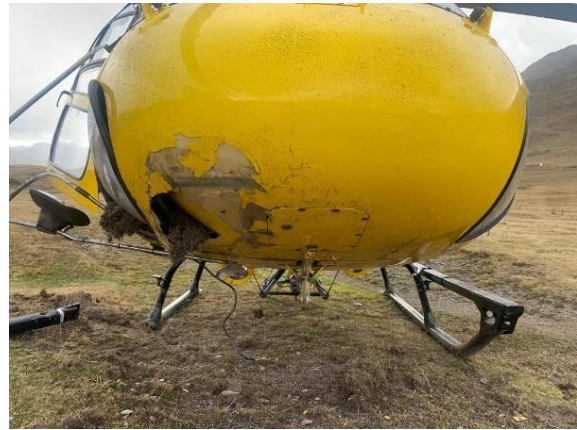
Photograph 21. Mirror support

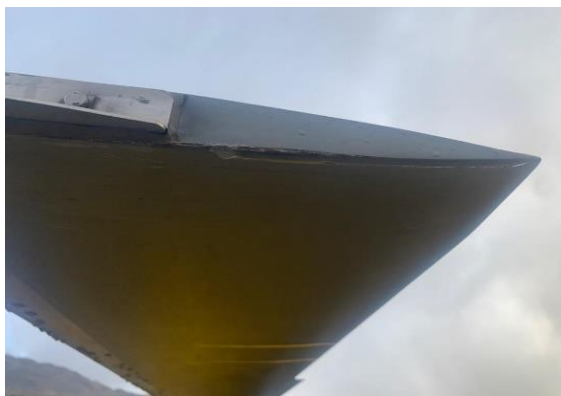
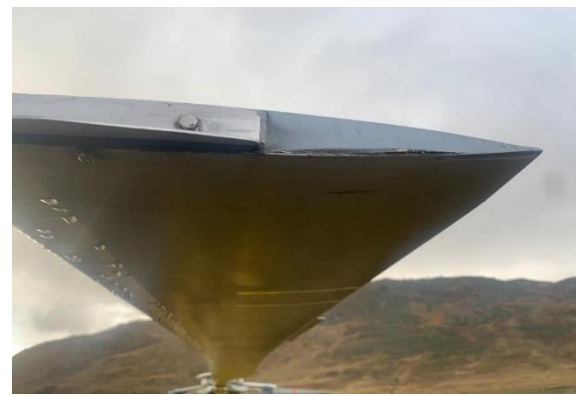
Photograph 22. Tips of the main rotor blade

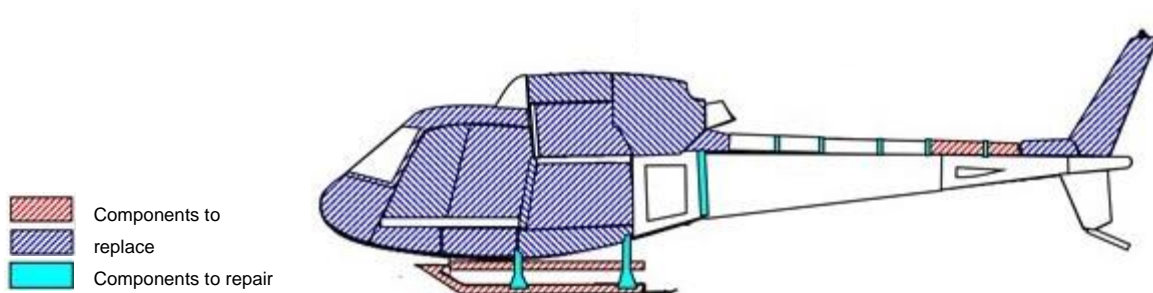
Both the aircraft and engine manufacturer determined that the helicopter's limitations resulted from the damage mentioned above, the engine being affected by damage to the rotor with hardly any to the blades, and the repercussions of making a hard landing with the engine running.

Figure 4. Identification of damage to the structure of the aircraft involved in the event

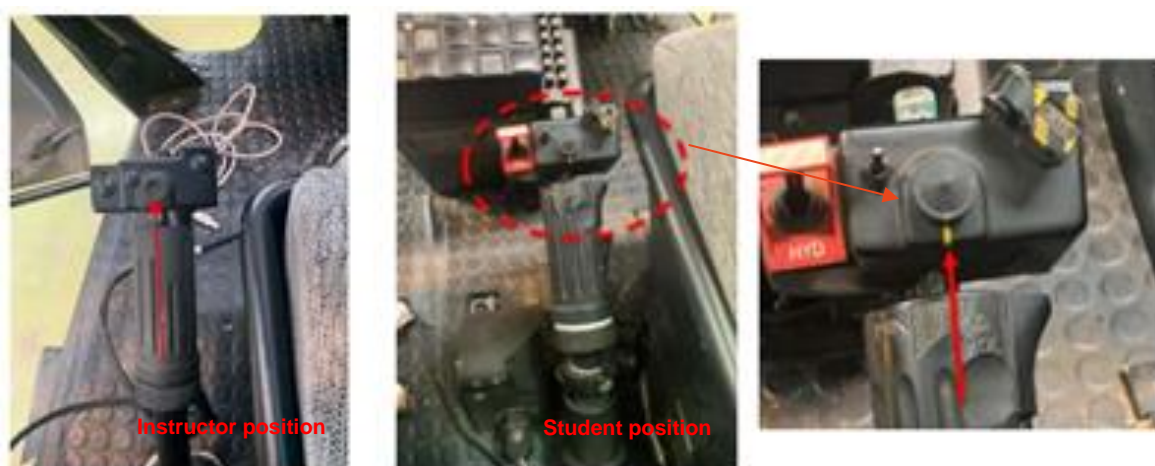
Photograph 23: Position of left twist grip, right twist grip and close-up of right.

After the impact, it was established that the twist grips were not in the flight position, as shown in photo set 23. The operator's interviews with the crew identified confusion around the procedure described in FLM Supplement 6 and when to abort the simulated governor failure manoeuvre.

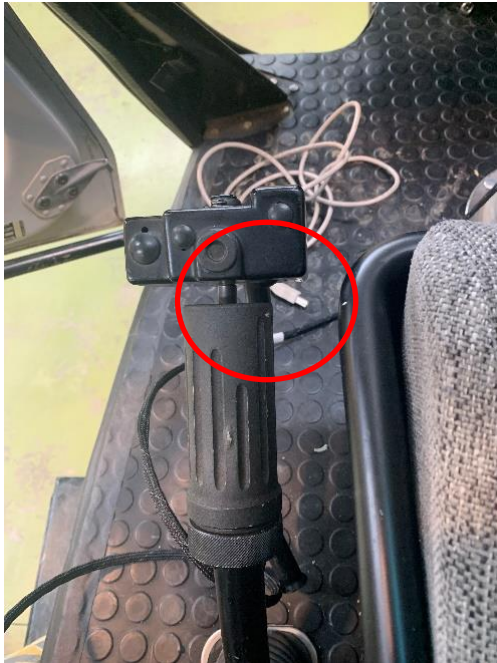
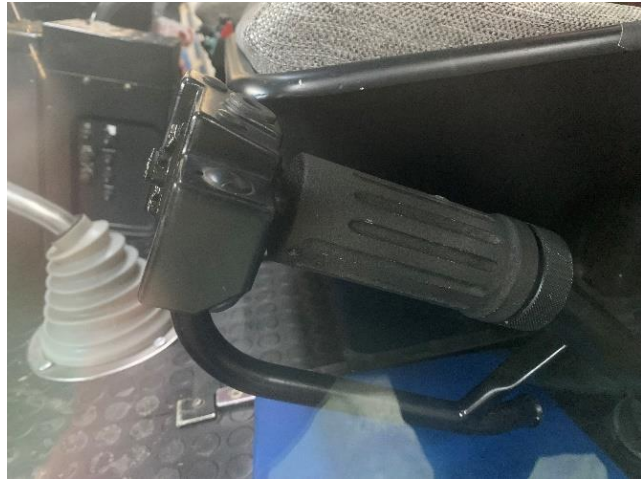
Photograph 24: Twist grip installed for training in the left-hand position occupied by the instructor. Absence of yellow mark highlighted with a red circle.

The control installed for training purposes has no position markings on the twist grip, making it difficult to interpret its position visually.
