CIAIM-04/2023 report

Collision between the fishing vessel ZERUKO ERREGIÑA and the recreational vessel CLEM 7 miles east of the lighthouse of La Entallada (Fuerteventura), on March 30, 2022

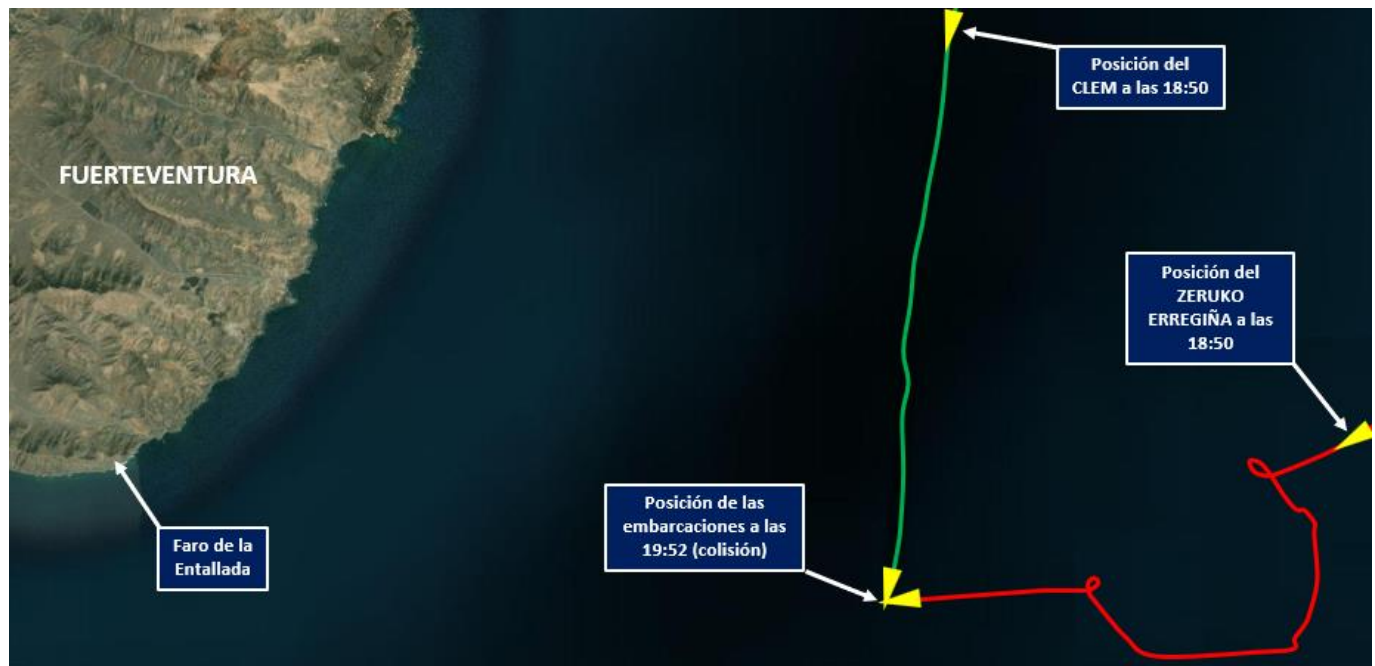
Figura 5. Courses followed by the fishing vessel ZERUKO ERREGIÑA (in red) and the recreational vessel CLEM (in green) since one hour before the accident. (Special data infrastructure viewer of the Hydrographic Institution of the Spanish Navy)

In Figura 5 of the previous section, which shows the courses of the CLEM and the ZERUKO ERREGIÑA starting from one hour before the accident, no significant changes of direction on the part of the two boats are observed in the moments prior to the accident. This can be seen clearly in the representation shown in Figura 7 and by an analysis of the data in Table 1.

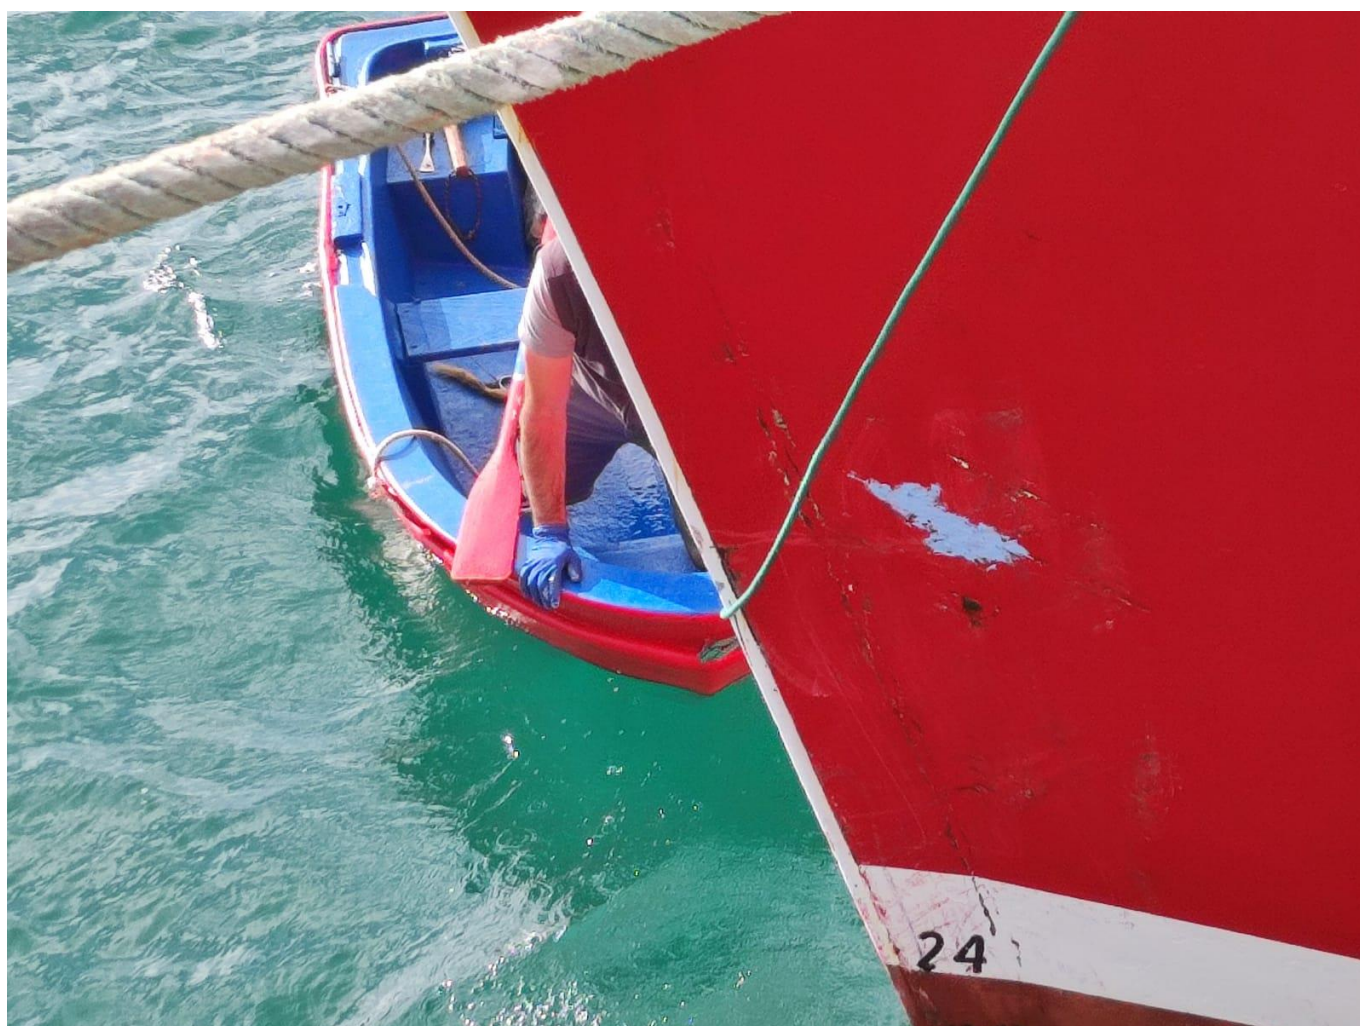
On 31 March a technician from a boatyard in Arrecife inspected the damage to the fishing vessel ZERUKO ERREGIÑA (see Figura 6). In his report, the technician stated that during his inspection he did not observe any structural damage in the zone affected by the collision, but only a few scratches.

Figura 6. Close-up of the damage suffered by the ZERUKO ERREGIÑA during the accident

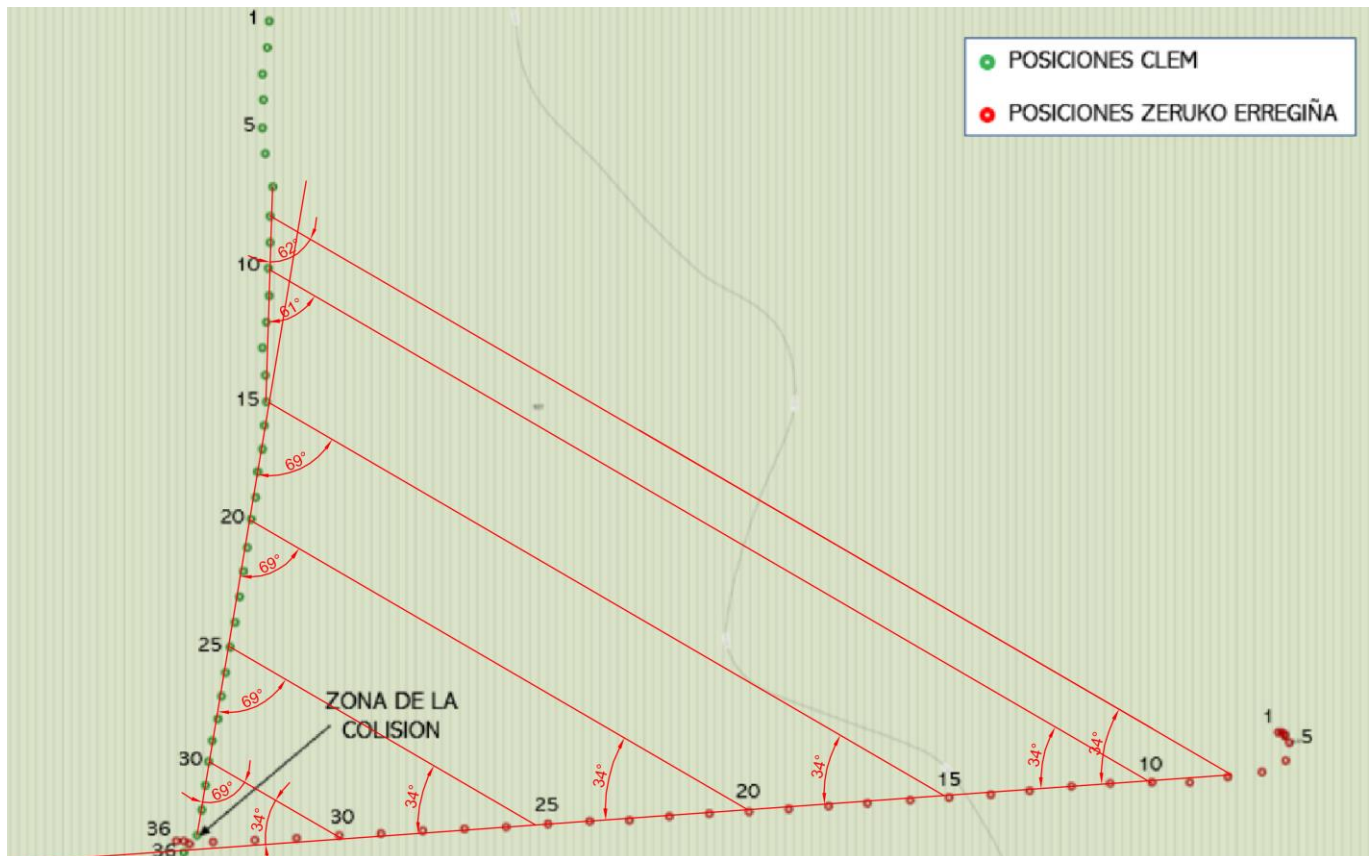
Figura 7 shows the courses followed by the vessels from 18:35 hours up to the moment of the collision, on the basis of the AIS data shown in Table 1 of this section. It should be noted that the positions indicated in the representation of the vessels' courses coincide with Rows 1, 5, 10, 15, 20, 25, 30 and 36 of Table 1 showing the positions of both the boats included in Table 1.

Figura 7. Positions of the fishing vessel ZERUKO ERREGIÑA and the recreational vessel CLEM before the accident

During the 15 minutes prior to the accident, the distance between the two boats decreased from two and a half nautical miles, the distance between the boats when they were at their initial positions in Figura 7, without the two skippers doing anything to avoid the risk of collision, which increased progressively with the passing of time. The accident occurred at 19:52 hours, near Position 33 in Table 1.

An analysis of Table 1 and of the graph in Figura 7 shows that towards 19:38 hours, near Position 8, the skipper of the fishing vessel set its direction on a course close to 260° and increased its speed to 8 knots. The direction and speed of the boat remained more or less constant until the time of the accident. The variations in the direction of the vessel seen in the table of data are due to the drifting caused by the wind and the swell, and the corresponding corrections made by the automatic pilot to maintain the direction set. The variations in speed may

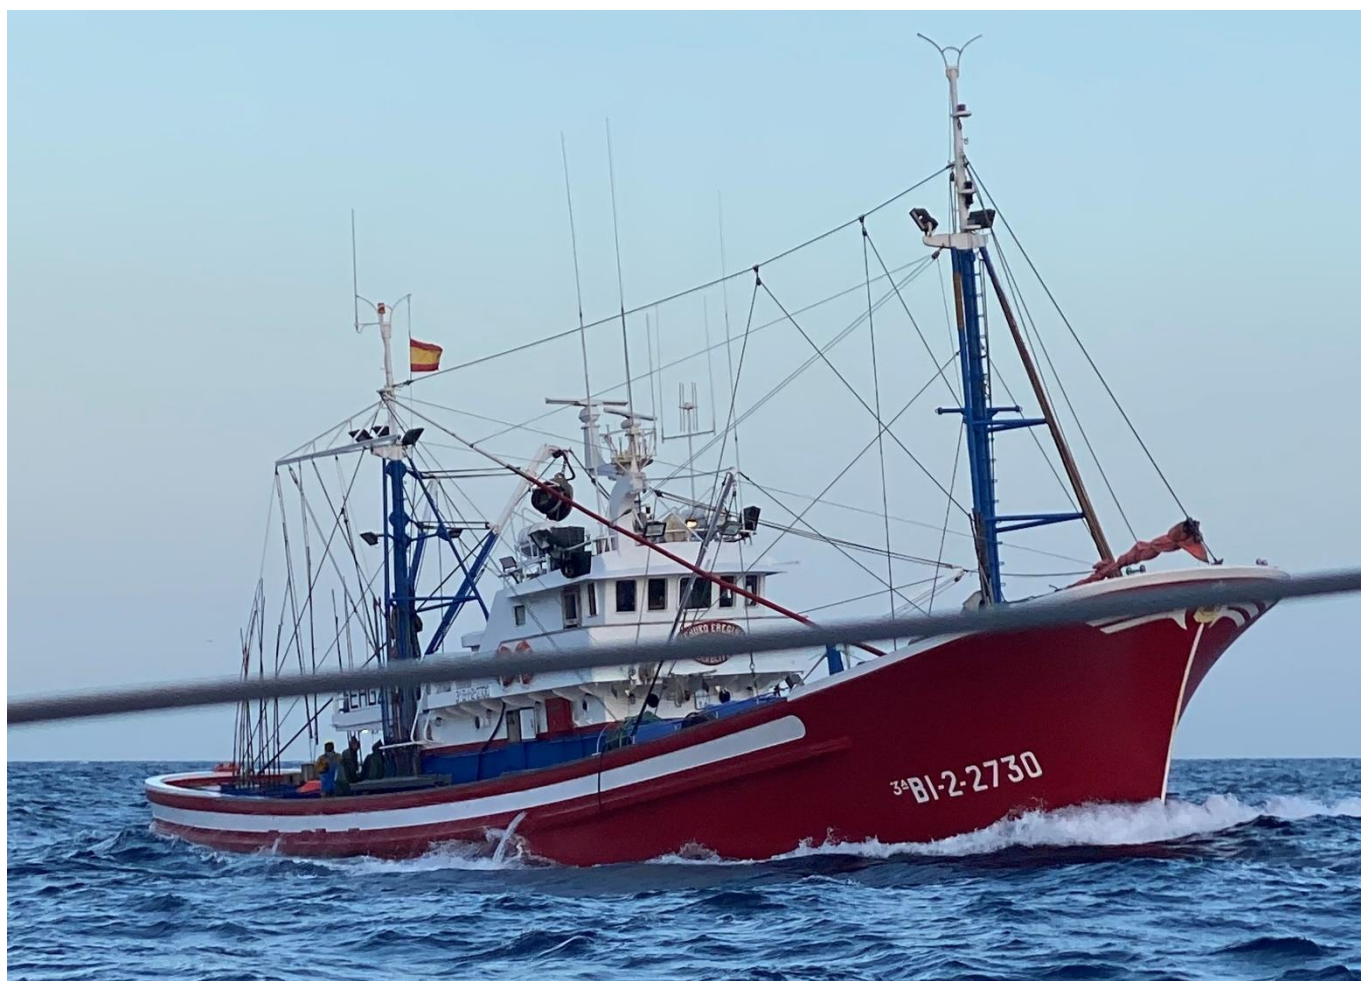
Figura 8. Photograph of the fishing vessel ZERUKO ERREGIÑA taken by the skipper of the CLEM just before the accident

Furthermore, in the previous image it can be observed that the ZERUKO ERREGIÑA does not display any indication that can identify it as a fishing vessel, as required by the COLREGs in Rule 26 - Fishing vessels.
