CIAIM REPORT-10/2020

Fires in the engine room of the passenger and wheeled vehicle ferries
VOLCAN DE TENO, on May 16th 2019, and CHAMPION JET, on June 25th
2019.

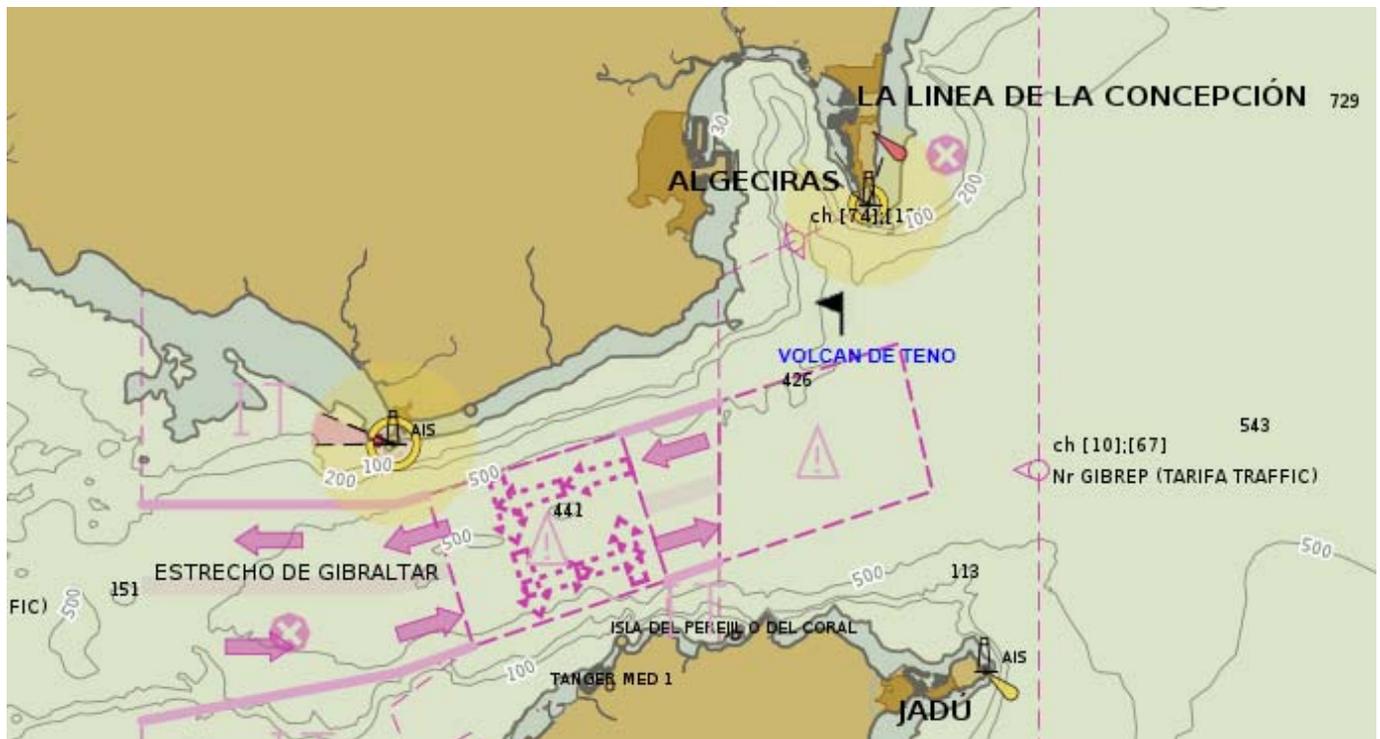
Figure 5. Accident site. VOLCAN DE TENO

The voyage was uneventful, sailing at a speed of about 28 knots, until 23:00, when the CCTV monitors installed in the bridge showed flames in one of the main engines. The engine affected was the SOME (*Starboard Outer Main Engine*), in the starboard engine room.

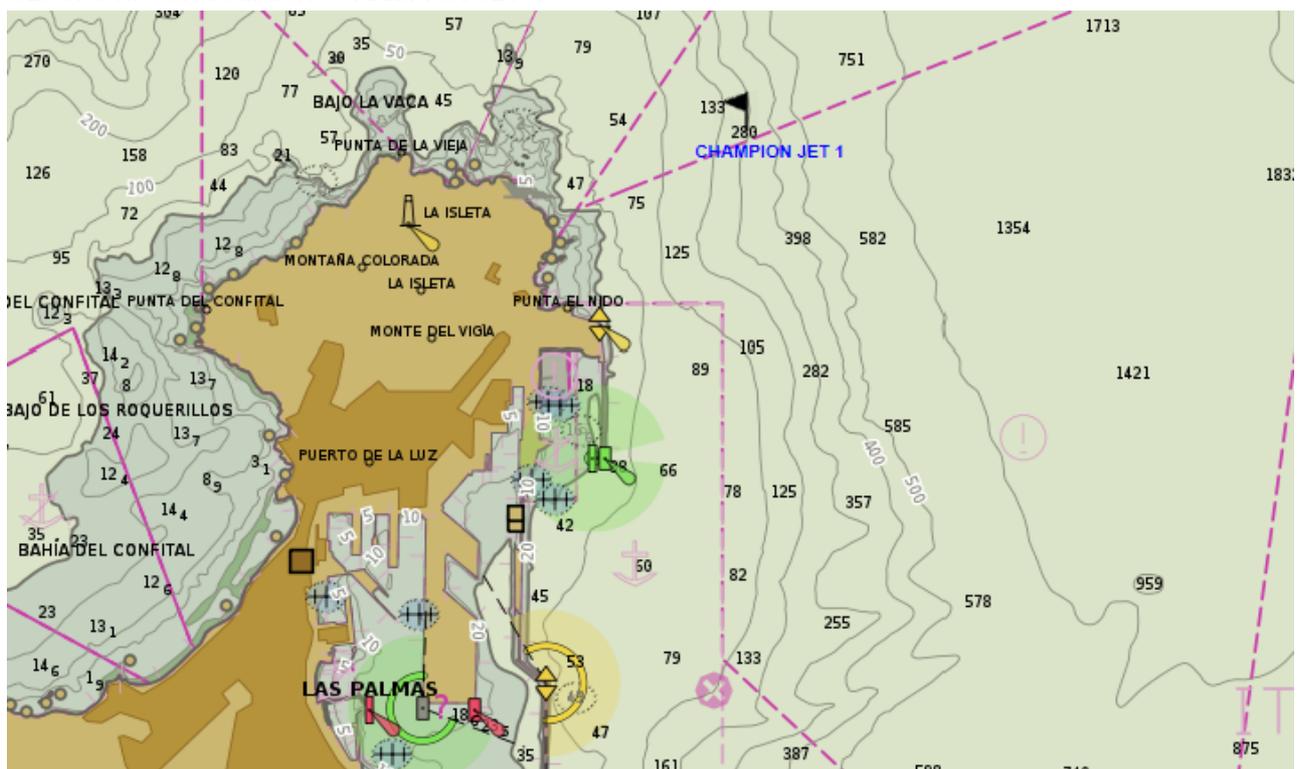
Figure 6. Accident site. CHAMPION JET 1

The voyage was uneventful until 20:10, approaching Las Palmas, when the starboard SOME propulsion engine low fuel pressure alarm in the bridge went off. Seconds later, the CCTV showed flames in the engine affected. The captain ordered the fire dampers and fire doors to be closed. After checking that there was no-one in the starboard engine room, the fixed CO₂ fire extinguisher system was triggered and fire-fighting teams were enlisted. The fire was seen to be out, and the captain communicated the incident to the Las Palmas CCS.

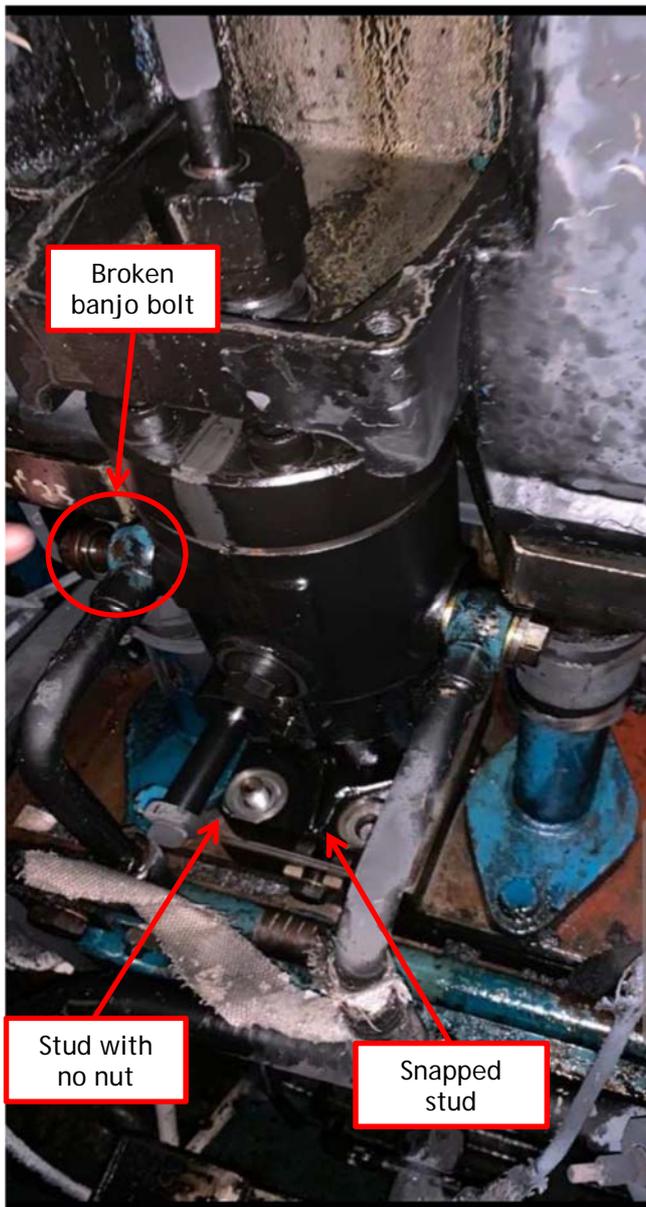
Figure 7. VOLCAN DE TENO fuel pump

On the 17th of May, after ventilating the space and carrying out the appropriate checks, the starboard engine room could be accessed. During the first inspection, it was found that the fuel feed tube (a hollow bolt, or *banjo bolt*) of fuel pump 1B of the SOME had snapped off. At the same time, two of the studs holding the fuel pump to the engine block had snapped and a third had no nut.

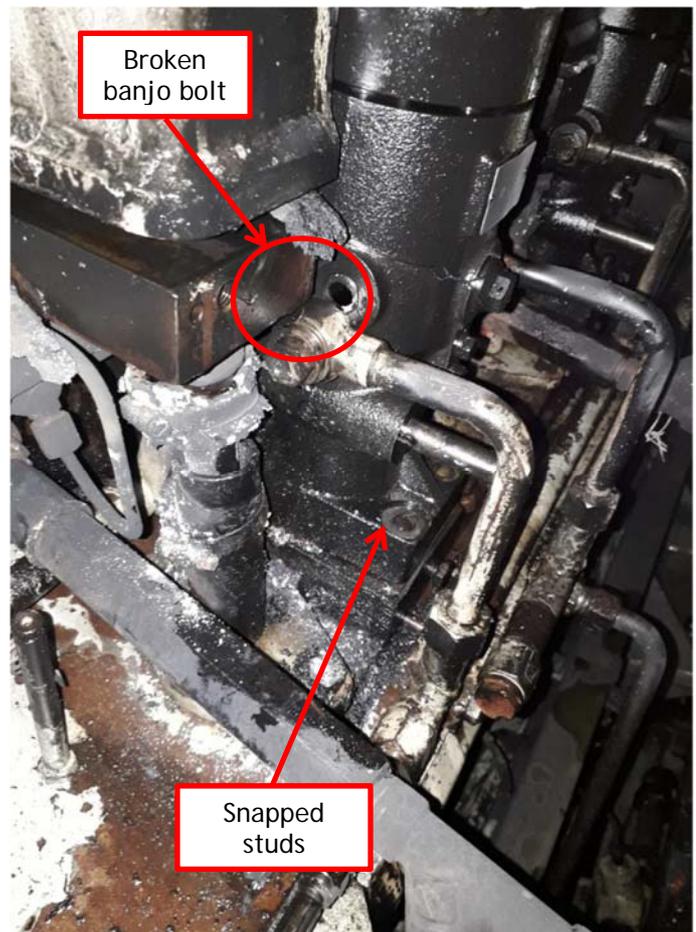
Figure 8. CHAMPION JET 1 fuel pump

The next day, after accessing the engine room affected, it was found that the fuel feed tube (a hollow bolt, or *banjo bolt*) of the fuel pump of cylinder A10 of the SOME had snapped off. The four studs attaching the fuel pump were also found to have snapped.

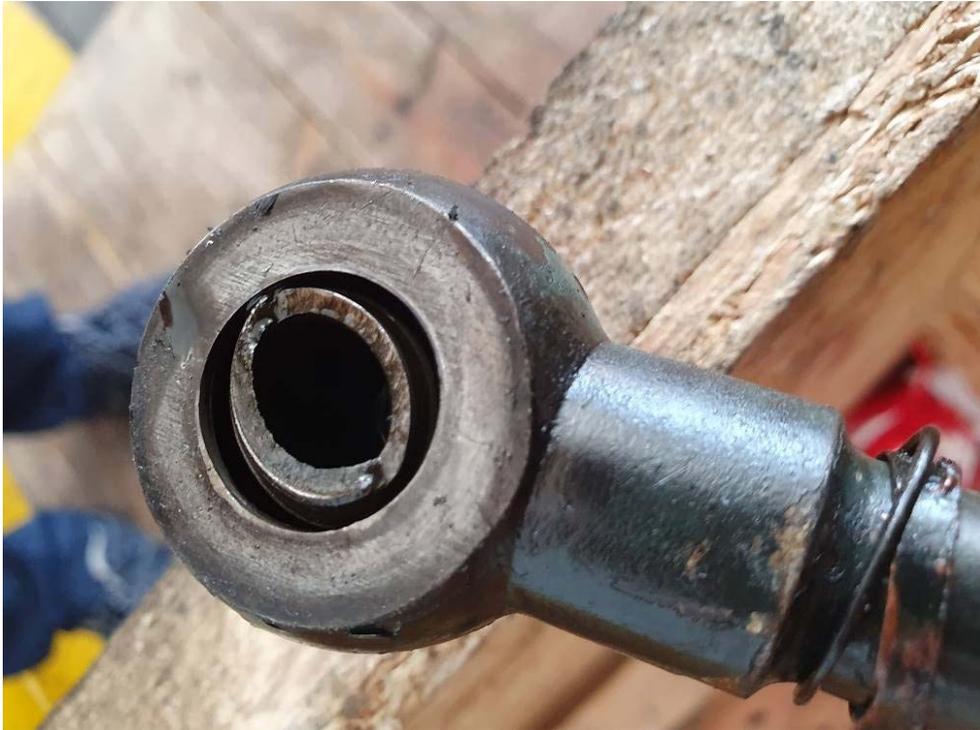
Figure 9. VOLCAN DE TENO. Broken fuel line "banjo bolt"

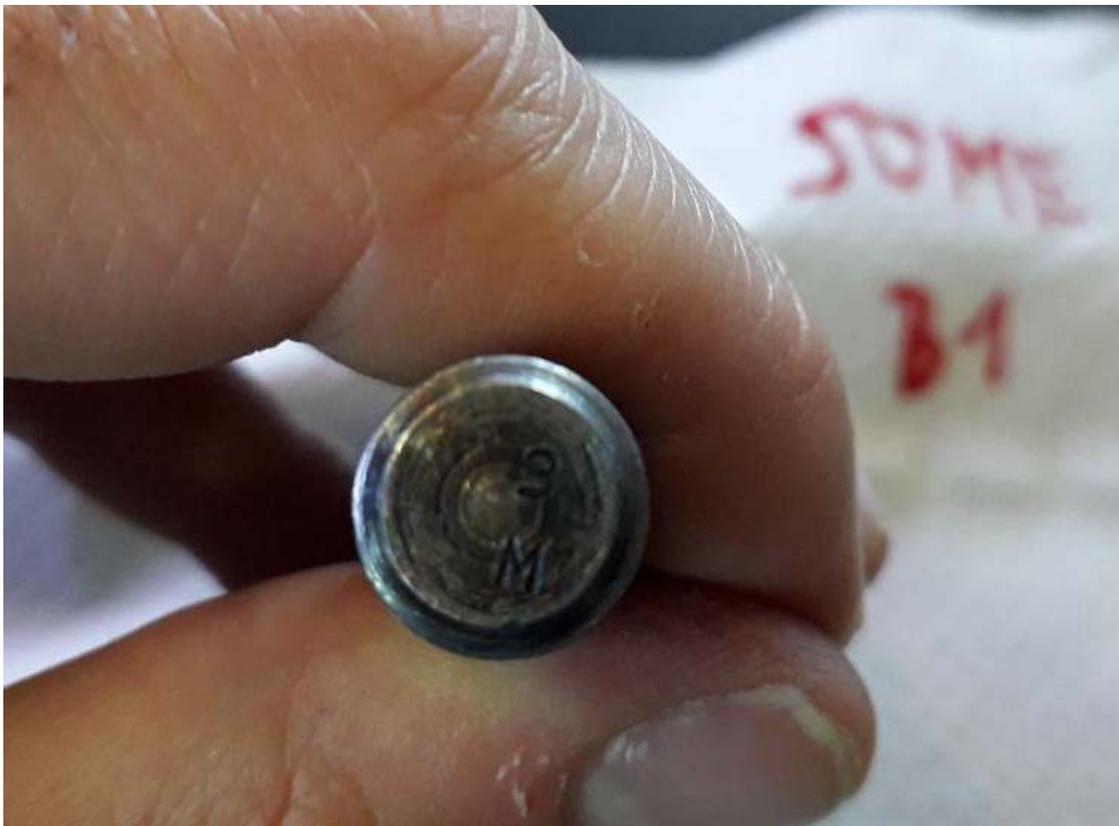
In the VOLCAN DE TENO, some of the broken studs were marked with the "3" corresponding to the new design (see Figure 10), while others did not. In the CHAMPION JET 1, the studs that snapped were not of the new design, and in addition to this, non-original studs were found, presumably having been replaced at some time before the operating company took over the operation of these vessels.

Figure 10. VOLCAN DE TENO. One of the new-design studs, stamped with a "3"

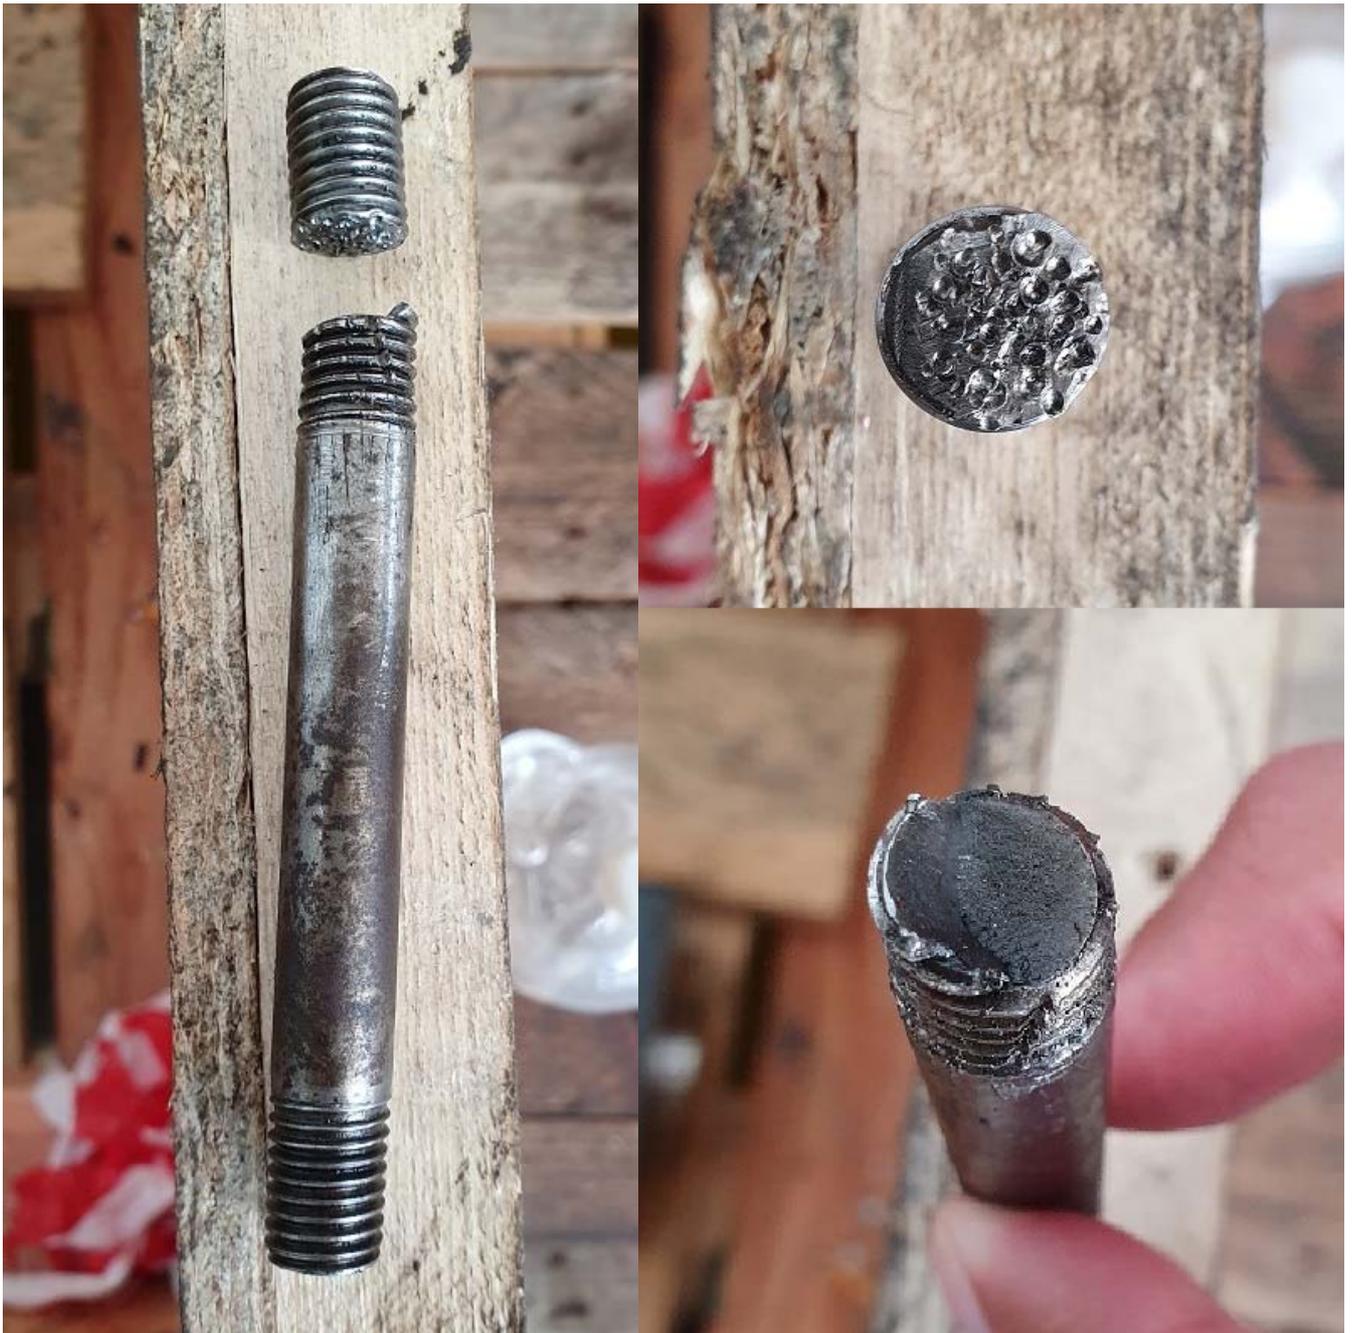
Figure 11. VOLCAN DE TENO. One of the snapped studs
