COMISIÓN PERMANENTE DE  
INVESTIGACIÓN DE ACCIDENTES  
E INCIDENTES MARÍTIMOS

## CIAIM REPORT-10/2023

Fall and death of a crew member while using the combination ladder to board the BORDEIRA oil tanker from the PICASSO PRIMERO service vessel on 4 May 2021 in the Bay of Algeciras.

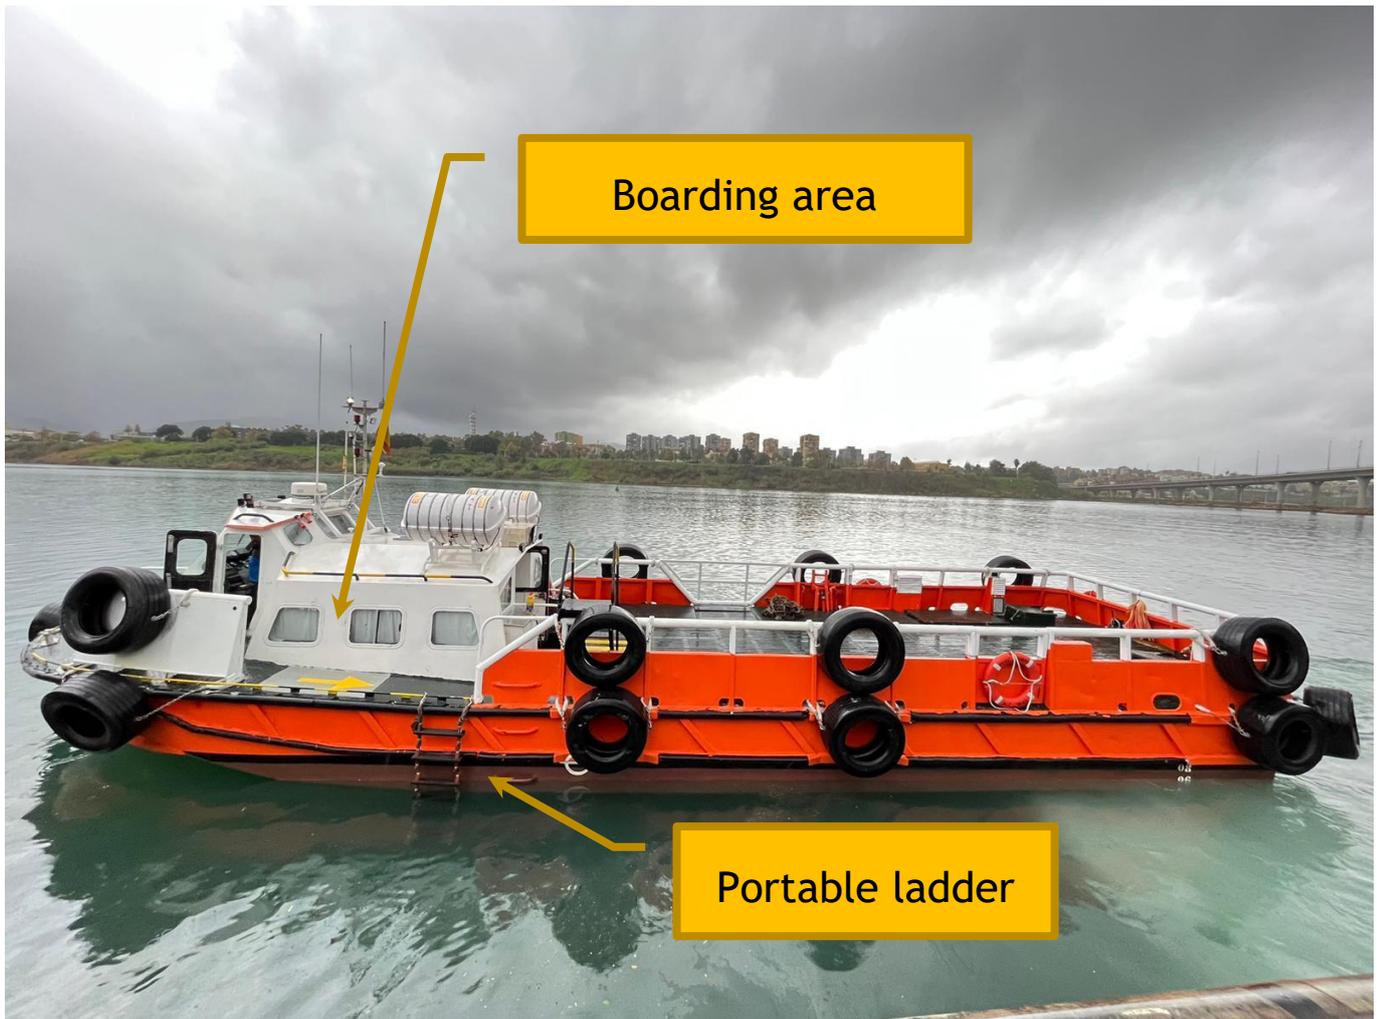
Figures 7 and 8 show the port side of the vessel and the boarding area from where the replacement crew members boarded the BORDEIRA and to where the BORDEIRA crew members who were going on leave disembarked. The crew member fell onto the cabin adjacent to the boarding area. Based on the appearance of the injuries, the crew member impacted the structure between its lateral and horizontal surfaces before falling into the water.

Also shown in Figura 7 is the portable ladder, which was fitted to the vessel and deployed at the indicated location during the emergency to rescue the fallen crew member. From its point of attachment on deck to the first rung you have to step onto in the water, there is a distance of 1.85m. The freeboard in that area is 90 cm, so the ladder's first rung would be approximately 90 cm from the waterline, adequate for a reasonably fit person to place their feet on it and climb up the ladder.

Figura 7. View of the port side of the PICASSO PRIMERO.

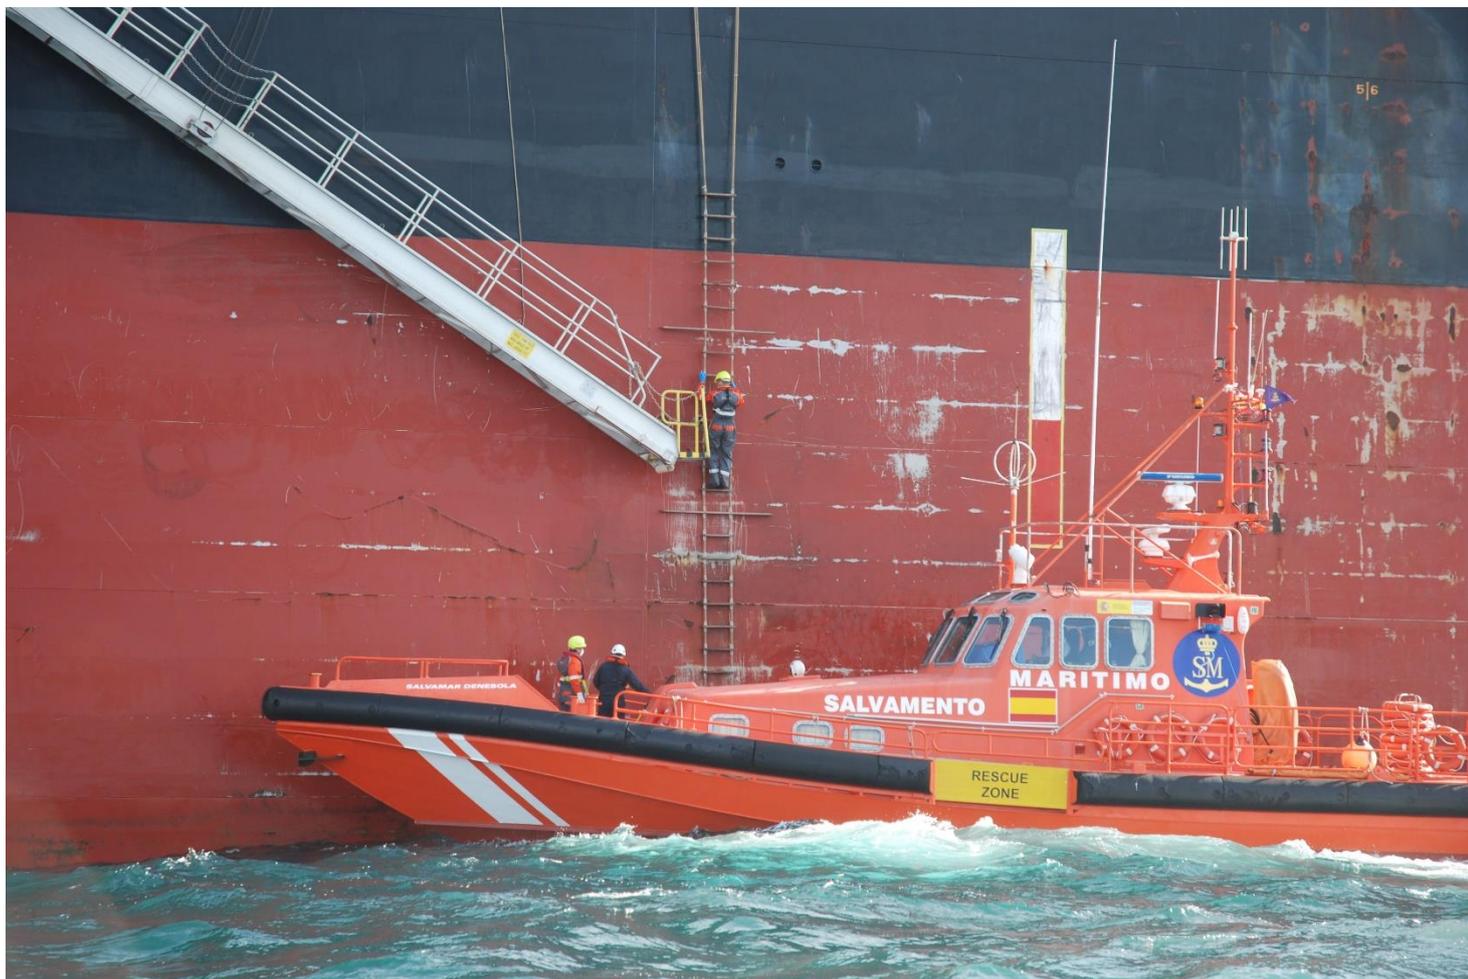
The crew member climbed a vertical ladder of the "pilot ladder" type, the construction of which must comply with a number of industry standards to ensure its safety. The Harbour Master's inspection services have not reported any defects, nor have the witnesses to the accident reported any problems with the ladder.

Notwithstanding the above, the fall may have been facilitated by the fact that the crew member was carrying a rucksack<sup>19</sup> with, apparently, his personal belongings, although we cannot be sure whether this contributed to the accident or not. The rucksack's weight, which could have required additional effort and/or hindered the crew member's movements as he climbed the vertical ladder, is unknown. But regardless, the fall should have been into the water and not onto the boat. The possibility that the rucksack's weight was sufficient to pull the crew member backwards if he fainted has not been ruled out.

Figura 8. Reconstruction on the BORDEIRA's starboard combination ladder. Height from which the crew member fell. Source: Judicial Police

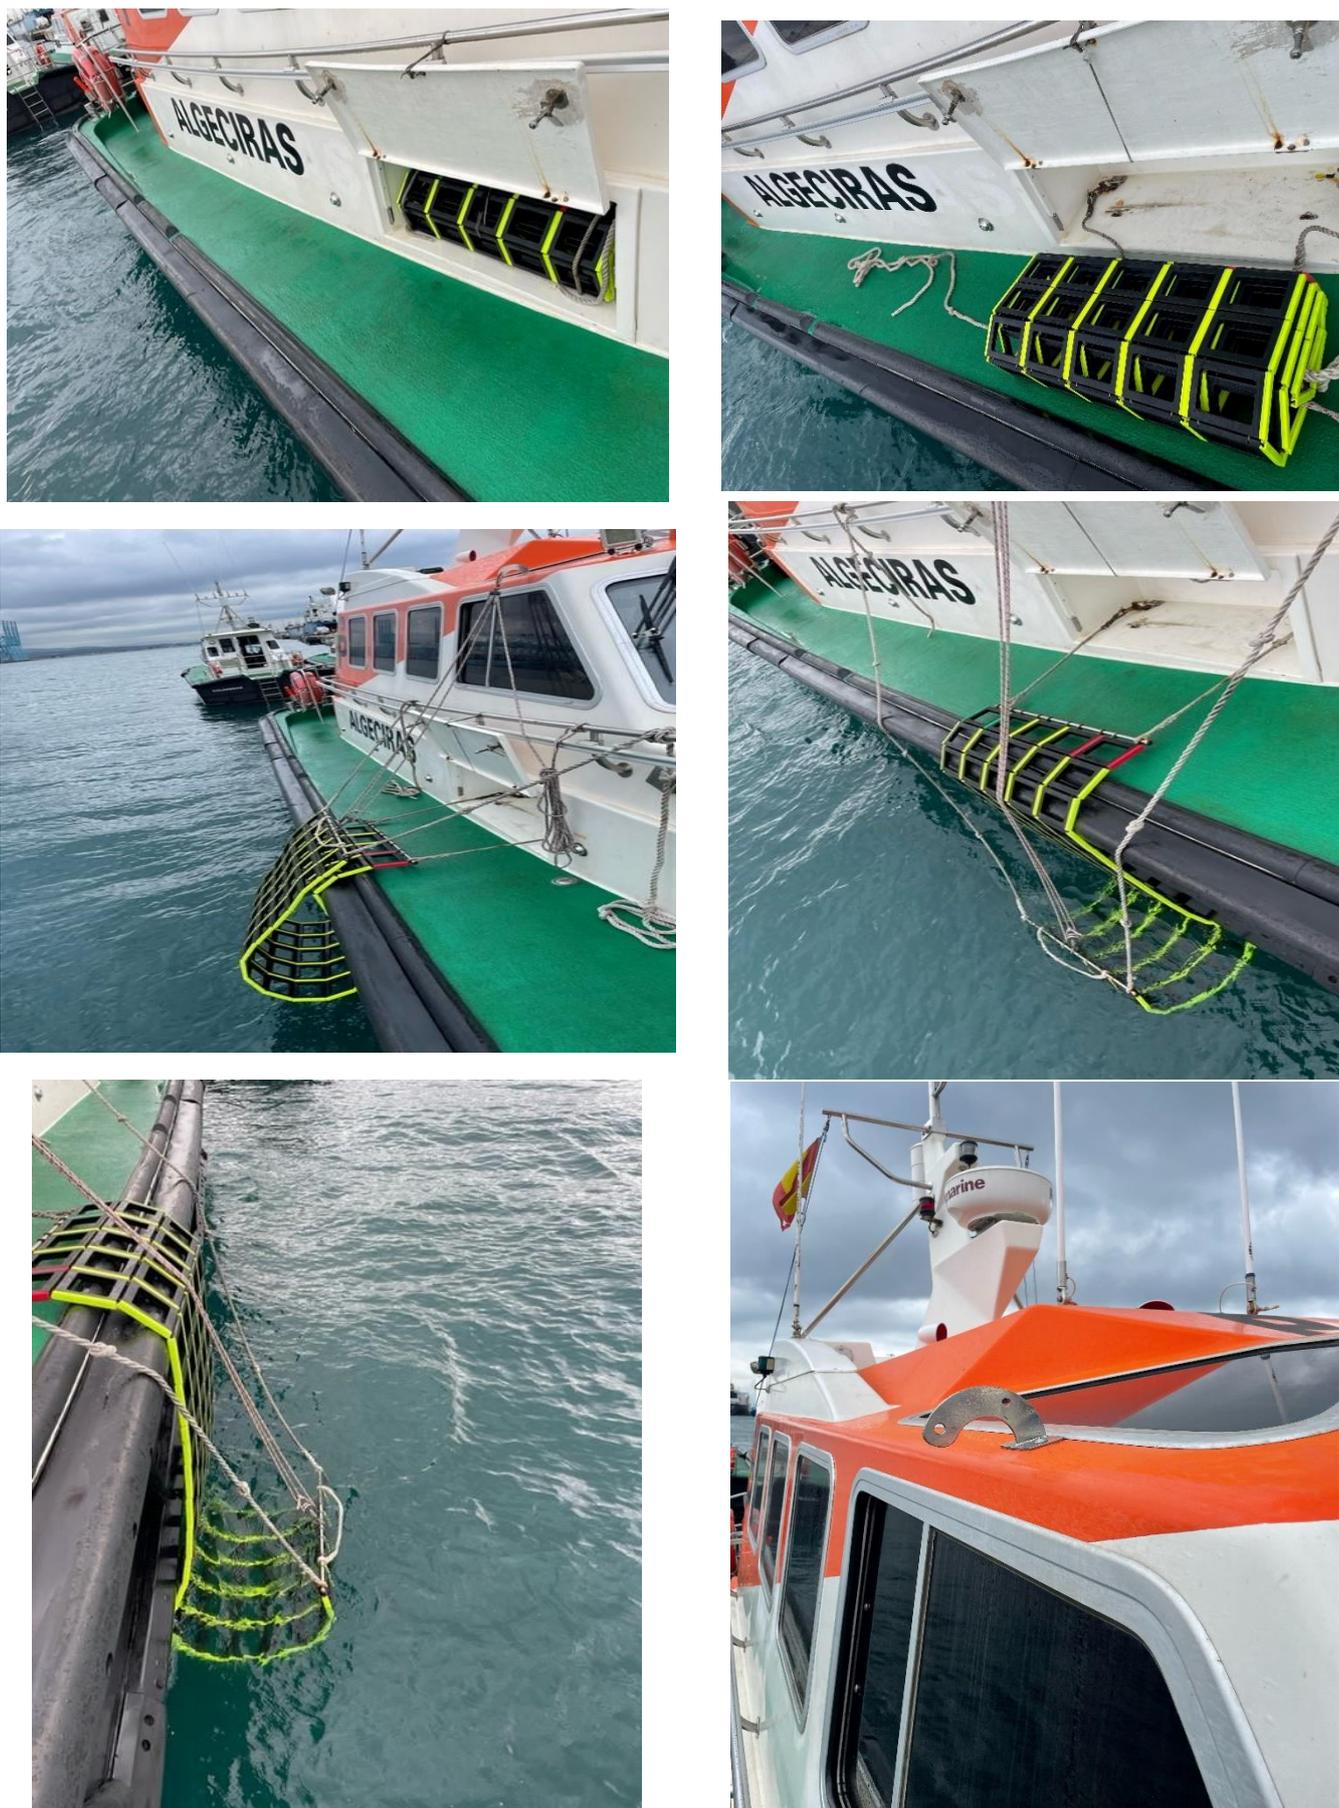
The skipper of the GETARES then jumped into the water to grab the casualty and pull him to the vessel's lifting device<sup>12</sup>.

Figura 9. Images of the device used by the GETARES to rescue the injured crew member.

5. It is recommended that the General Directorate of the Merchant Navy instruct the Harbour Masters to require companies engaged in the transfer of persons at sea to prepare a protocol for carrying out crew transfer operations, based on the guidelines of the International Maritime Organisation as set out in MSC-MEPC.7/Circ.10, on safety during the transfer of persons at sea and/or recognised standards, e.g. UK-MCA MGN 432 (*Safety during transfers of persons to and from ships*). The protocol shall include procedures to ensure operations are conducted as safely as possible and provide for vessels to carry equipment (similar to that shown in this report) for the rapid and safe recovery of persons who fall overboard.
