Report

IN-020/2017

Incident involving an ATR 72-212A aircraft, registration EC-KKQ, operated by Swiftair, at flight level 170 in the vicinity of reporting point NARGO (Albacete-Spain) on 9 September 2017

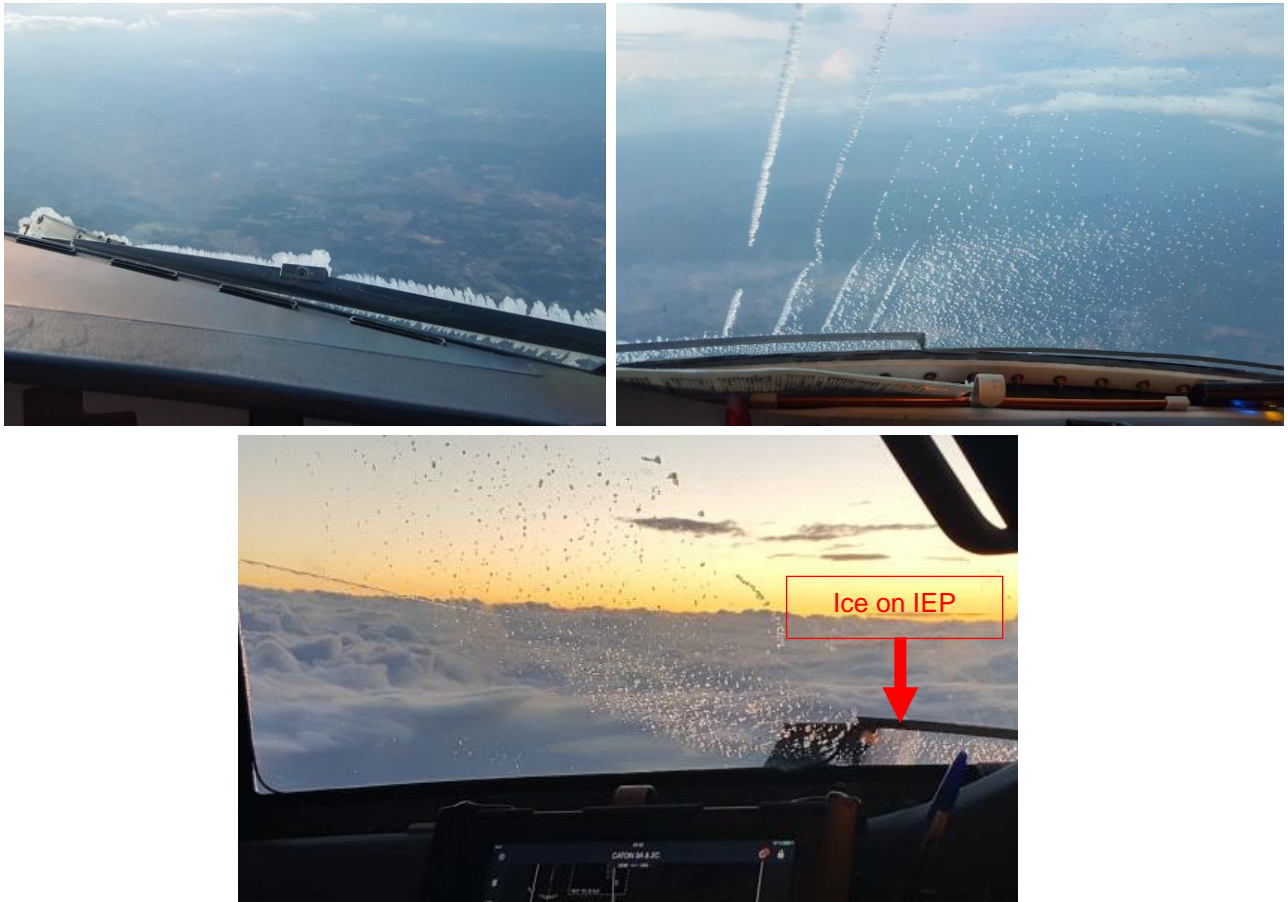
Figure 5. Photos taken by the first officer

The crew took photographs from the cockpit 8 min (and 27 NM) after the event (point marked on Figure 4). These photos²¹ show:

- Ice build-up on the windshield wipers, on the side windows of the cockpit, at the interface between the boots and the leading edge of the right wing and on the flap actuator fairings.
- A 5-cm block of ice on the IEP.

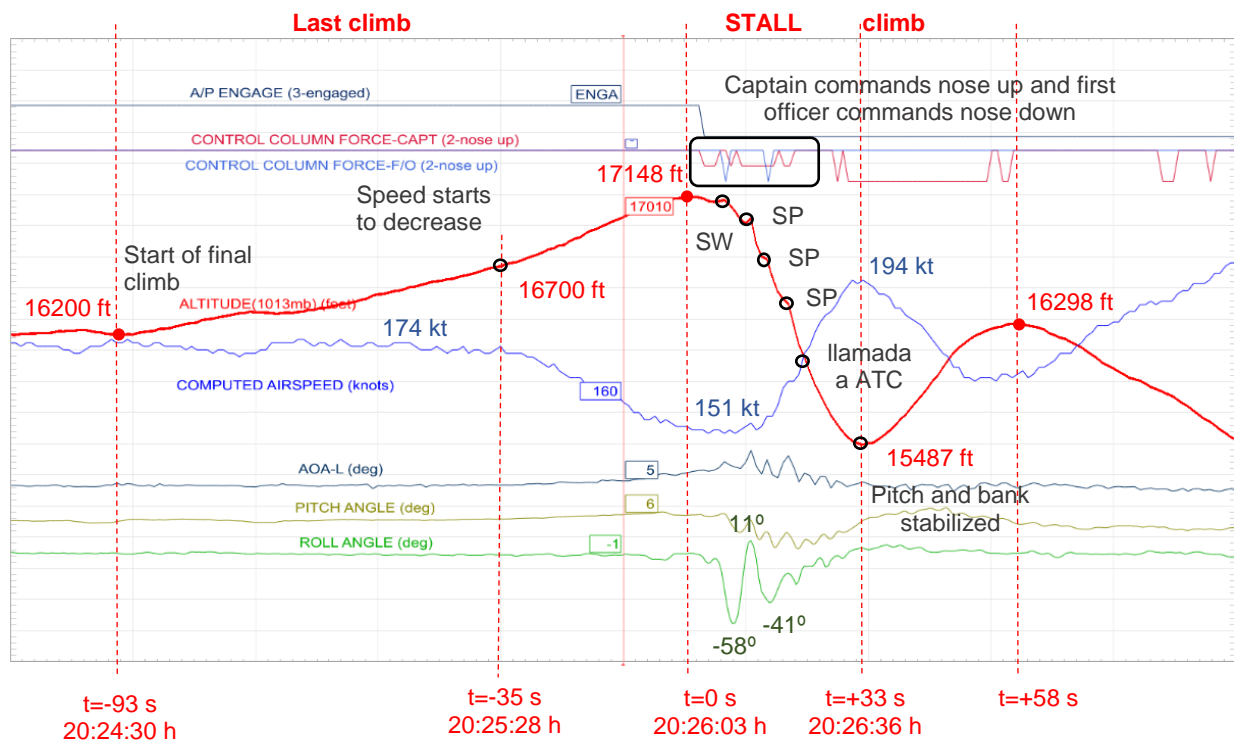
Figure 7. Detail of the stall

After reaching the highest point (t=0 s, 17148 ft, 20:26:03), the aircraft started a descent during which the following events were recorded:
