# Technical report

## IN-027/2022

Incident on 28 May 2022 involving a BOEING 737-8AS aircraft operated by Ryanair, registration EI-EKR, and a CIRRUS SF-50 aircraft, registration N66HR, in the Palma ATZ (Balearic Islands, Spain)

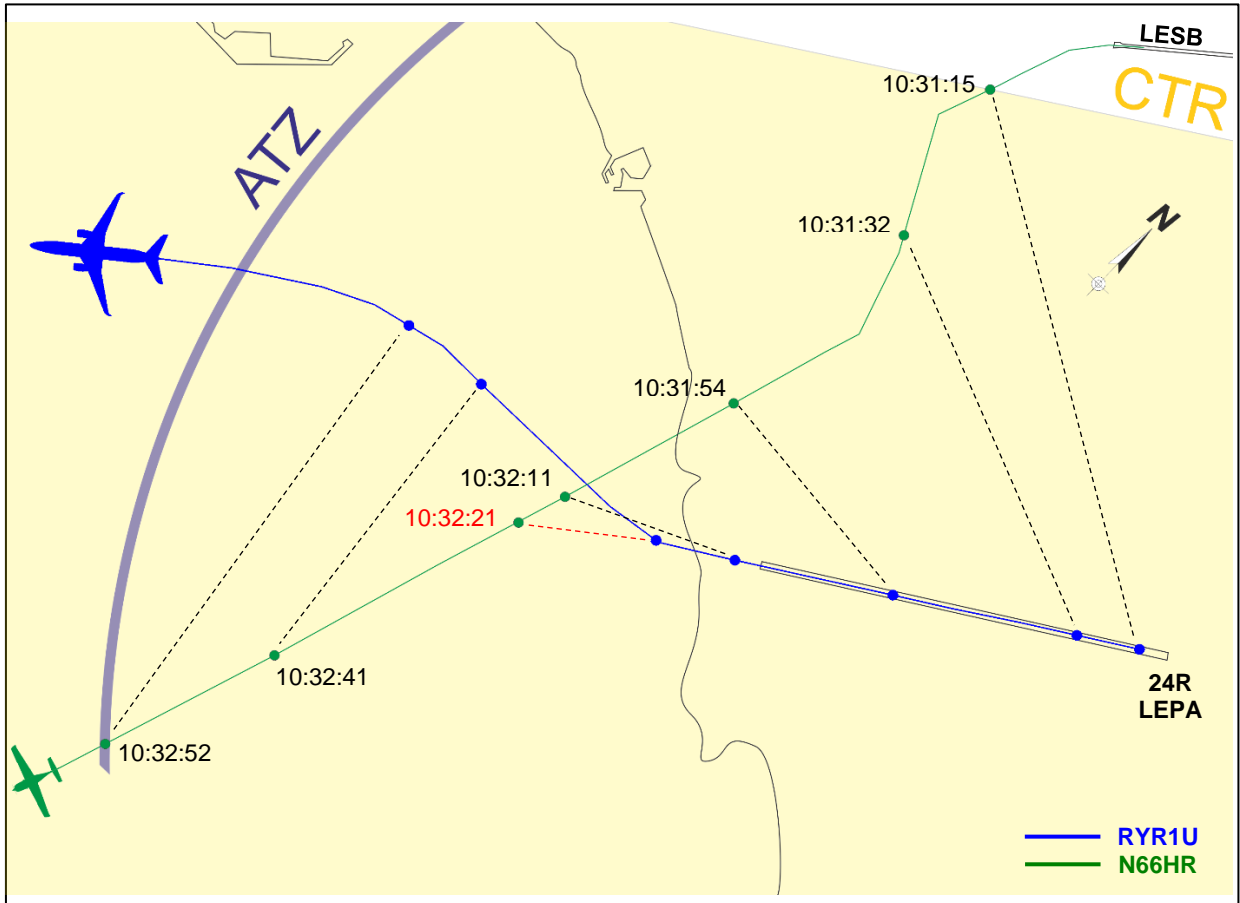
The shortest distance between the aircraft – 0.65 NM horizontally and 116 ft vertically – occurred at 10:32:21 h when the N66HR aircraft was crossing the extension of runway 24R at LEPA and the RYR1U aircraft was continuing its evasive manoeuvre, with the RYR1U aircraft remaining above the other. After this point, the distance between the aircraft began to increase.

Figure 1. Aircraft trajectories and area in which the incident occurred.

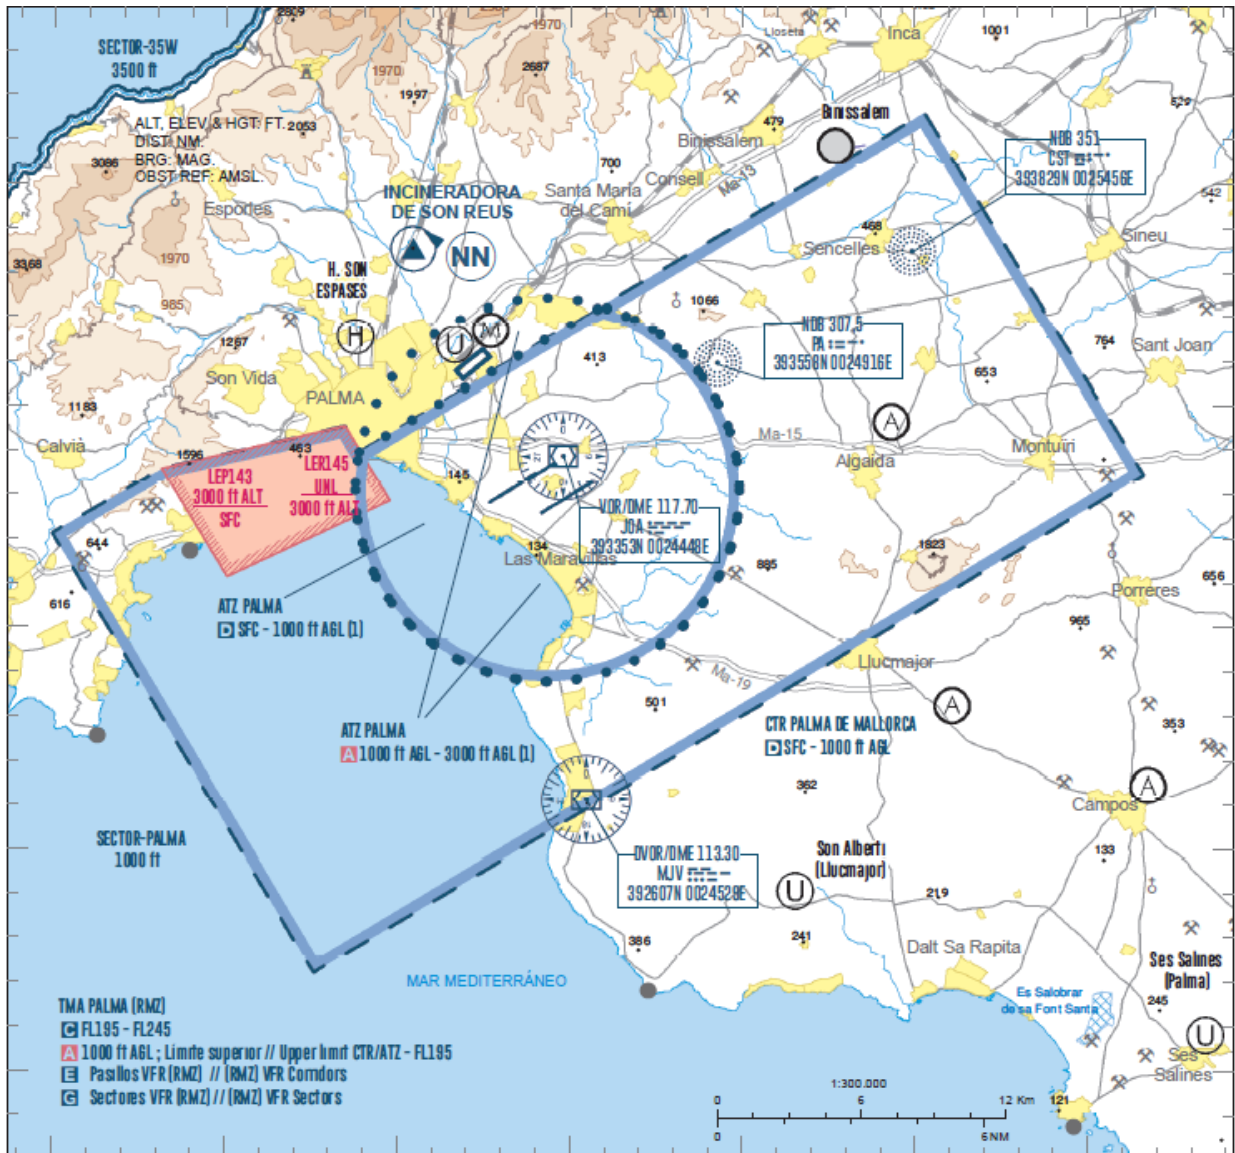
Figure 2. Detail of the airspace around LESB and LEPA. Source: LESB visual approach chart (AD 2-LESB VAC; information last revised in AIRAC AMDT 03/22; AIP ENAIRE).

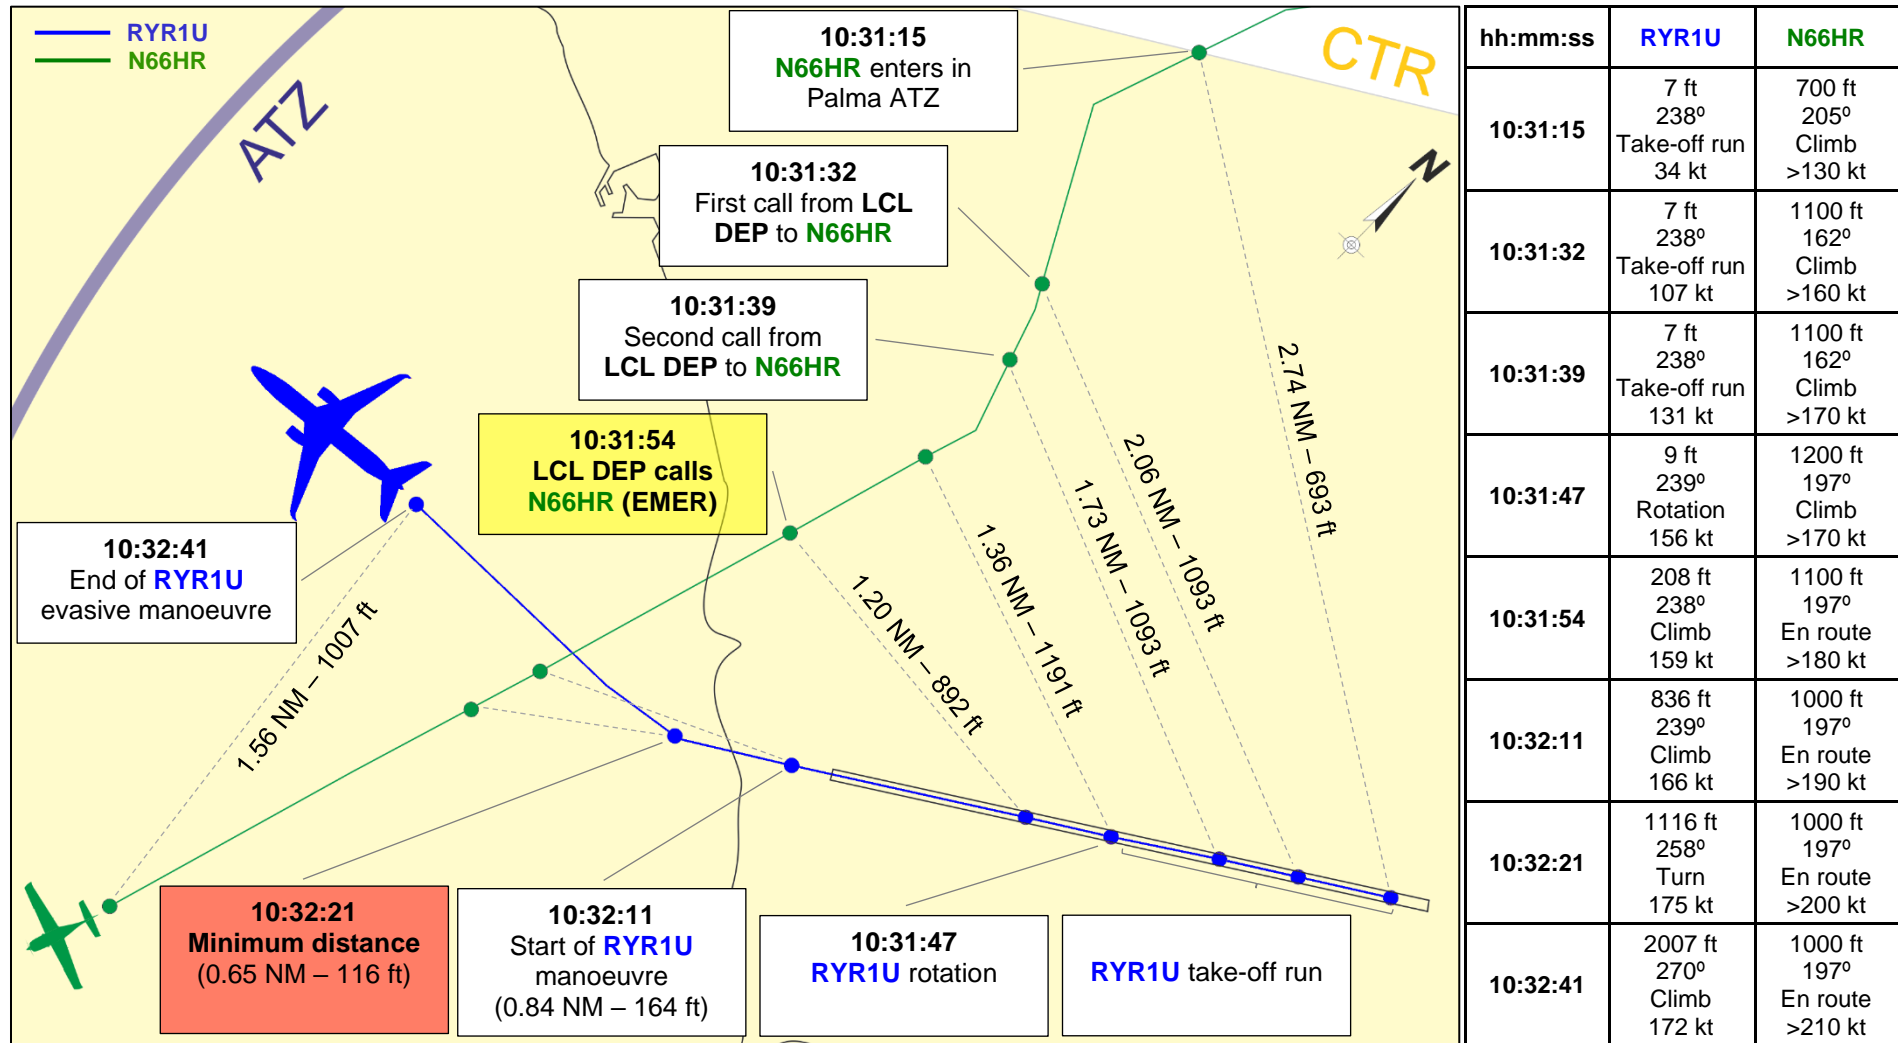
Figure 3. Trajectories of the aircraft within the Palma ATZ, flight parameters of the aircraft (altitude, heading, phase, GS) and separation between them.
