## Report IN-032-2018

**Incident involving a Boeing  
737-800, registration EI-FHZ,  
operated by Norwegian Air  
International, at the Alicante  
Airport (Spain) on 7 June 2018**

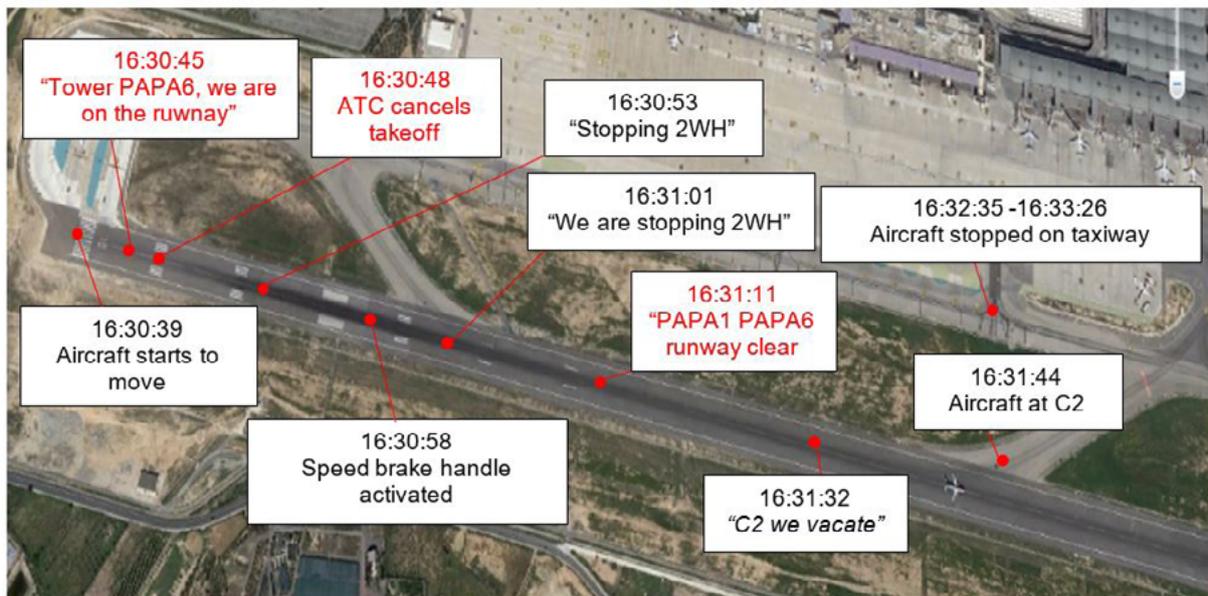
Figure 2. Positions of aircraft during takeoff run

- 16:31:11 PPAPA6 reports "runway clear". Location of aircraft shown at this moment. GS=41 kt.
- 16:31:32 Message from aircraft indicating leaving runway via C": "C2 we vacate". GS=36 kt.
- 16:31:44 Aircraft enters C2. GS=28 kt.
- 16:32:20 Aircraft on taxiway.
- 16:32:35 Aircraft stops until 16:33:26, that is, 52 s.
- 16:33:27 Aircraft starts moving to runway 10 threshold.
- 16:37:26 Takeoff run commenced.
- 16:38:03 Aircraft airborne.

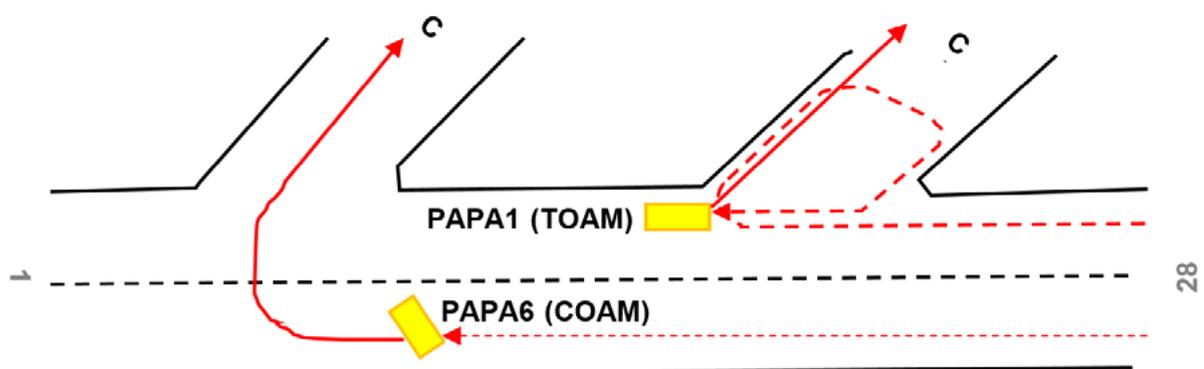
Figure 3. Position of cars PAPA1 and PAPA6 during the event

"They began the check at the same time, with the COAM (PAPA6) driving on the left side of the runway and the TOAM (PAPA1) on the right so as to completely check the runway and taxiways. The TOAM found something and had to stop to pick it up. He continued driving and thus was further ahead.

Figure 3 (not to scale) shows their positions on the runway and their routes before and after the incident (as they indicated during their interviews).

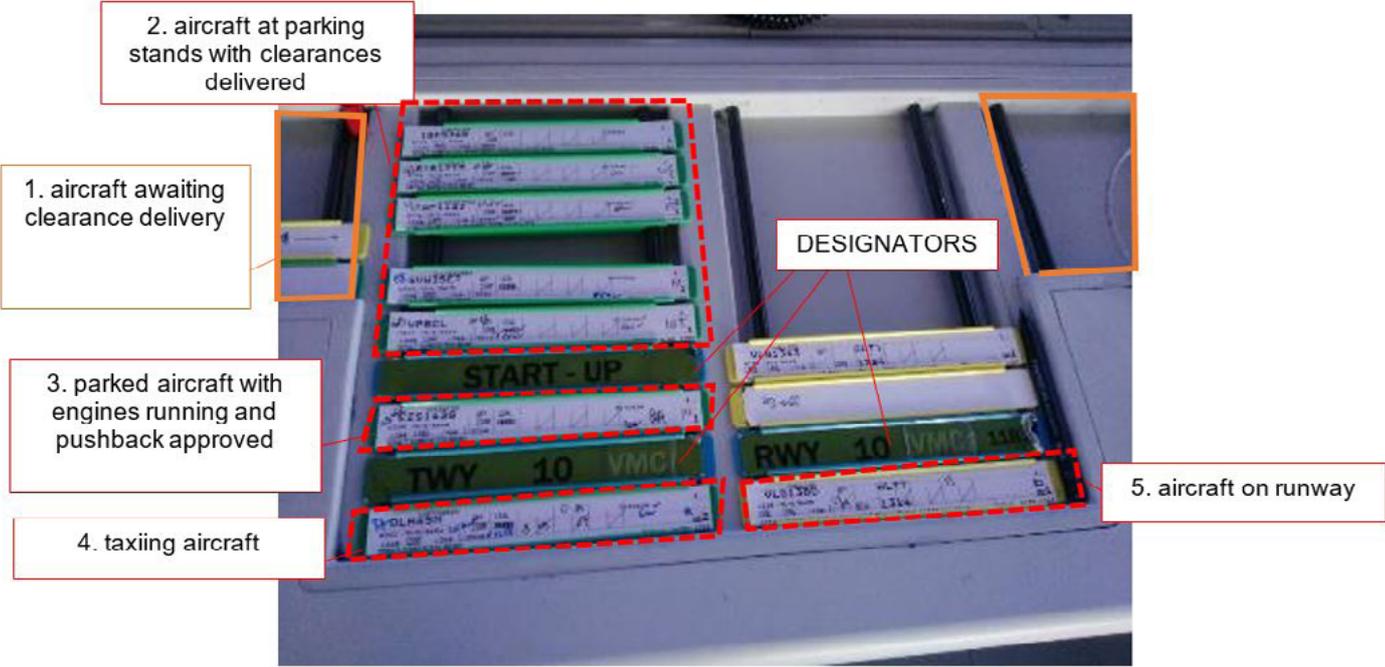
Figure 5. Strip management on the bay (for departing aircraft)

A given time before takeoff (or landing) time, the printer prints out a strip for each aircraft. This strip is placed in a strip holder (green for takeoff and yellow for landing) in the left of the bay, where pending aircraft are located. For departing aircraft, of interest to this investigation, when the controller issues the clearance, the strip is moved to the right, over the START UP designator. When the controller authorizes engine startup, the strip is moved down placing it underneath this designator. Once an aircraft is cleared to taxi, its strip is moved down until it is placed below the TWY taxi designator. And finally, when the aircraft is cleared to line up and take off, it is moved to the right and placed under the runway designator.

Traffic priority is determined by how close its strip is to the designator; that is, if there are three aircraft taxiing, number 1 to taxi will have its strip at the lower position.

As for the board, the statements were consistent in that the strip for IBK2WH was placed on the tracks, meaning the controller had the strip in his hands. Moreover, he would have had to write the takeoff time on it, meaning that at some point his eyes must have focused on the board, and specifically, on the area of the runway designator, but without taking in the information it was showing (despite the presence of the strip for the vehicles, in a conspicuous color, immediately above). The section below (2.4.2) analyzes the reasons that might have caused the controller to ignore this information.
