## Report IN-039/2018

Incident involving two Boeing 737-800 aircraft, registrations EI-FRY and EI-DWW, operated by Ryanair, at reporting point GOSVI at FL340 (Navarre) on 2 October 2018

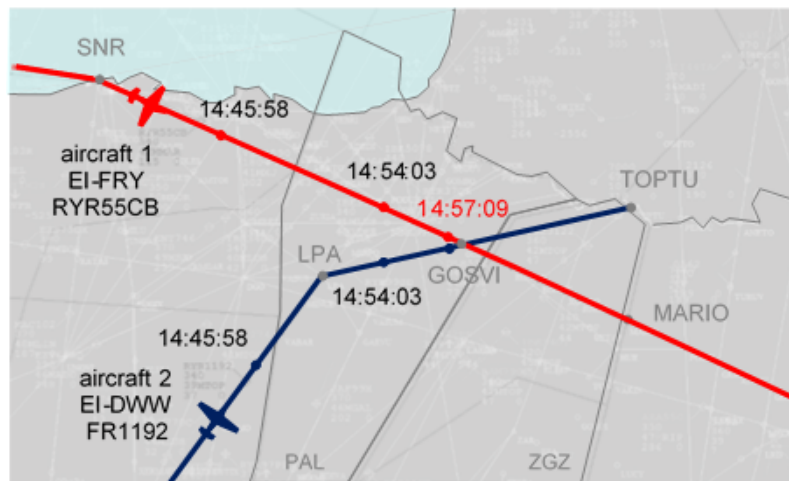
Figure 1. Aircraft flight paths

The event took place in the vicinity of point GOSVI. At their closest point, the aircraft were 2.3 NM apart horizontally and 334 ft apart vertically, with aircraft 1 above aircraft 2.

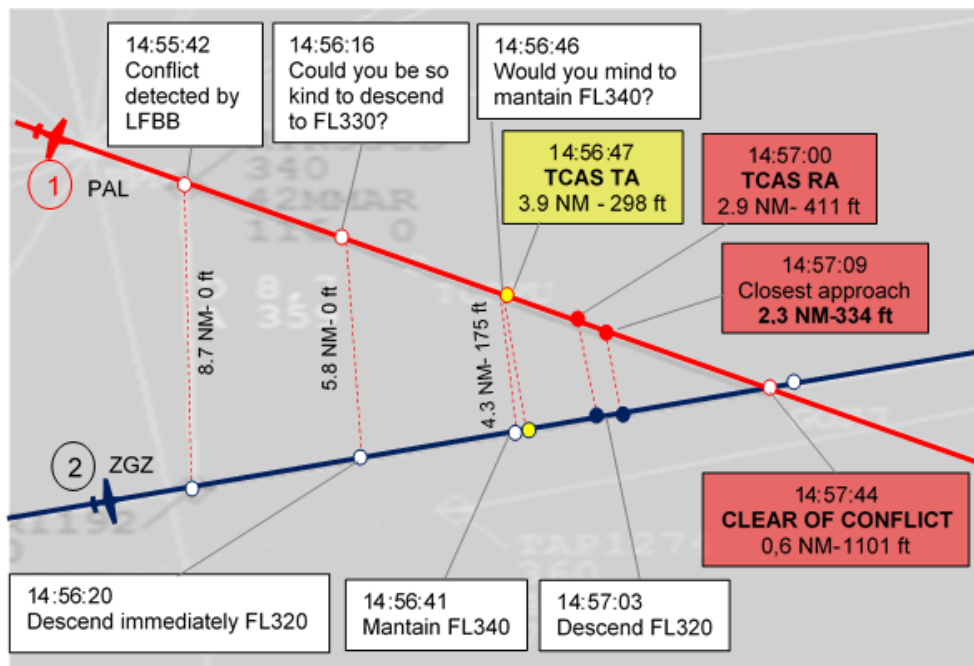
Figure 2. Flight paths between 14:55:42 and 14:57:44

At 14:54:36, an STCA PAC alert should have appeared for the two aircraft. This alert, which is displayed about 2 min before the minimum required separation is breached, was not generated<sup>2</sup>.

At that time, they were within 5 NM and 1000 ft, meaning the minimum separation was being violated. If the STCA system had worked properly, the PAC alert, which would have been activated for approximately 2 min, would have changed to a VAC.

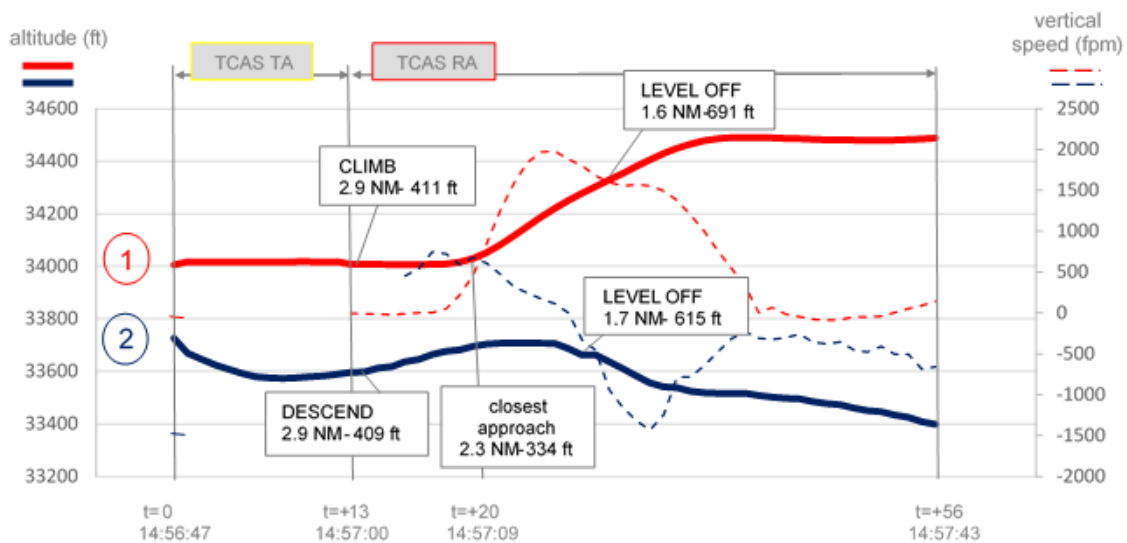
Figure 3. Changes in altitude and vertical speed during the TCAS RA

- 14:57:02: the A/P and A/T were disengaged.
- 14:57:09: the aircraft reached the point of closest approach, 2.3 NM and 334 ft (aircraft 1 at 34029 ft and aircraft 2 at 33695 ft).
- 14:57:16: the aircraft reported TCAS RA to ATC.
- The vertical speed began to increase gradually to a maximum of +1979 fpm.
- The aircraft climbed a total of 328 ft.

- Due to these positive values for vertical speed, the aircraft initially climbed toward aircraft 1, resulting in the closest point of approach at 14:57:09, after which aircraft 2 began to descend while aircraft 1 accelerated its climb, increasing the vertical separation between them.
- This phase lasted 16 s, during which aircraft 2 had a net elevation gain of 89 ft.
