## **IN-040/2019**

Incident involving a Sikorsky S-76 C+ aircraft,  
registration EC-JES, over the Vigo estuary  
(Pontevedra) on 26 July 2019.

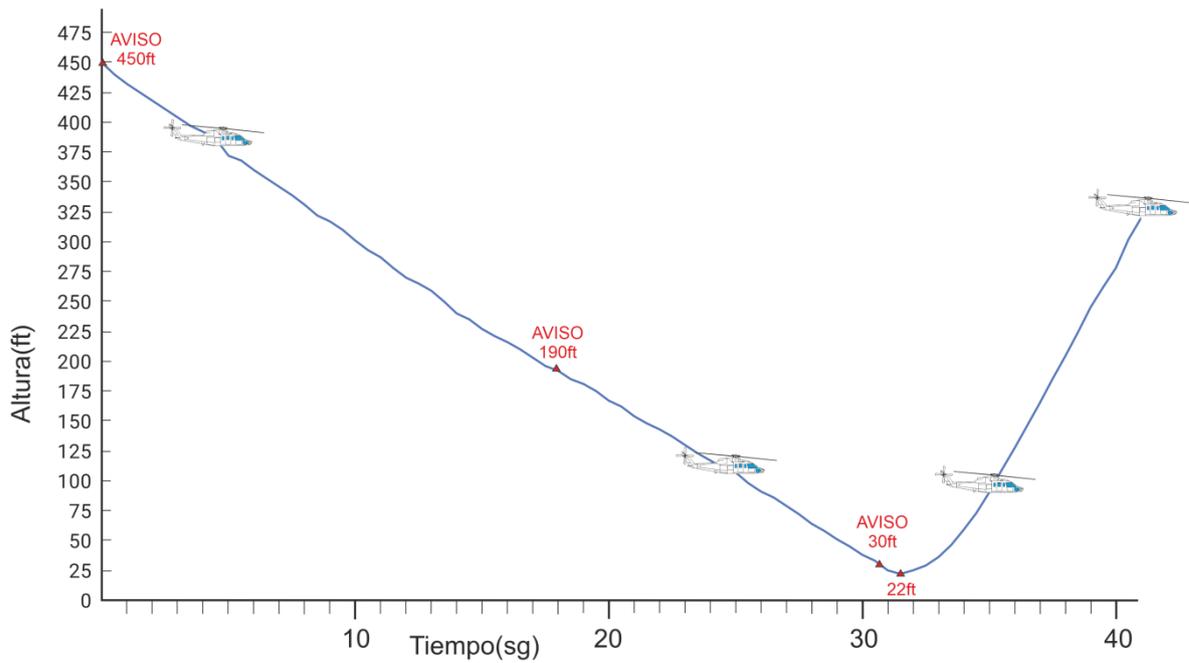
Fig. 2. - Profile of the flight path around the time of minimum altitude above the water

In that instant, the various members of the rescue crew began to call out, shouting that they were going down, at which point the co-pilot exclaimed "50 ft" and put the aircraft into a steep climb by pulling the collective pitch control lever upwards.

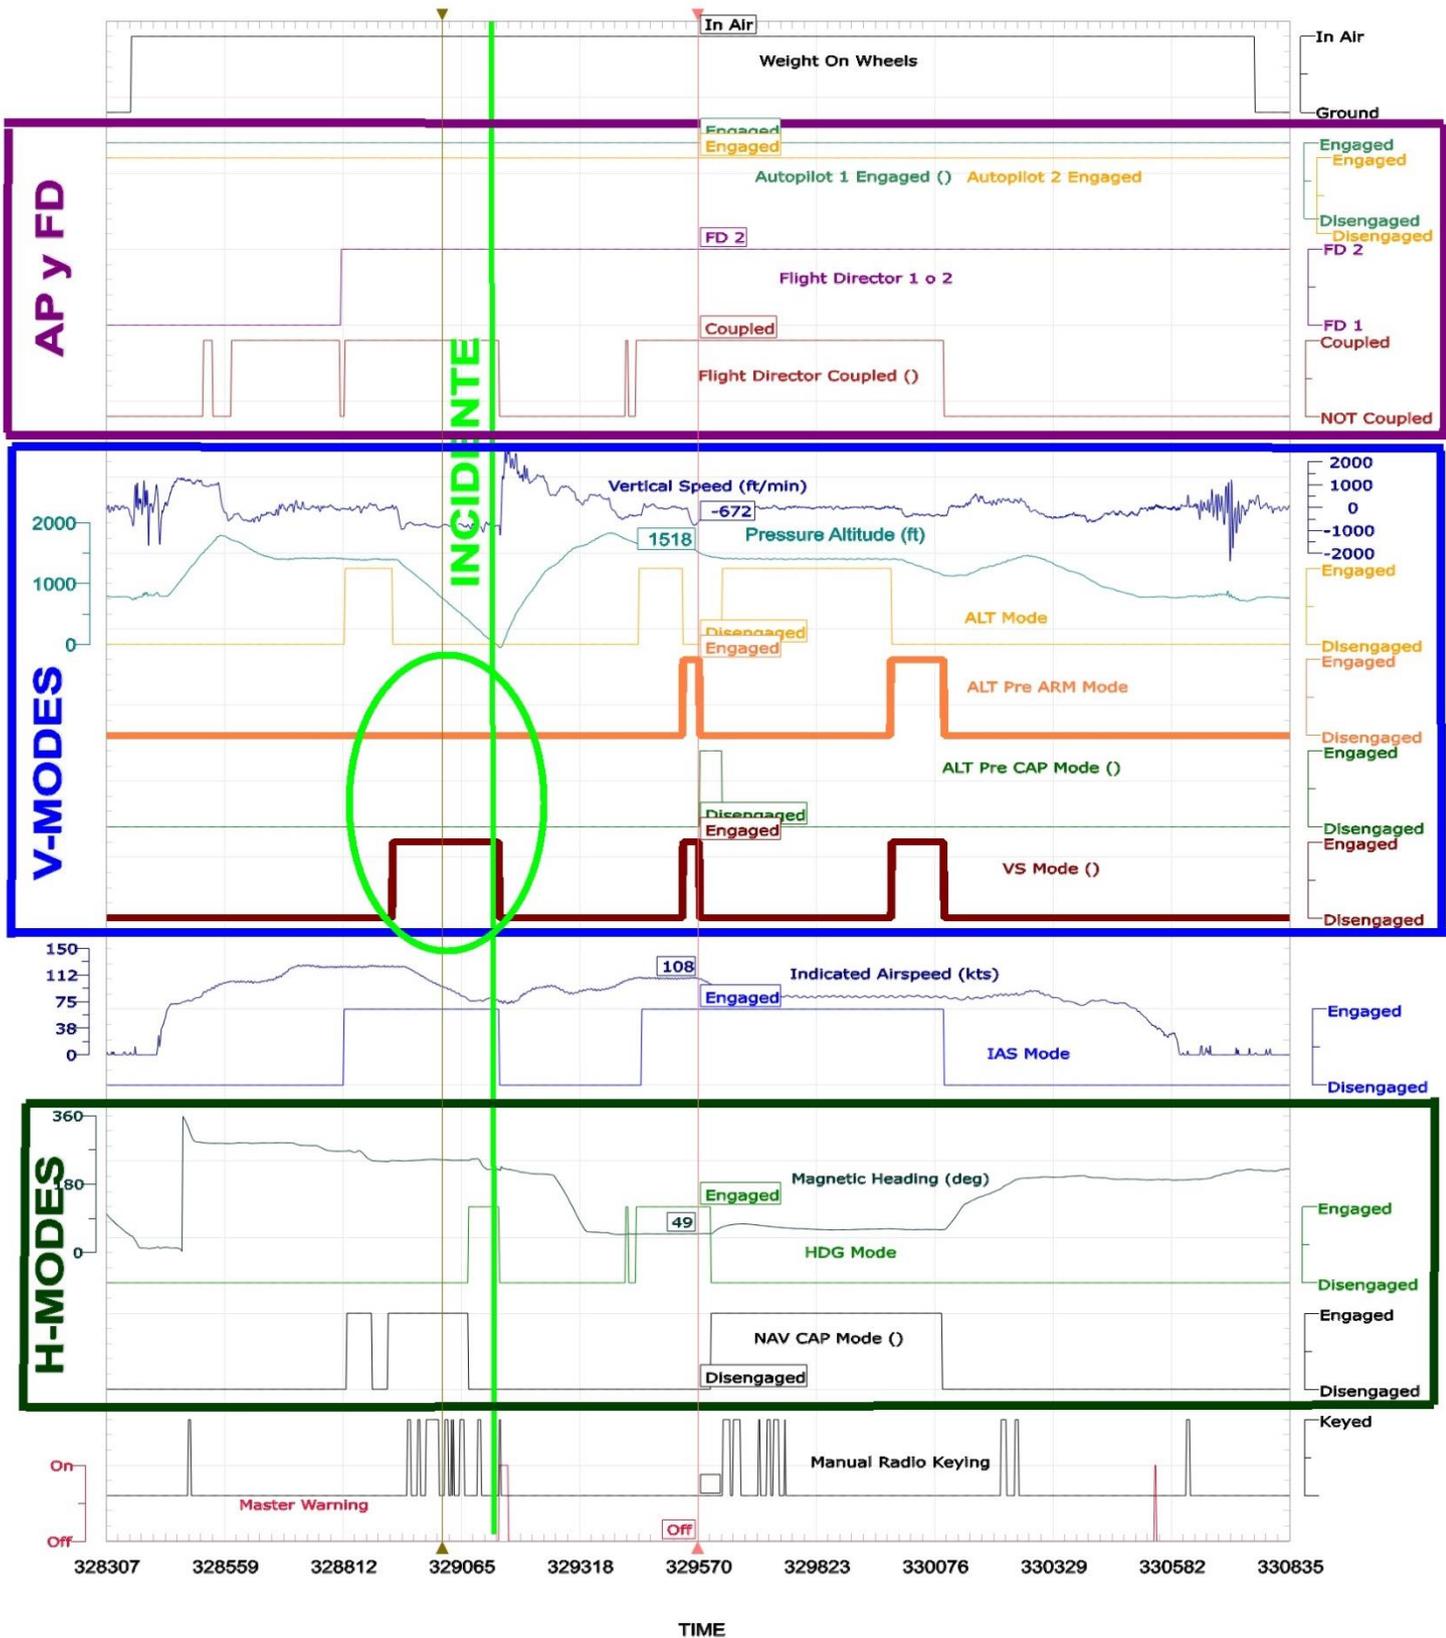
**Values of relevant FDR parameters**

This lack of awareness resulted from the crew's assumption that the aircraft was operating under altitude control, when, in fact, it was not because the corresponding system had not been activated. Excess confidence in the automatisms caused the crew to be complacent. They failed to carry out the mandatory monitoring of the descent, which led to a potentially life-threatening situation.

Parameters corresponding to the AP and FD at the beginning of the incident descent. The ALT-PRE MODE is not selected

REC 35/20: We recommend that the operator, Babcock, should implement the necessary measures to improve training on procedural adherence, response to warnings and alarms and, particularly, CFIT prevention during initial and recurrent crew training exercises.
