Report

IN-052/2019

Incident involving an ATR 72-212 A aircraft, registration EC-MPI, operated by Canarias Airlines at the Tenerife North Airport (GCXO) on 15 October 2019

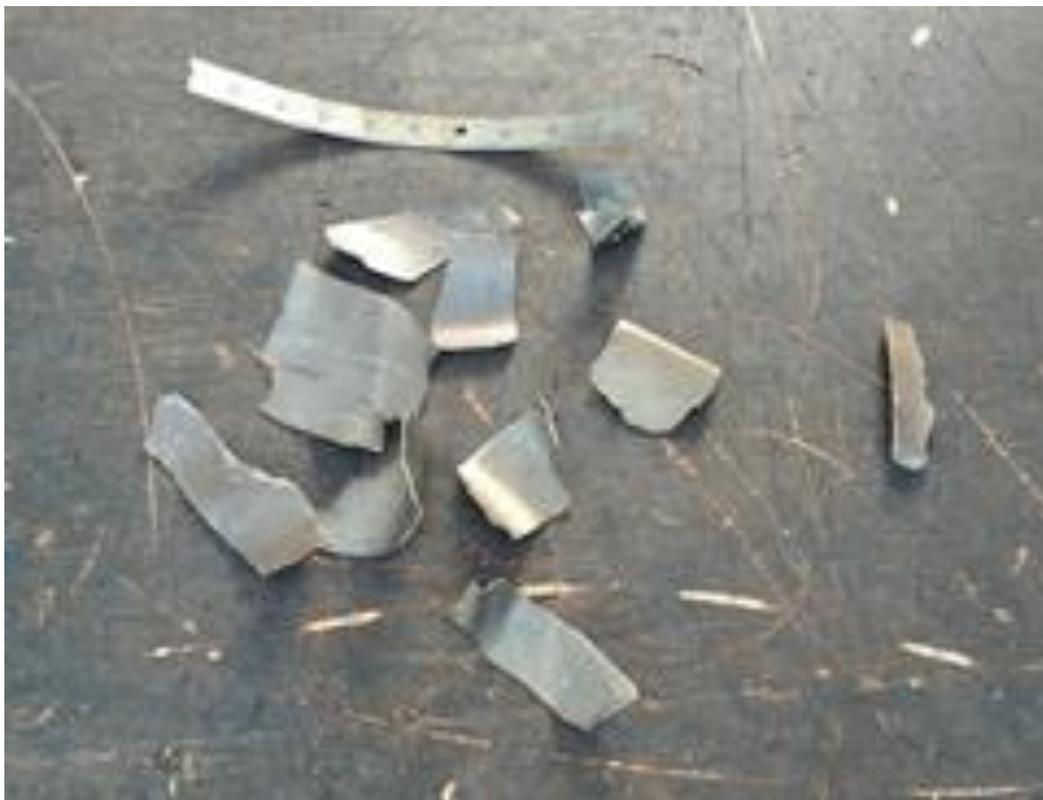
Figure 1. Fragments removed from the runway

Moments later, airport officials informed them that various metal fragments had been removed from the runway and from the vicinity of exit taxiways E1 and E2, which were later determined to have released from the right engine through the gas exhaust.

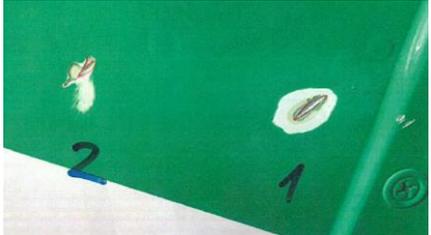
TYPE OF DAMAGE	LOCATION	LENGTH	WIDTH	DEPTH	PHOTOGRAPH
1. Scratch	85 mm FWD FR 28D 18 mm below ST 14	11 mm		0.35 mm

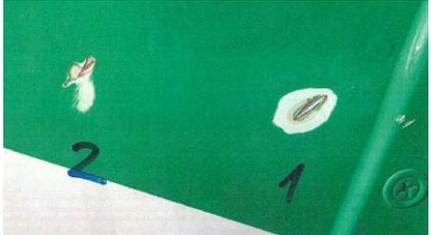
2. Scratch	150 mm FWD FR 28D 8 mm below ST14	7 mm		2.5 mm

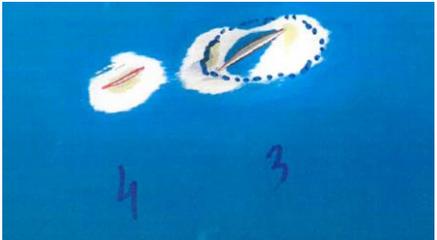
3. Scratch & dent	225 mm AFT FR 31 90 mm below ST 14	42 mm	25 mm	0.25 mm

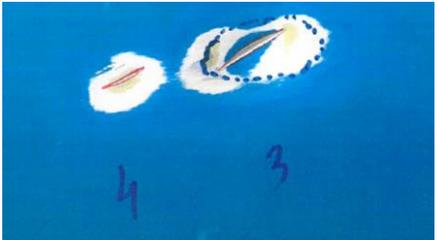
4. Scratch	180 mm FWD FR 31 90 mm below ST 15	16 mm		0.4 mm

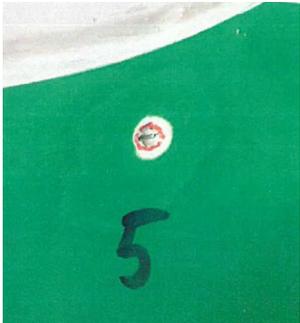
5. Nick	223 mm FWD FR 32 6 mm above ST 10			0.62 mm

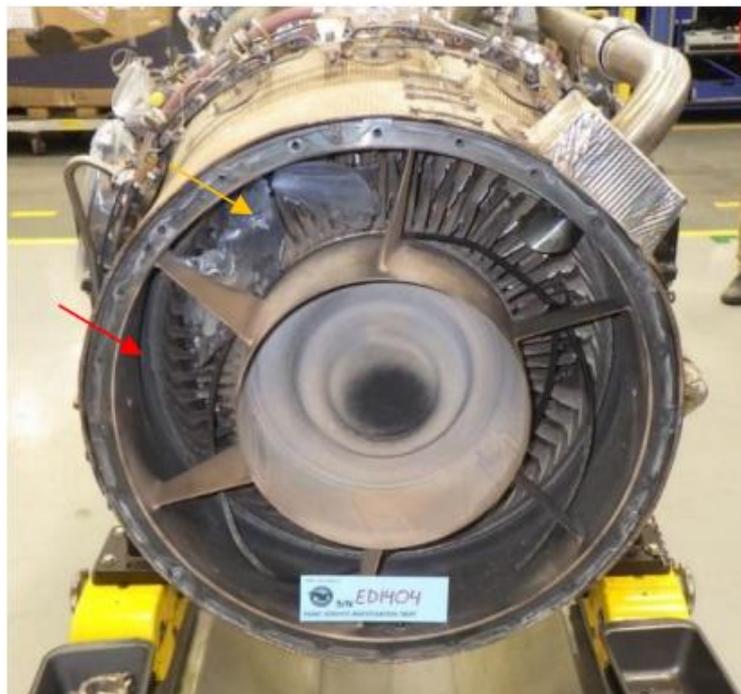
Figure 6. Engine seen from behind

The blades in the second stage of the power turbine (PT2) were found fractured, and multiple fragments were missing. The exhaust cover was fractured and deformed (red arrow, Fig. 4).

As a result, the engine contained all the detached and projected components, which were collected and sent for analysis, along with the engine (the orange arrow points to the bag where the fragments found on the runway were placed).

The purge valve was loose, attached only by one bolt, which was partially unscrewed. The valve connector and cable were damaged.

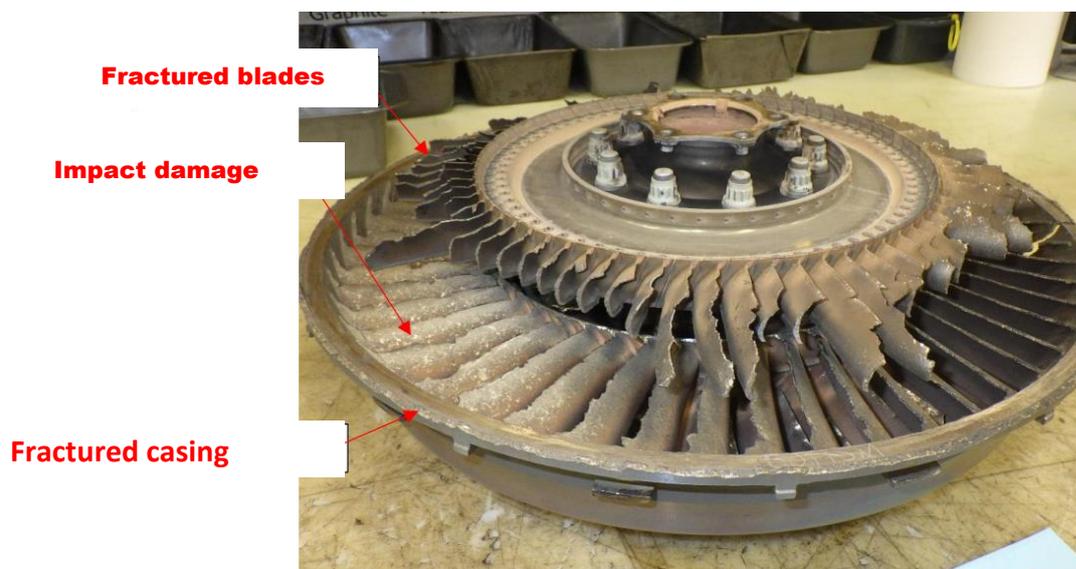
Figure 7. Damage to PT2

All the blades in the second stage of the power turbine (PT2 disk) were fractured at various lengths. The case on this stage of the turbine was also fractured, and multiple secondary damages were found on the trailing edge of the stator on the power turbine (PT2 vane).

The ring of blades on the second stage of the power turbine (PT2 vane) was fractured.

The first stage of the power turbine (PT1 disk) showed damage from secondary impacts to the trailing edges of the blades. The deflector on this stage was fractured and dented, and some components were missing.

The tips of the blades on the low-pressure turbine disk exhibited wear due to friction associated with the wear observed on the segments of the LPT casing. The tips of the blades on the high-pressure disk were found to have considerable wear due to friction and loss of material. Most of the cooling holes on the blades were not visible.

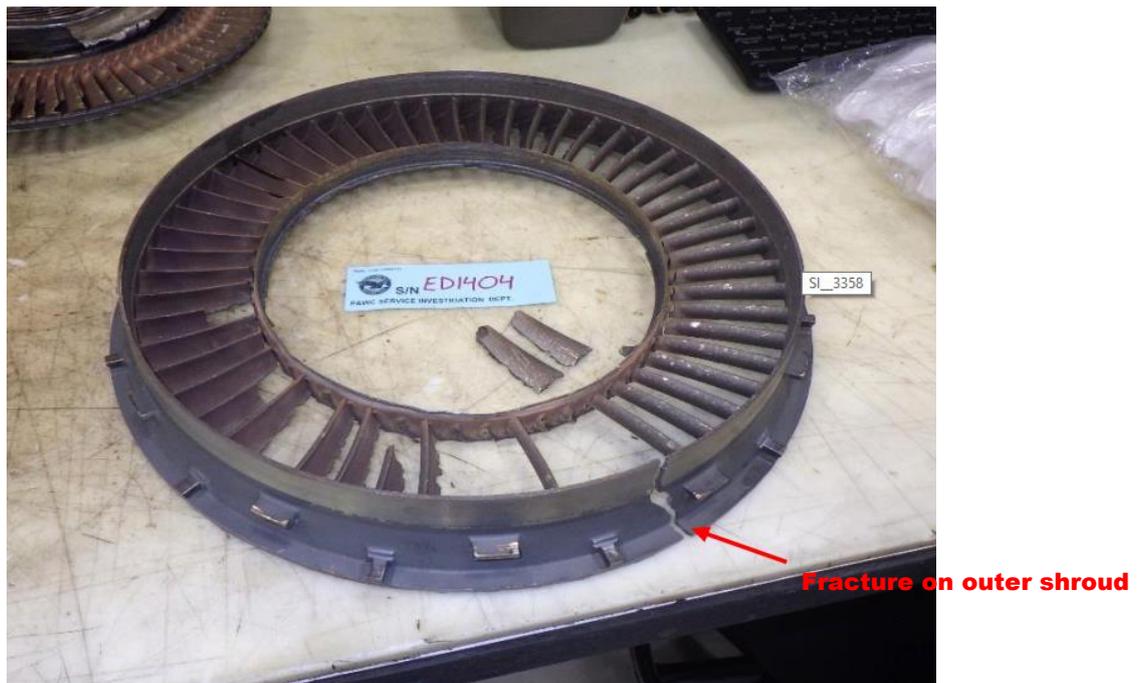
Figure 8. Damage to PT2 stator

The HP vane exhibited damage due to excess temperature and cracks on the aerodynamic airfoils. In addition, the LP shaft contained marks from rubbing against the HP disk.

The profiles on the LP impeller were also worn due to friction with the casing.

The outer diameter of the PT shaft was also worn due to friction with the inner diameter of the LP shaft.

The profiles of the blades on the HP impeller were worn and matched the wear found on the HP casing.

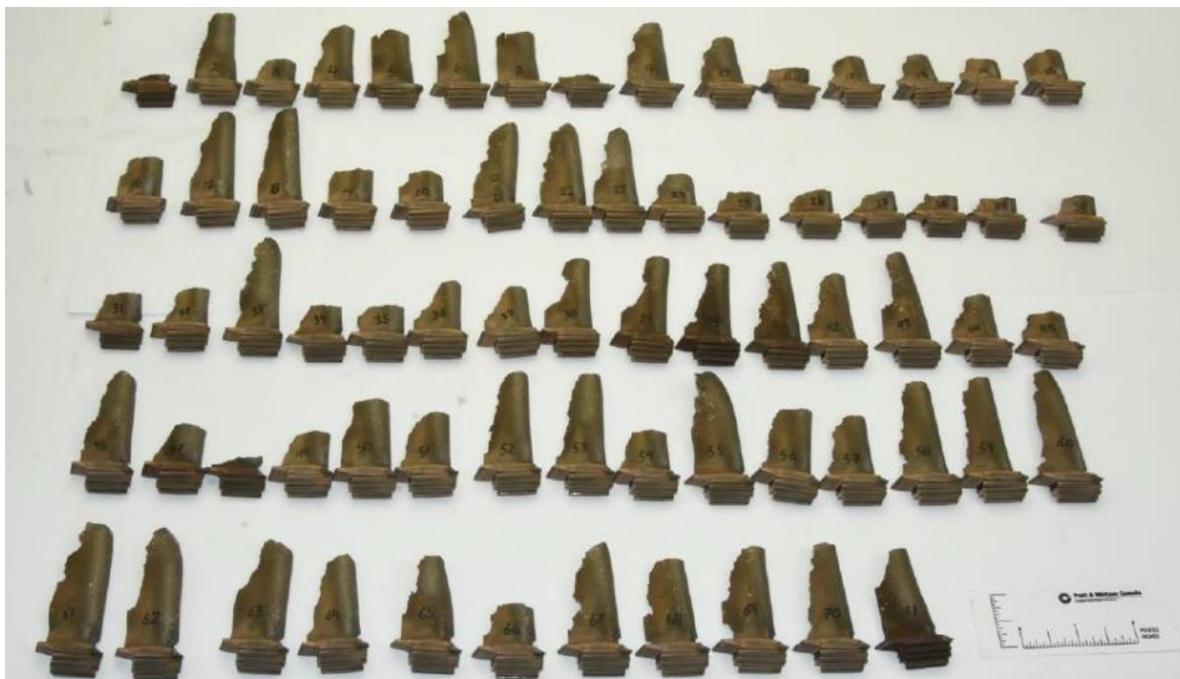
Figure 9. Blade fragments found

As noted earlier, numerous blade fragments were found that had a type of localized straight fracture either directly on or just above their respective platforms.

Other blades exhibited impact damage and angled fracture planes that were consistent with secondary damage.

The analysis of all the PT2 blades that exhibited a plane fracture near the platform revealed that only one of them (#8) showed evidence of fatigue near the leading edge, exhibiting significant wear.

The remaining blades had fractures consistent with overload.

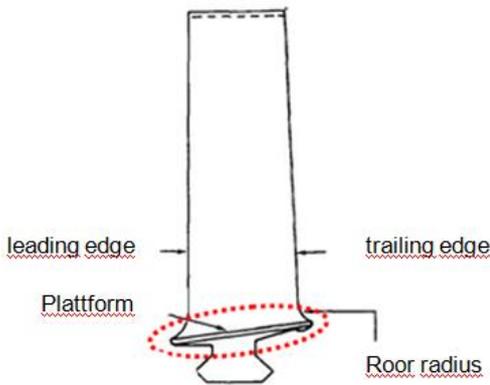
Figure 10. Parts of a blade

On the blade that showed signs of fatigue, most of the fracture was located approximately 0.25" above the platform, and the region where the fatigue characteristics were found was located about 0.125" above the platform. The fatigue characteristics were around 0.150" away from where the leading edge would have been.

The area with the fatigue crack exhibited more oxidation than the rest. Upon noticing that the fatigue crack on the only affected blade was small, it was decided to perform a metallographic test of another blade (#18), as its profile was in the best overall condition, although since its leading edge was also missing, its trailing edge was examined.

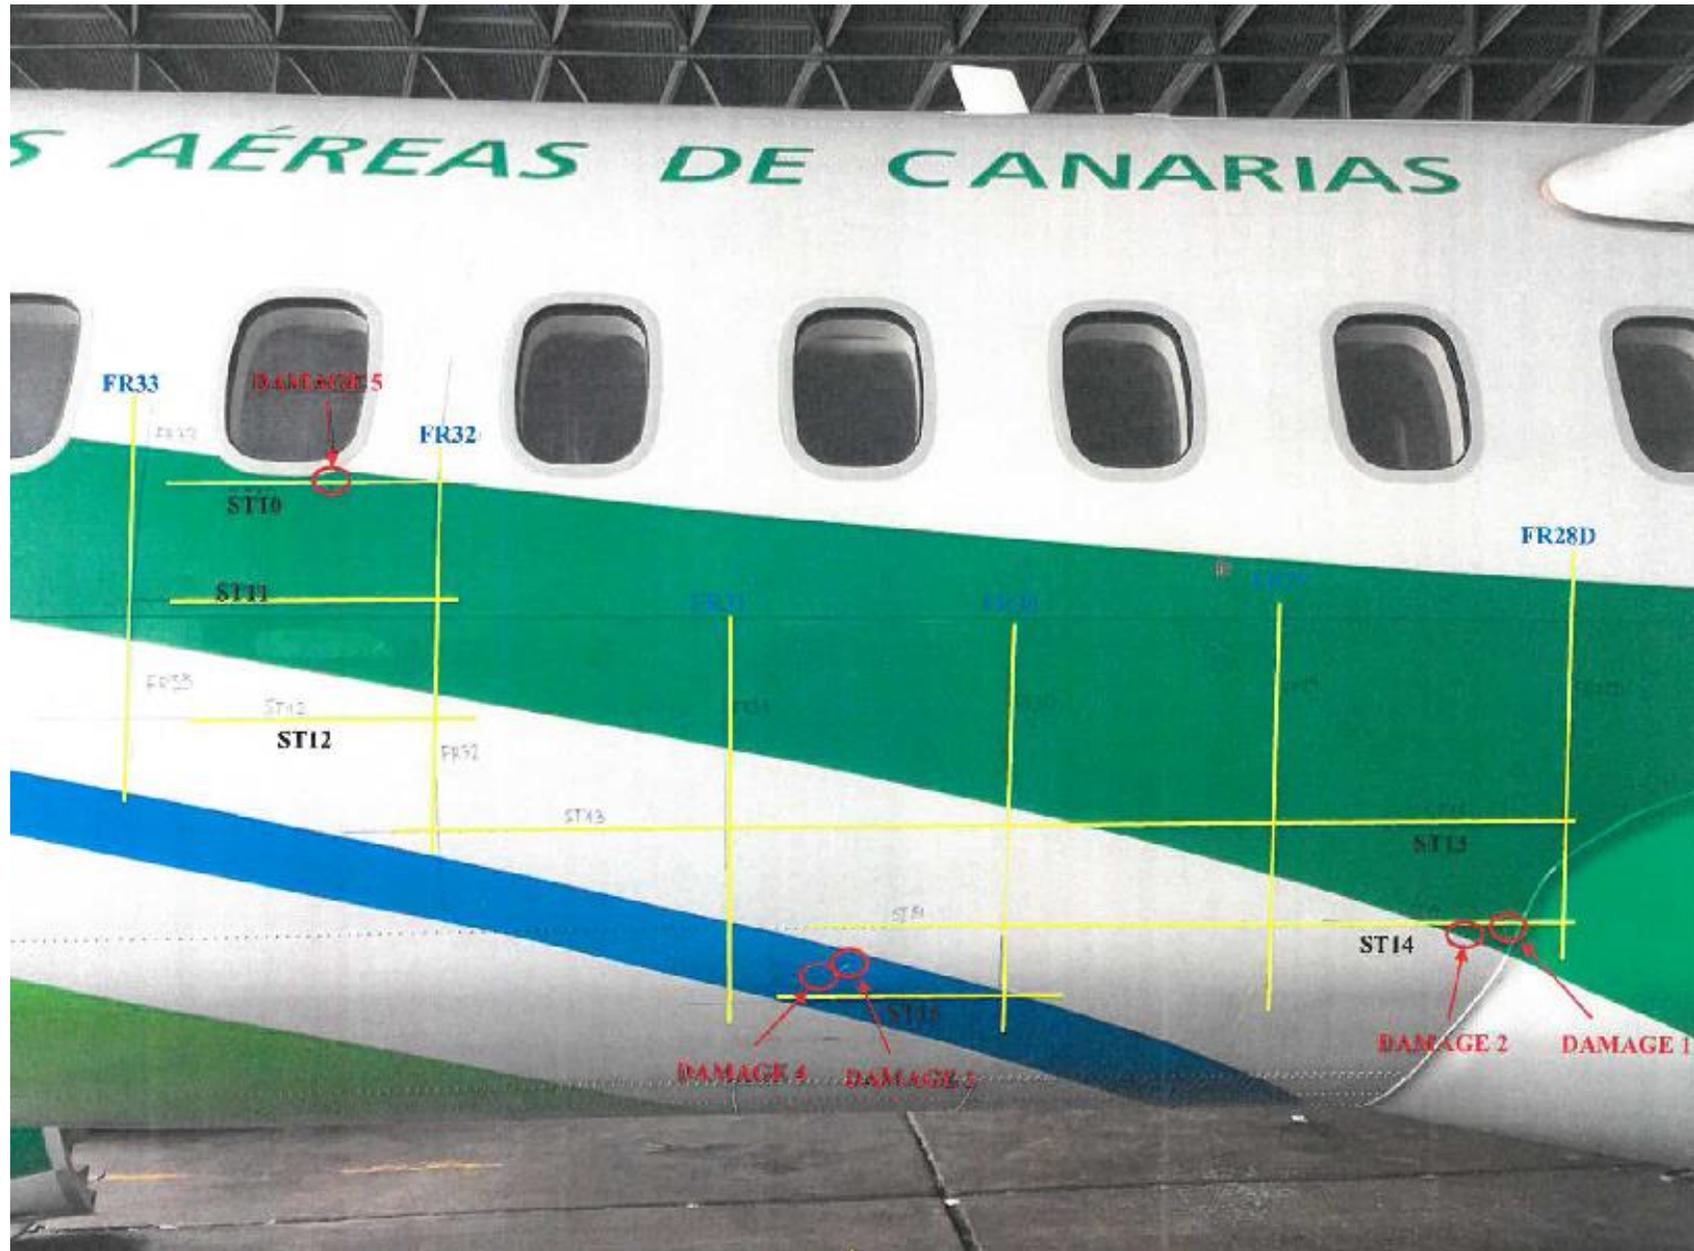
ANNEX 1. DAMAGE TO THE FUSELAGE

During the engine failure, several metal pieces detached that caused damage to the right side of the fuselage, between form ribs 28D and 33, and stations 9 and 15 (see Annex 1), as listed below:

6. Nick located 67 mm FWD FR 31 and 18 mm below ST 15.
7. Nick located 125 mm FWD FR 31 and 12 mm below ST 15.
8. Nick located 10 mm FWD FR 31 and 12 mm above ST 14.
9. Scratch located 125 mm FWD FR 32 and 20 mm below ST 13.
10. Scratch located 35 mm FWD FR 32 and 69 mm below ST 13.
11. Nick located 47 mm FWD FR 32 and 38 mm above ST 14.
12. Scratch located 168 mm FWD FR 33 and 19 mm above ST 14.
13. Nick located 95 mm FWD FR 33 and 19 mm above ST 14.

16. A perforation was also found on the vertical stabilizer on the dorsal fin panel.
