Technical report

IN-057/2022

Incident on 6 October 2022 involving an AIRBUS A-320-214 aircraft, registration EC-MAO, operated by Vueling Airlines S.A., and a PIPER PA-28-161 aircraft, registration EC-MBV, operated by Flight Training Europe S.L, at Seville Airport (Spain)

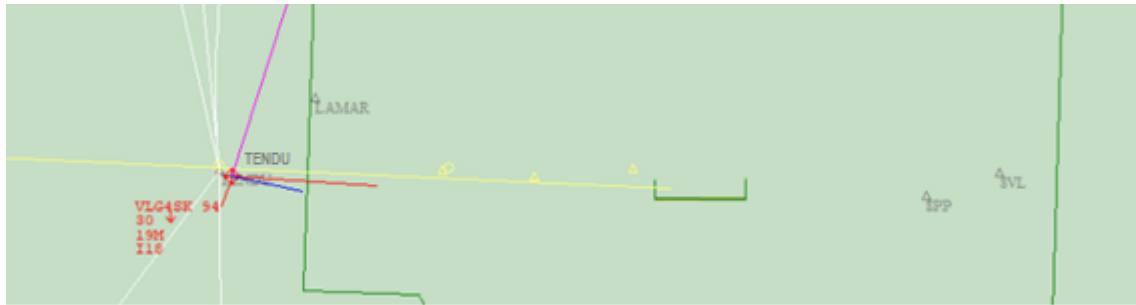
Figure 1 – Radar image (1).

At this moment, the radar trace shows this aircraft over the TENDU⁶ instrument approach fix (IAF) on approach to runway 09 at 3,000 ft AGL and approximately 9 NM from the airport:

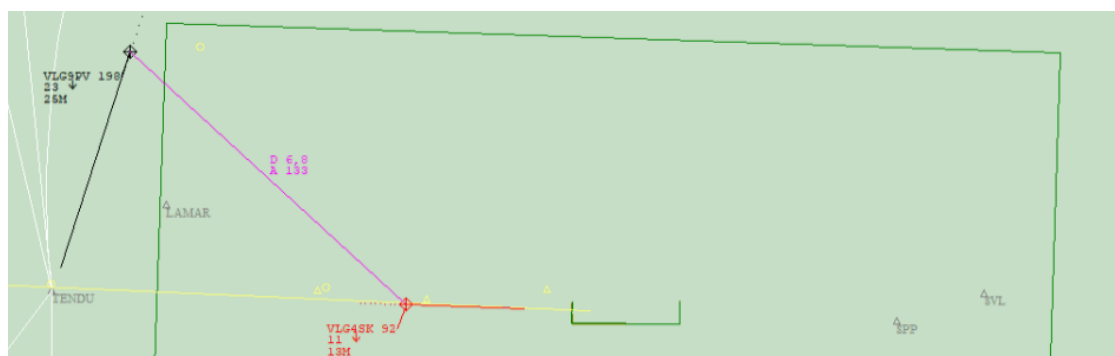
Figure 2 – Radar image (2).

Despite this, the controller did not ask the student pilot of the EC-MBV aircraft to confirm that he had received the communication correctly, nor did the controller repeat the instruction.

At this moment, the radar trace shows the EC-MAO aircraft on final approach at 1,100 ft AGL and approximately 3 NM.

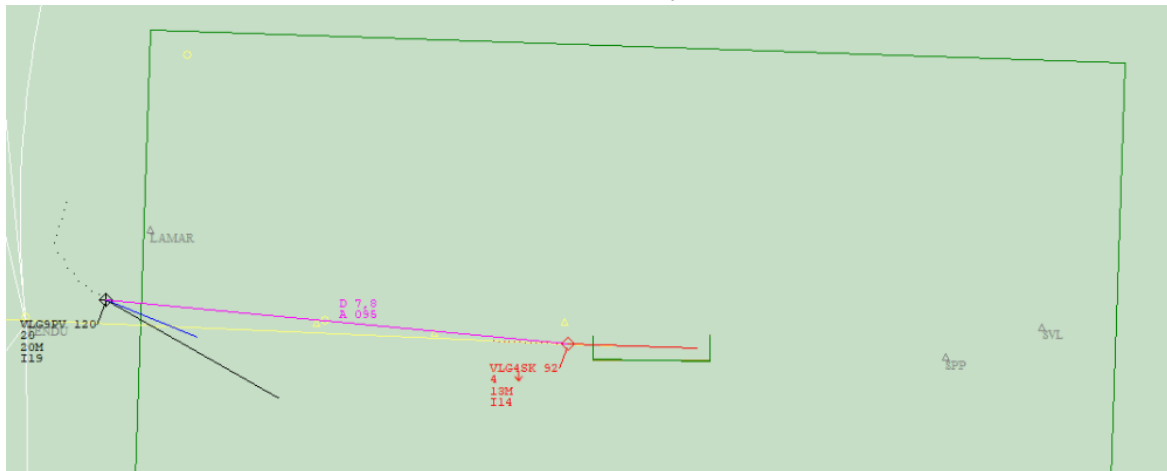
Figure 3 – Radar image (3).

At this moment, when the crew of the EC-MAO aircraft became aware of the EC-MBV aircraft, the radar trace shows the EC-MAO aircraft on very short final at 400 ft AGL and at a distance of about 0.75 NM from the head of runway 09.

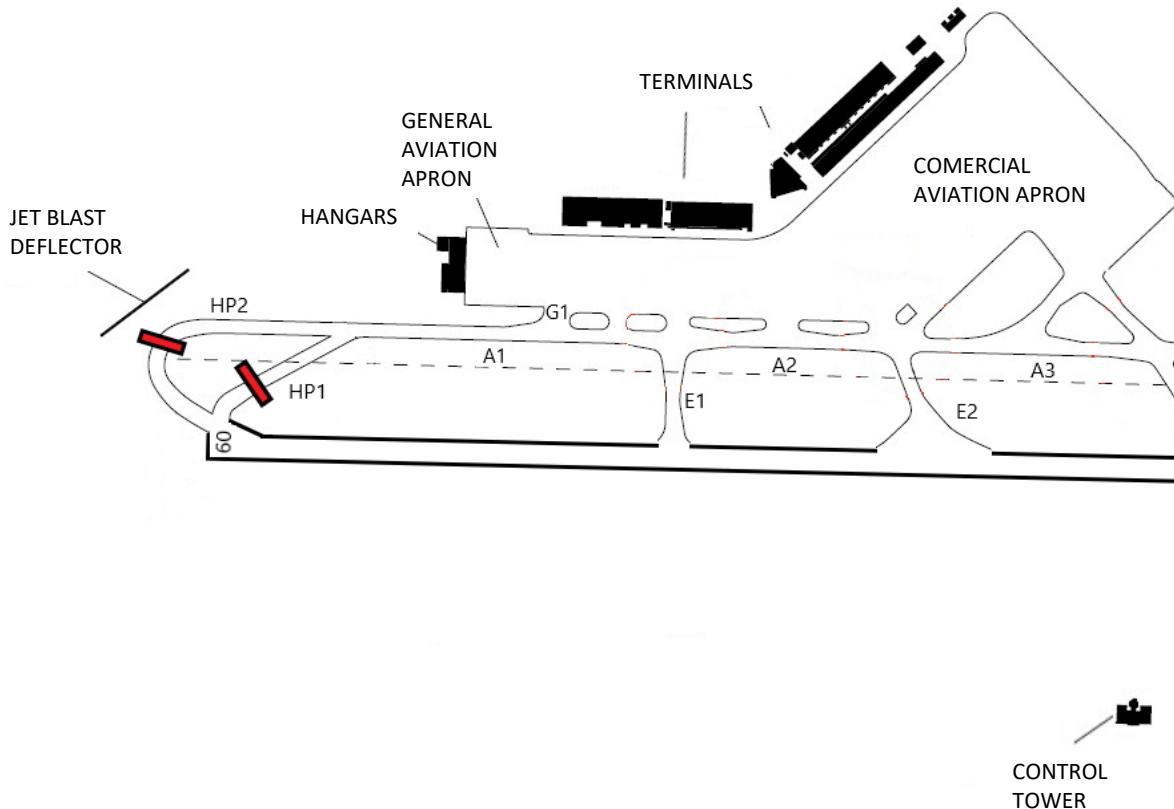
Figure 4 - Map of Seville Airport (south-west area).

Rectangles indicate the runway access holding positions on taxiways HP1 and HP2. Also shown on the map is the jet blast deflector protecting the A4 motorway from the jet blasts emitted by aircraft on HP2.

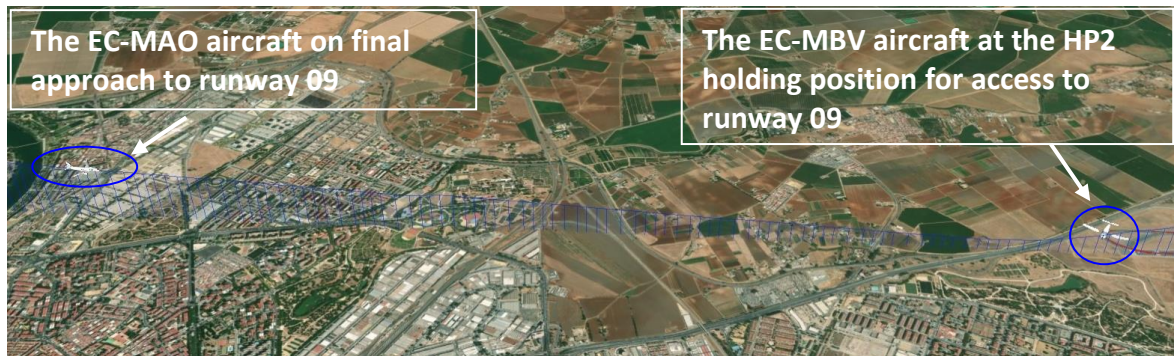
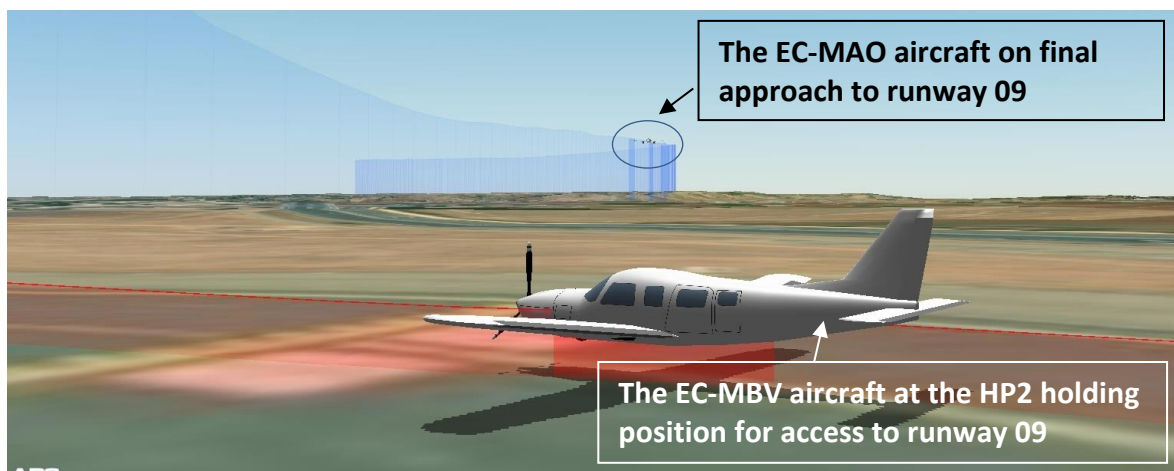
Events: In response to the student pilot's communication that he was ready to take off, the controller instructed him to hold short of the runway.

The EC-MAO aircraft was at an altitude of approximately 1,150 ft and about 6.12 km from the threshold of runway 09.

However, after this communication, the student pilot entered runway 09.

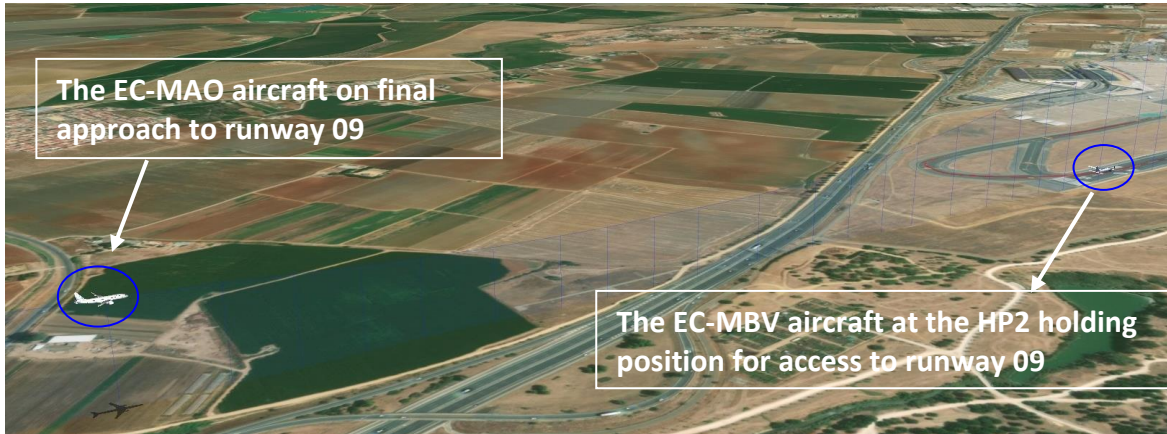
Figure 7 - Positions of the aircraft at 16:14:39 h (simulated figure).

Events: The PM on board the EC-MAO aircraft contacted the controller to inform him that there was something on the runway. The aircraft was on short final, approximately 1.3 km from the threshold of runway 09 and at an altitude of 269 ft.

The student pilot was stopped on the runway 09 threshold.

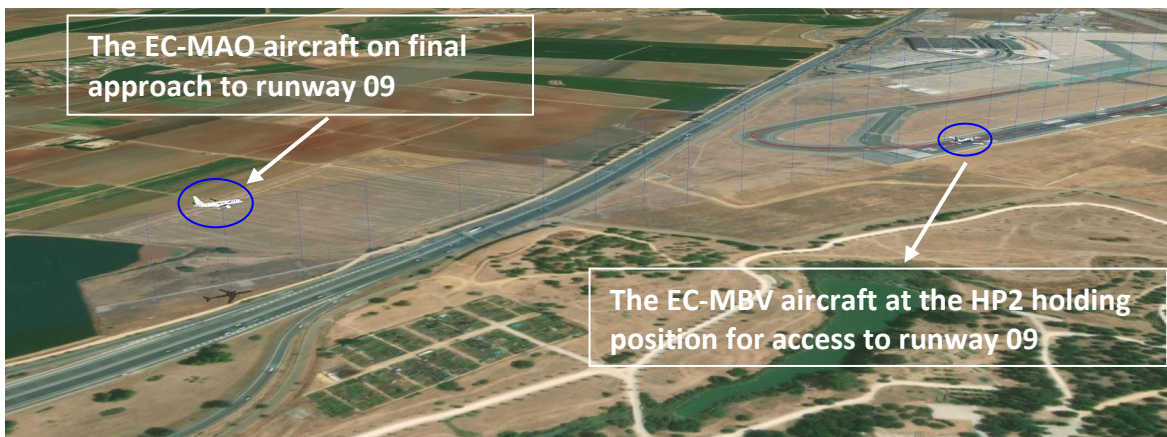
Figure 8 - Positions of the aircraft at 16:14:45 h (simulated figure).

Events: The crew of the EC-MAO aircraft commenced the go-around. They were approximately 196 ft above the ground and around 830 m from the threshold of runway 09.

The student pilot remained on the runway 09 threshold.
