# Technical report

## IN-018/2022

Incident on 20 March 2022 involving a Boeing B777-223 aircraft operated by American Airlines, registration N777AN, en route (Zaragoza, Spain)

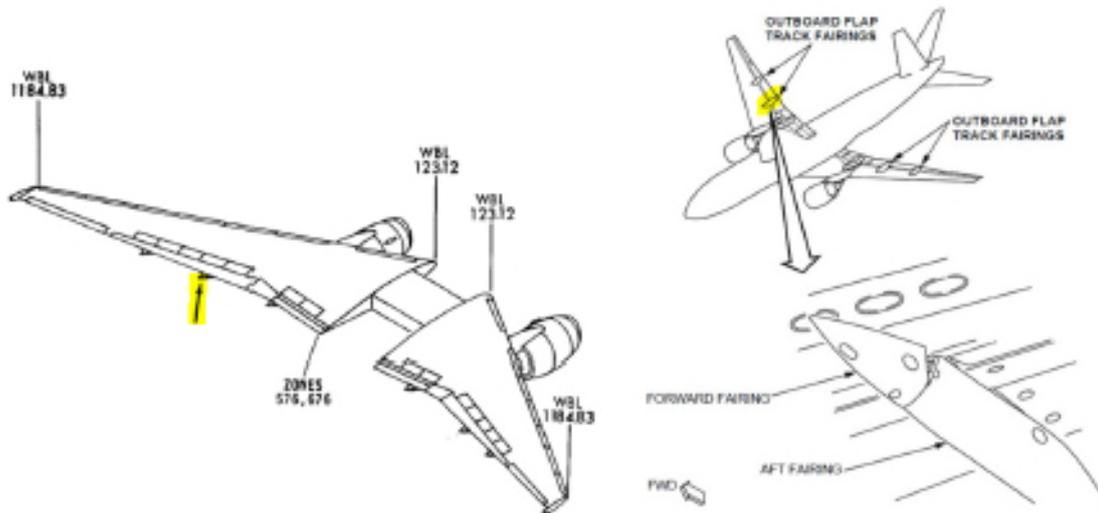
Image 2: Position and assembly of the number 2 outboard flap fairing

The number 2 outboard flap fairing, which came off during the incident, is the innermost flap fairing. The fairing covers the flap support mechanism:

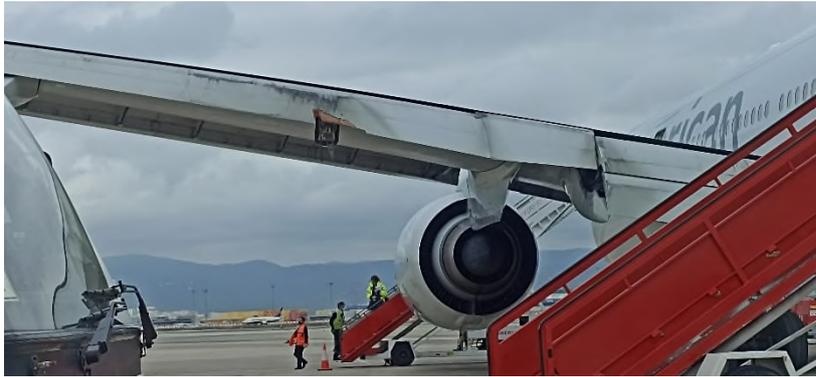
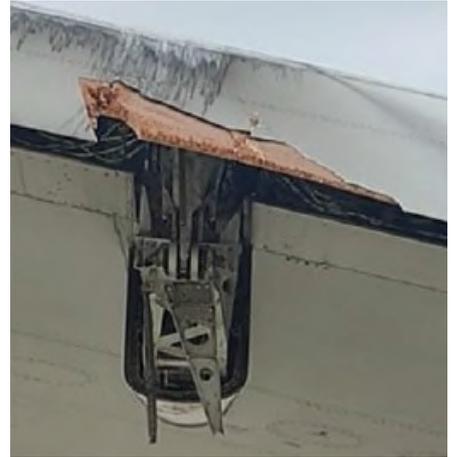
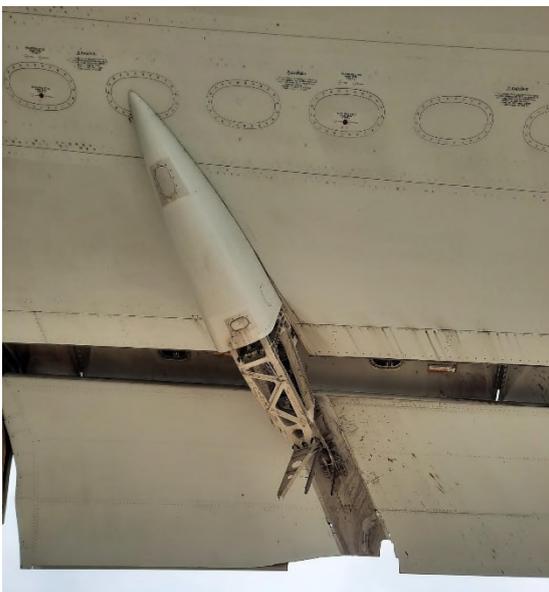
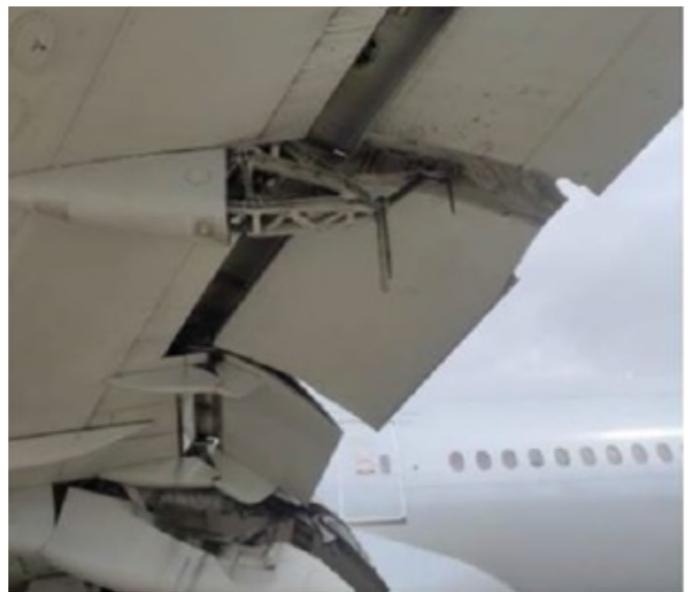
The aircraft lost the flap fairing on its left wing and incurred damage to the trailing edge of the flap.

The following photos show the missing left centre flap fairing and damage to the flap's trailing edge, which was presumably caused by the fairing when it detached<sup>5</sup>:

- Two bolts were missing from the front connection.
- All three rear connections were damaged.

After replacing the flap and applying configuration deviation CDL57-07<sup>2</sup> for the missing fairing, the aircraft was put back into service on 26 March. Once in the United States, the fairing was repaired.
