Combined report on the investigations of
Two fatalities connected with the
operation of the workboat

GPS Battler

off Almeria, Spain

in Marin, Spain

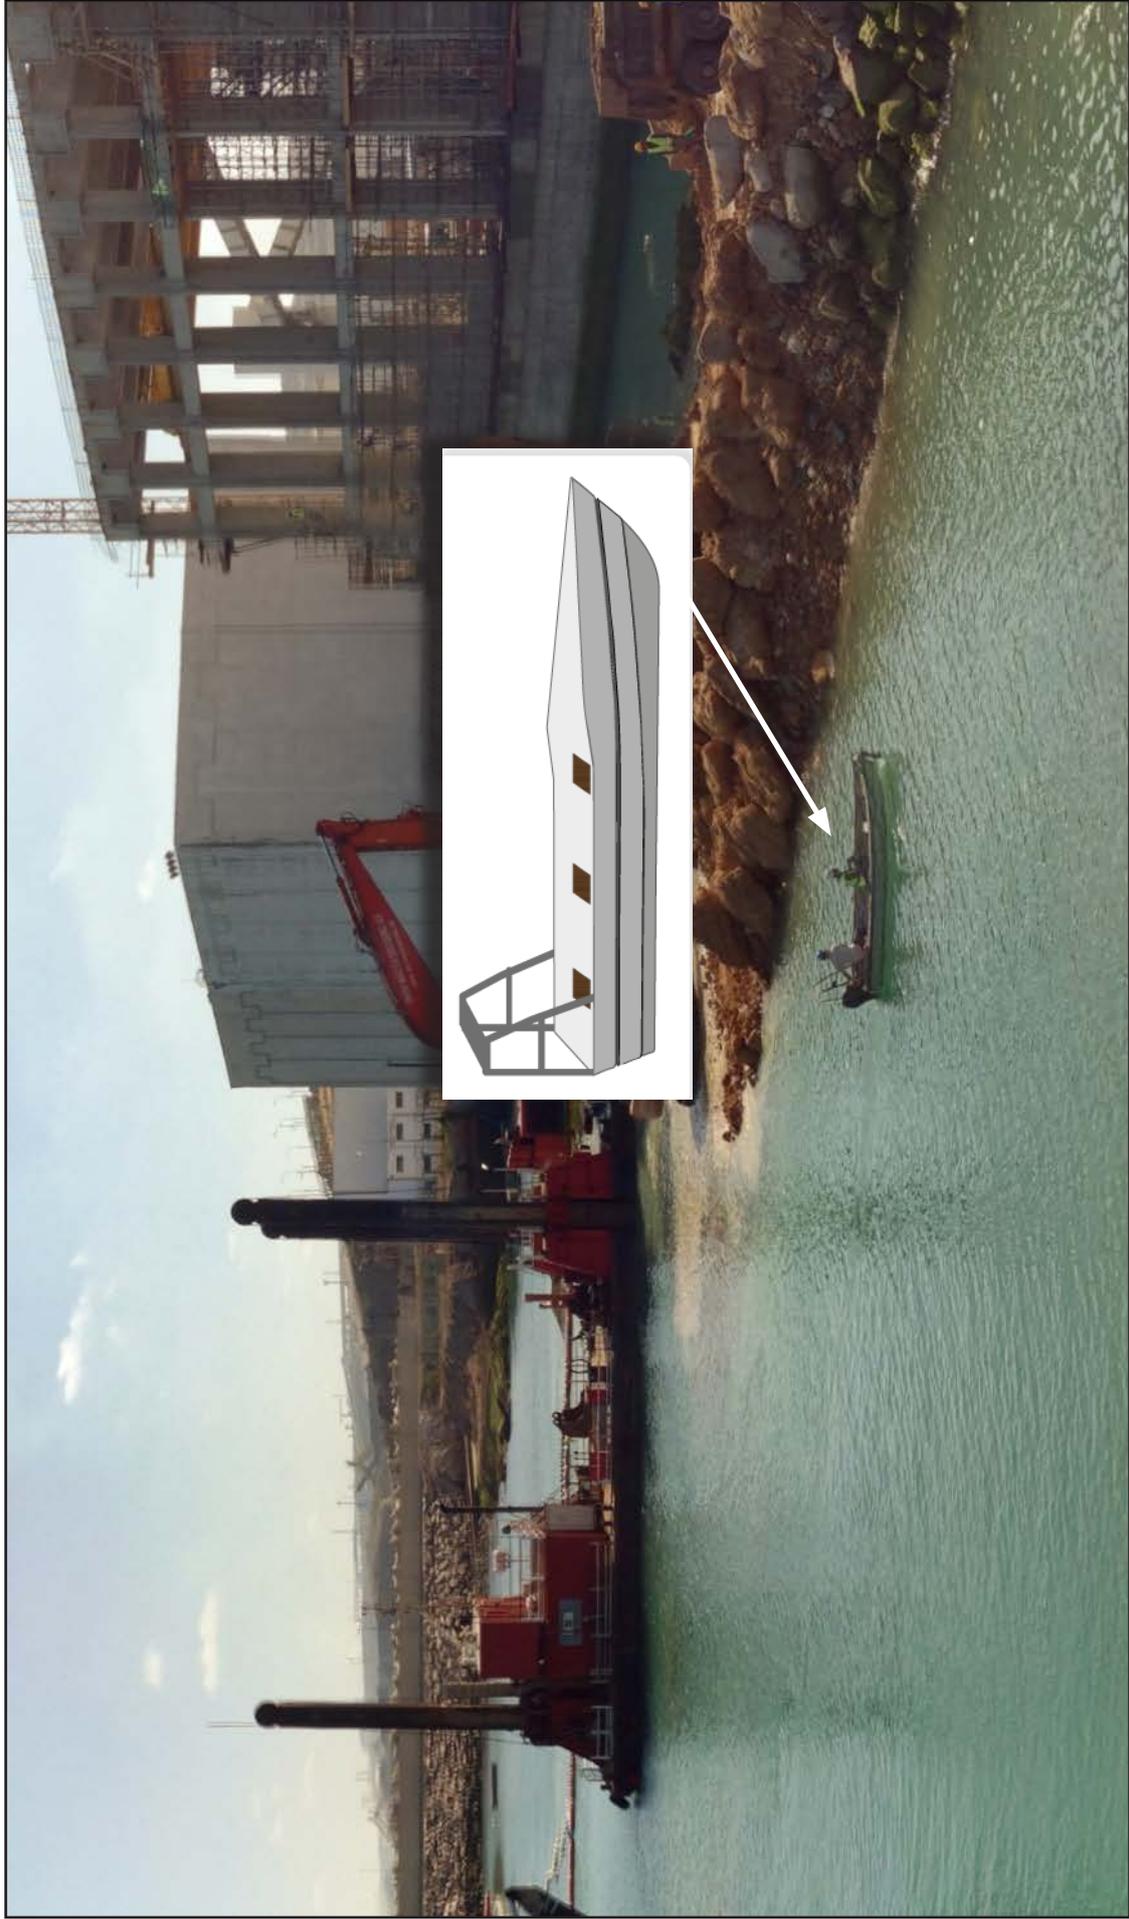
Figure 6: Tender during dredging operations

There is no evidence to suggest that *Von Rock's* tender was not fit for purpose for its intended role when operated close to the shore in sheltered waters. However, the tender's swamping off Almeria indicates that the sea conditions prevailing on this occasion exceeded the boat's safe operating limit.

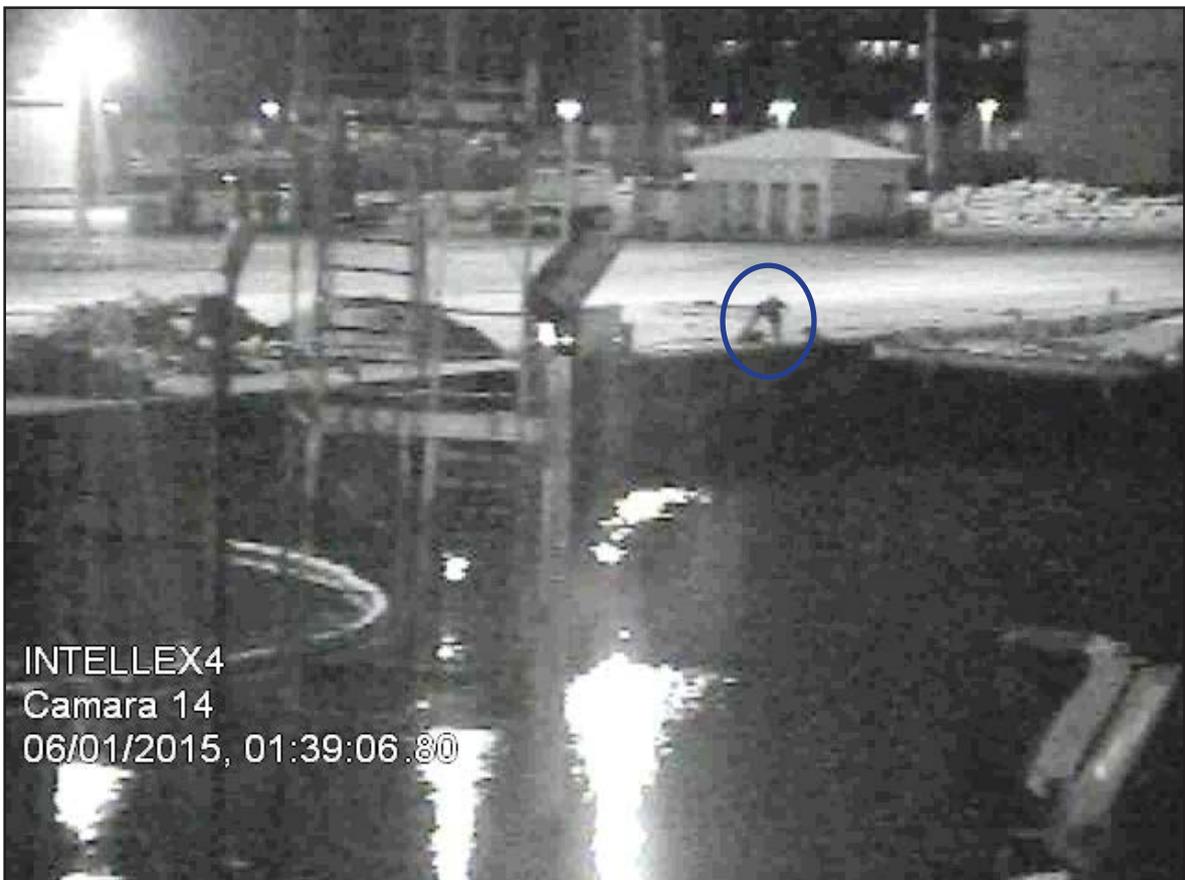
Figure 11: Still from CCTV at 0139 - mate by quay edge

The mate's high blood-alcohol concentration, together with fatigue would have impaired his motor skills and co-ordination, and CCTV footage shows he was unsteady on his feet as he walked from the pedestrian gate towards *GPS Battler*. It is also likely that the alcohol he had consumed would also have caused a loss of understanding and slurred speech. Indeed, the mate's failure to respond when approached by the bosun as he leant against the skip probably indicates that he was in an alcohol-induced stupor. In such a state, it is almost certain that the mate fell into the water because he either stumbled or lost his balance.
