MARINE SAFETY INVESTIGATION REPORT

Safety investigation into the serious occupational accident on board the
Maltese registered heavy lift /pipelay vessel

PIONEERING SPIRIT

MARINE SAFETY INVESTIGATION REPORT NO. 02/2021

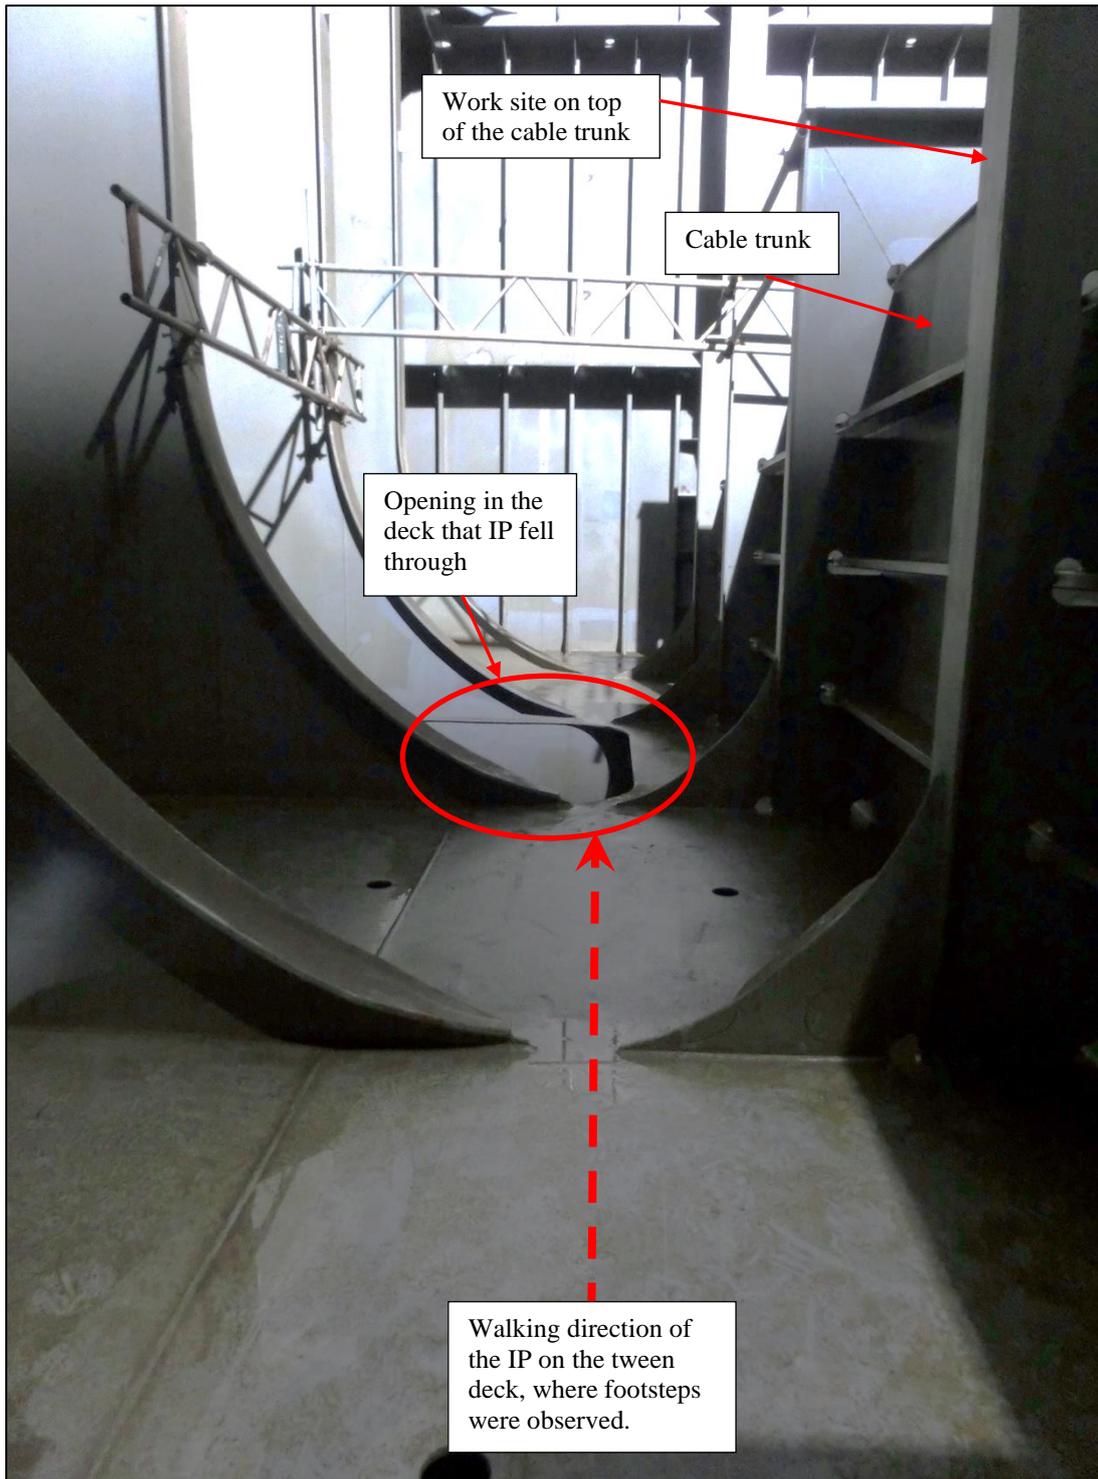
Figure 12: Access ladder passing cable trunk. Lighting conditions are similar to those at the time of the accident

The opening in the deck through which the IP fell, was located about halfway from the guard railed passageway to the aft bulk head of the tank (Figure 12). Neither permanent nor temporary barriers had been fitted specifically around the opening in the deck.

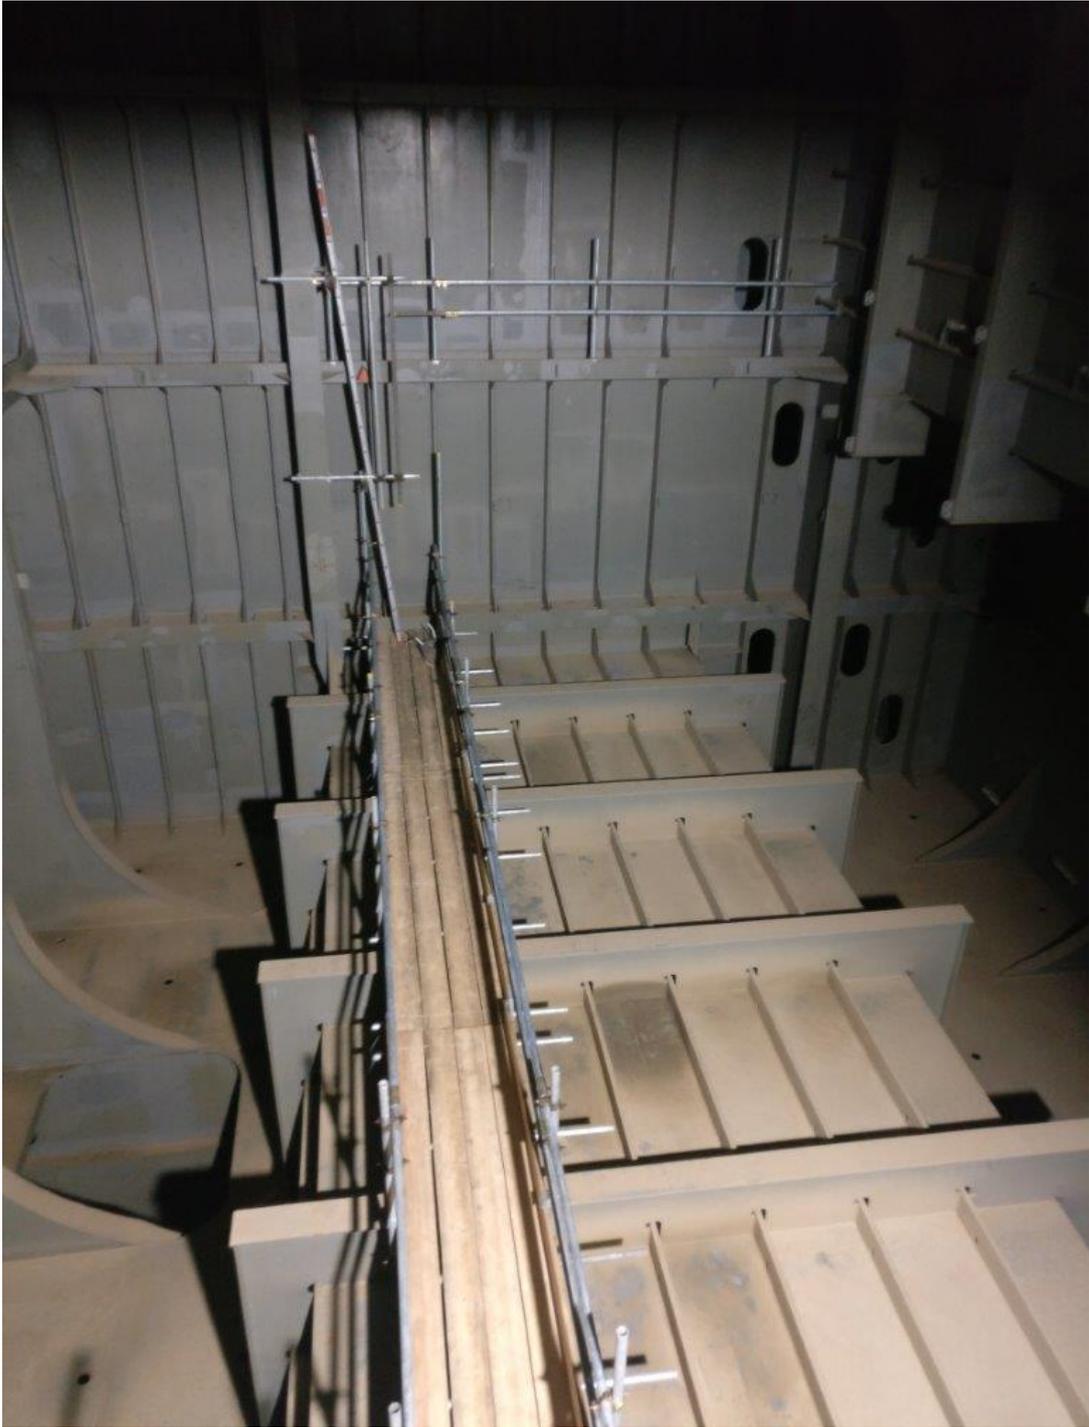
Figure 13: Scaffolding during initial work in tank in October 2018

The previous work done at the work site, was done in Tenerife, during which a scaffolding was set up to provide access to the work site (Figure 13). A scaffolding was not erected for the welding job at the time of the accident, as this was considered to be a small and quick task.

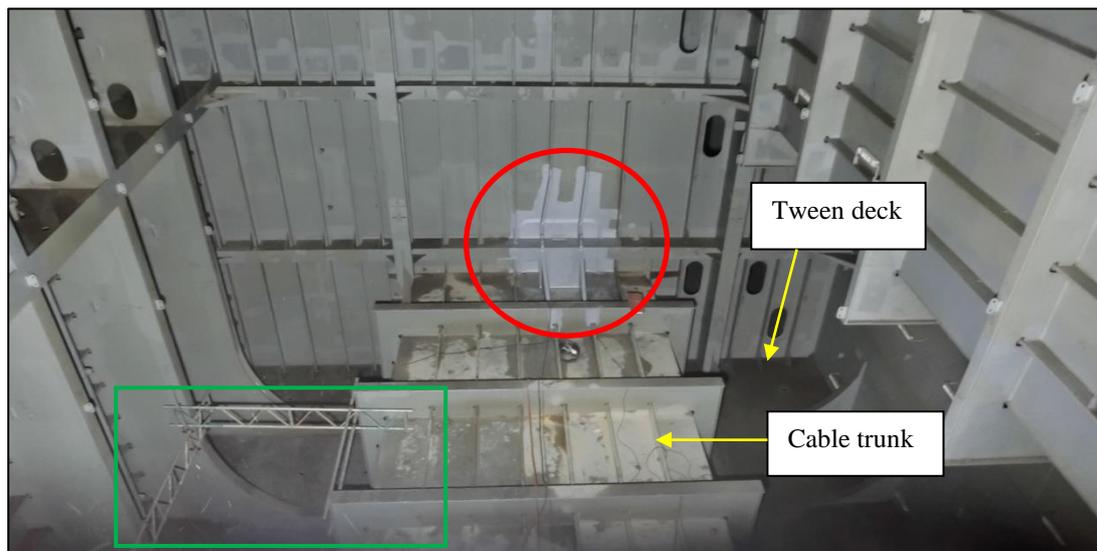
Figure 5: View inside of the WBT. Position where stiffeners were to be welded on, marked in red. Scaffolding (marked in green) was rigged during the recovery of the IP

The welding job was to be carried out at the aft bulkhead on top of a large cable trunk, located on the tween deck of the tank structure (Figure 5), which the welder⁶ had stepped on to, from the access ladder. When the IP started lowering the hoses from the welding machine, the welder grabbed and dragged them to the work site. At this time, the two crew members that were inside the tank had visual contact with each other. After that, the welder observed the IP making his way down the second access ladder, and then he turned around, and started to mark where the stiffeners had to be welded on to the sheave-block assembly reinforcement.

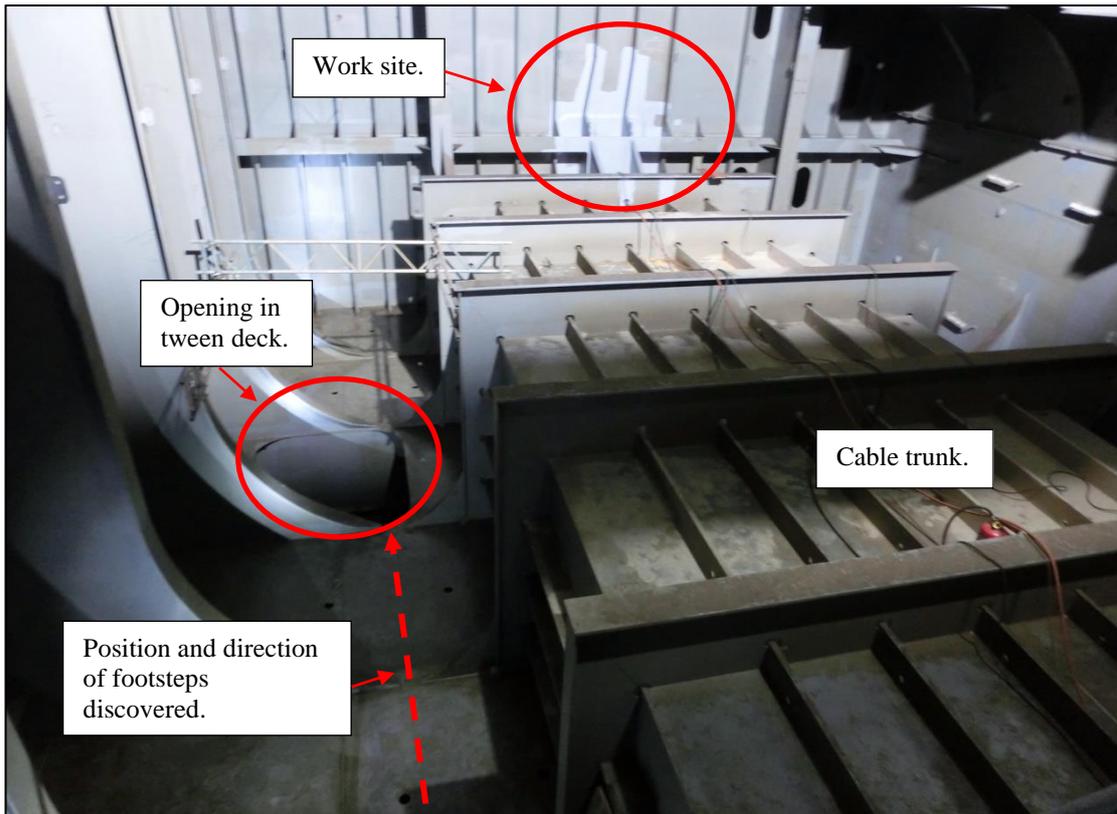
Figure 6: Most probable route taken by the IP

At around 1330, on his way down the ladder, the first welder helper shouted for the IP but received no response. He shouted to the welder that the IP was nowhere to be found on the tween deck below the trunk. When the first welder helper made a turn at the bottom of the access ladder, he observed fresh shoe prints on the otherwise untouched sludge coating on the tank tween deck going aft from the tank access pathway, which was bounded by hand railings. The shoe prints led along the side of the trunk in the direction of the work site (Figure 6).

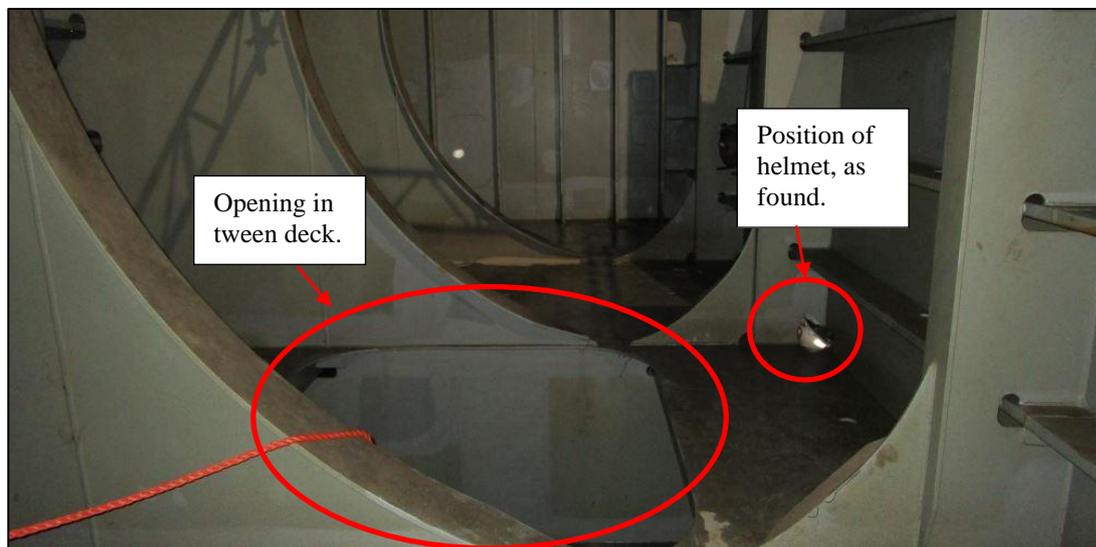
Figure 7: Accident site

There, the first welder helper discovered a hard hat lying on the deck with the head torch still lit just next to a large opening in the deck leading to the lower level of the WBT (Figure 7).

This safety investigation believes that absence of material barriers around the tween deck opening inside of WBT no. 1006, was contributory to this occurrence.

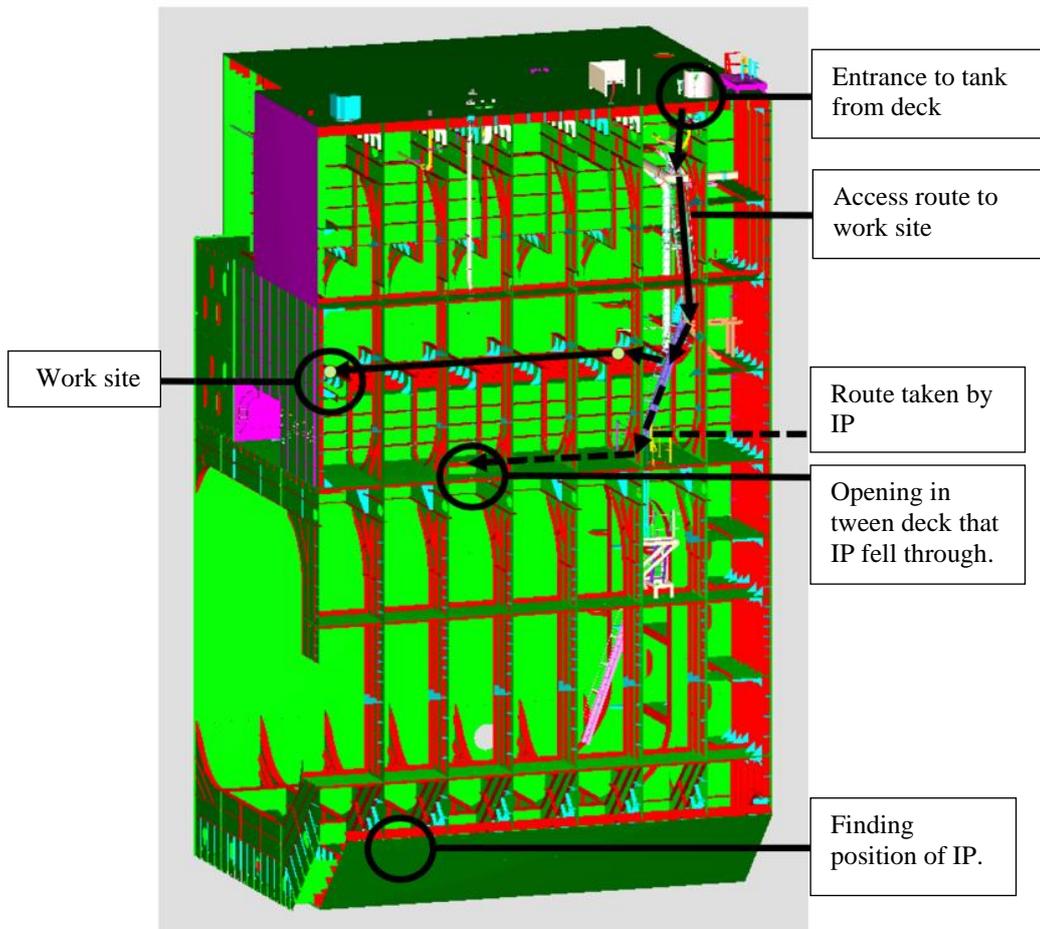
Figure 15: 3D model of water WBT no. 1006, as viewed from starboard side - walking routes marked

- the IP was looking up in the direction of the work site while walking ahead, failing to see the opening;
- the bag he was carrying may have obstructed the opening on the tween deck;
or
- the IP noticed the opening ahead of him but, while circumnavigating it, slipped and fell through the opening.

Through these hypothesis, the safety investigation also considered the possibility that the IP was uncomfortable with crossing the one metre gap in between the access ladder and the cable trunk.

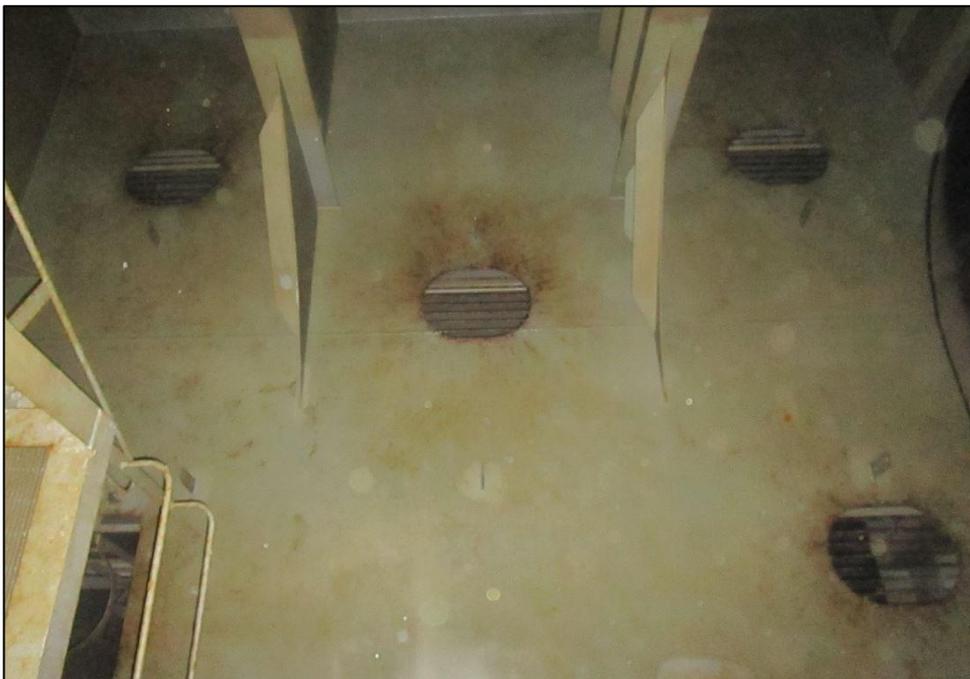
Figure 16: Protected openings on tween decks of other water ballast tanks

It was later revealed that at several locations in the WBTs, bars had been installed across the tween deck openings to prevent personnel from accidentally falling through (Figure 16). These openings were noticed to be of smaller diameters than the one in WBT no. 1006. The openings in WBTs (including no. 1006) were designed to allow large volumes of ballast water to flow through. Additionally, these openings were considered as an access to the large valves, which were installed on the lower part of the tank and, should maintenance be necessary, these openings would be used for the lifting of these valves. Thus, barrier systems such as the bars fitted in other locations of the WBTs were not feasible for such openings.

It was later revealed that some WBTs fitted on board *Pioneering Spirit* had bars across the tween deck openings to prevent someone from going through. These openings were noted to be of smaller diameters than the ones fitted in the WBT (Figure 16). It was not known why these bars had not been installed on all tween deck openings of all tanks present on board.
