Report ULM A-014/2018

Accident involving a Flight Design
CTSW aircraft, registration EC-EV5, in
the aerodrome of Algodor (Madrid) on
3 July 2018.

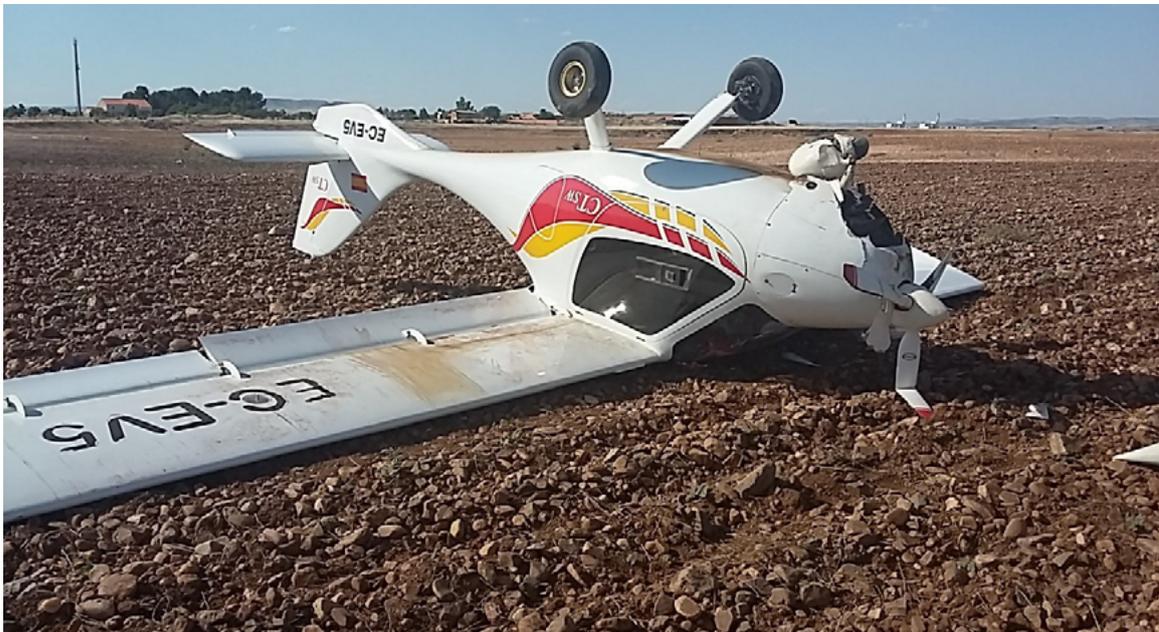
Figure 1. Condition of the aircraft

After applying the brakes, the aircraft exited the end of the runway and went into the adjacent field, which had recently been plowed. The ground was soft and the furrows were perpendicular to the runway heading. As a result, after traveling about 30 m, the nose gear collapsed, driving the propeller into the ground and causing the aircraft to flip over.

The aircraft sustained significant damage, primarily to the lower front part of the fuselage, the landing gear and propeller.

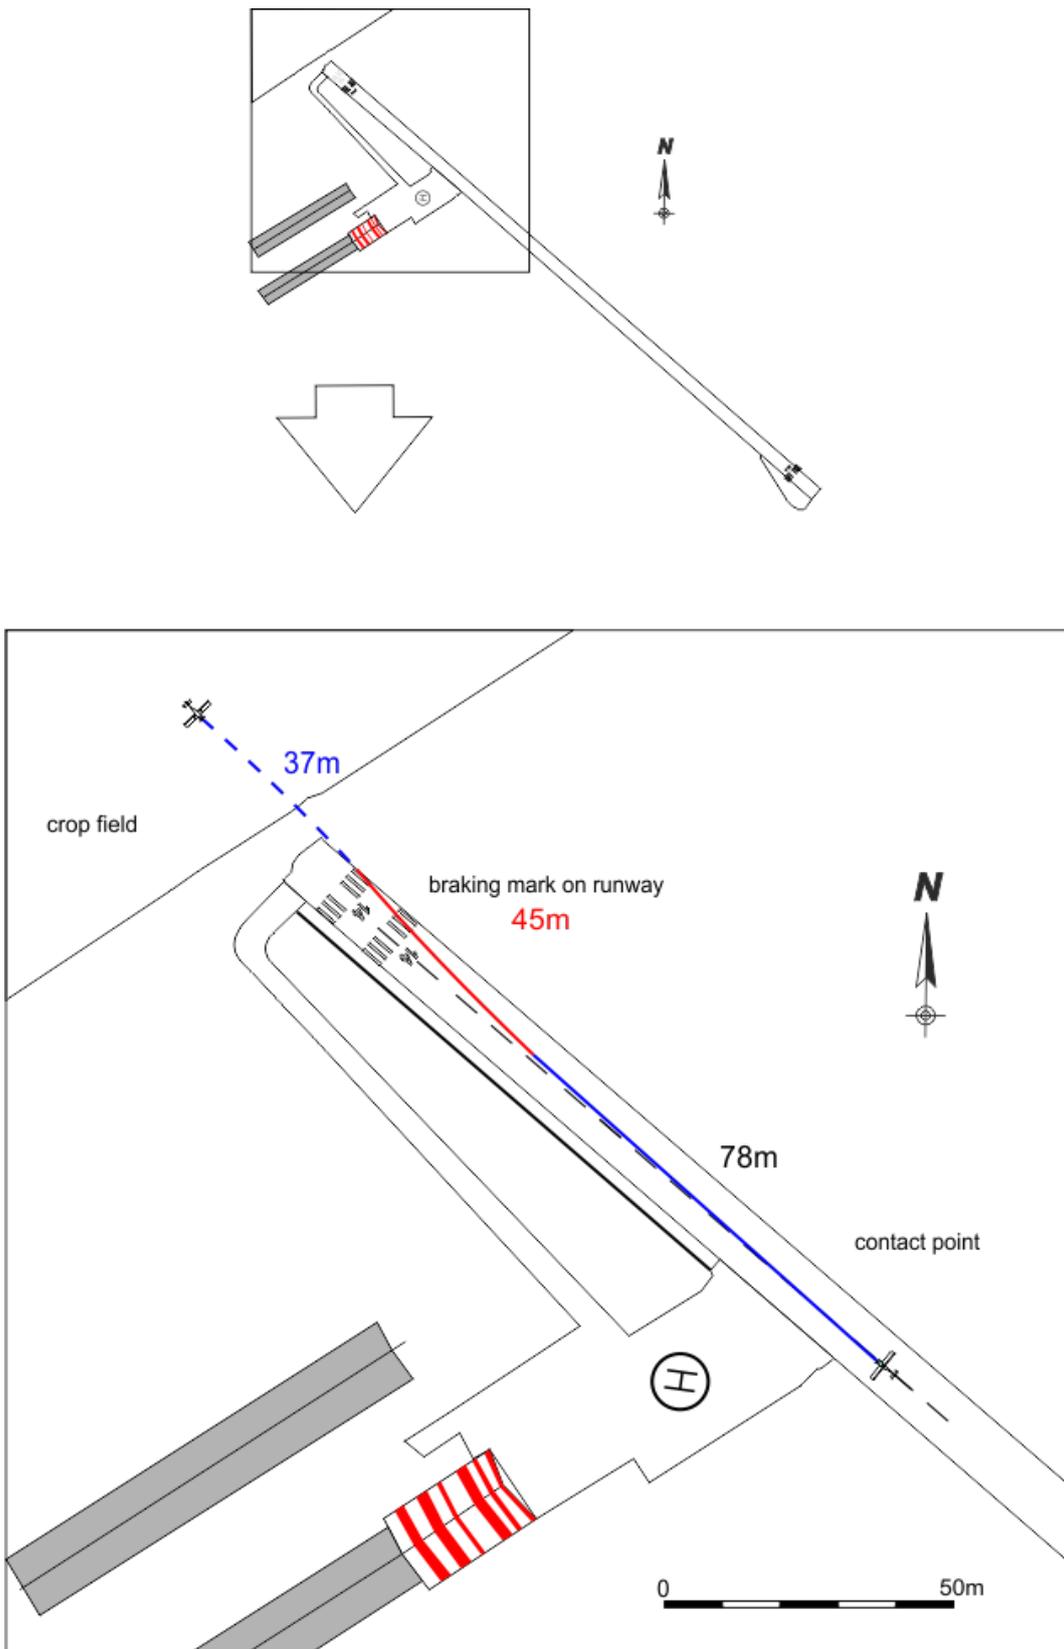
Figure 2. Diagram of the tracks and location of the aircraft

The aircraft stopped 37 m beyond the end of the runway in an adjacent crop field. It was inverted, with the nose facing in the opposite direction of the approach.

The aircraft touched down in the final third of the runway. It traveled along the centerline for 78 m. After this, two 45-m parallel tracks were observed on the asphalt that continued until the right shoulder at the end of the runway.

From that point on, outside the runway and on the crop field, there were two parallel tracks that traveled for 37 m, ending at the final location of the aircraft.

The pilot's statement and an analysis of the wreckage and of the tracks on the ground indicate that the aircraft contacted the runway near the exit taxiway, past the two-thirds point with only 123 m of runway remaining. For the first 78 m, the aircraft traveled along the runway centerline and then, as shown by the tracks on the asphalt, the brakes were applied as the aircraft veered to the right for 45 m before going off the far right corner of runway. It then traveled a further 37 m over the adjacent terrain until the nose gear collapsed, causing the aircraft to turn over.
