REPORT

ULM A-005/2018

Accident involving a FLIGHT DESIGN CTSW, registration EC-LXE, in Gurrea de Gállego (Huesca, Spain) on 3 March 2018

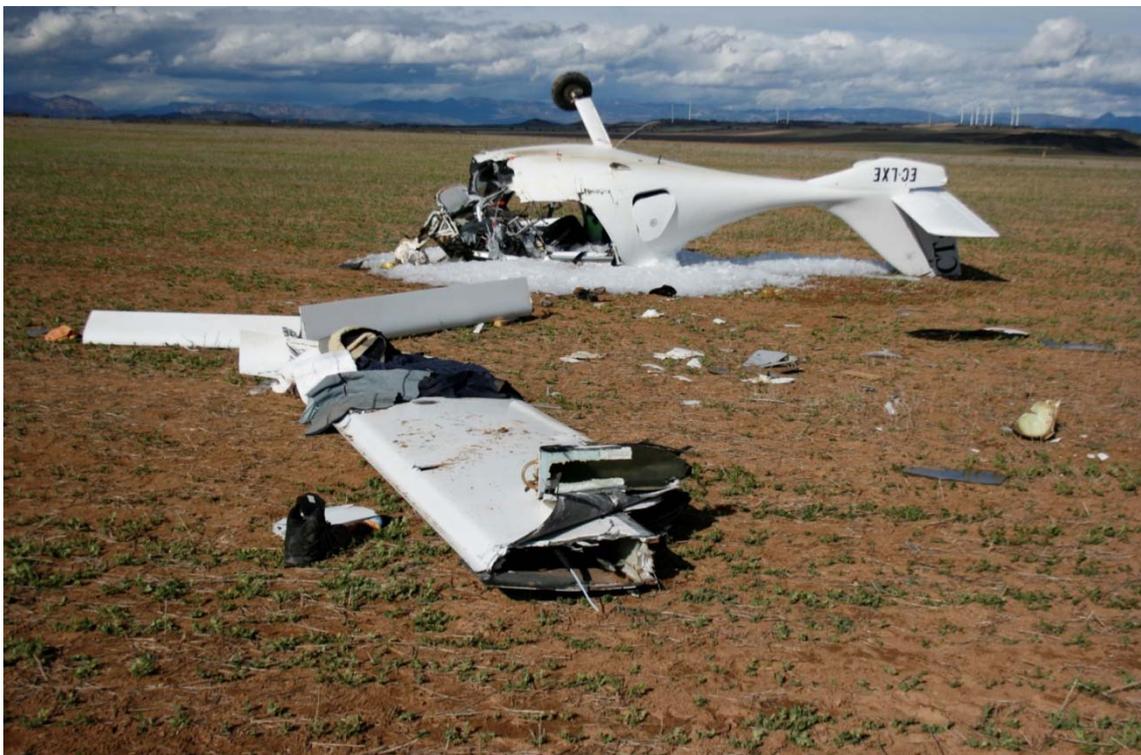
Figure 1. Final position of aircraft

The aircraft crashed in farmland next to the aerodrome, some 100 m to the right of runway 30. The impact caused an initial mark, made by the right wingtip, some 85 m away from the runway centerline. Eight meters north of this mark was another impact mark made by the bottom of the cabin. The aircraft came to a stop in an upside-down position 16 m north of this second impact mark.

The aircraft came to a stop in an upside-down position facing approximately northwest. Since it was leaking fuel, it was covered in foam by firefighters so as to prevent a potential fire.

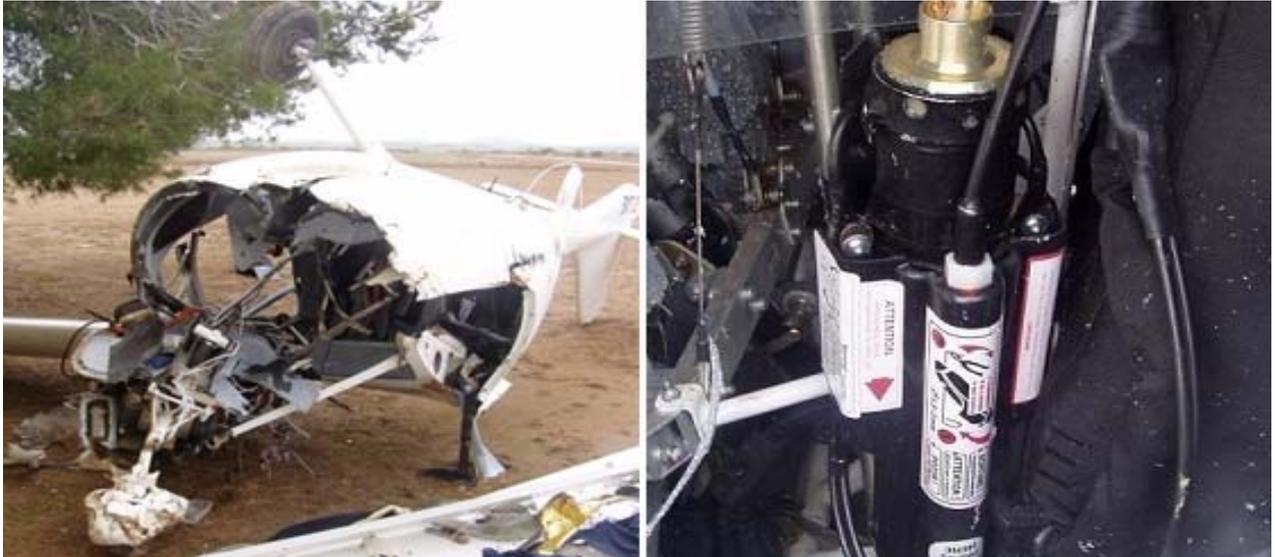
Figure 2. Final condition of aircraft and ballistic parachute

The propeller blades had been fractured by the impact with the ground and the right wing had detached.

The engine mount was broken, which shifted the engine from its position and damaged multiple components. The control panel in the cockpit was also shifted and damaged.

Due to their condition, the continuity of the controls could not be verified. The aircraft was also equipped with a ballistic parachute, which did not detonate.

Figure 2 shows the condition of the aircraft after the accident, with the cockpit destroyed due to the impact with the ground, and the installed ballistic parachute system.

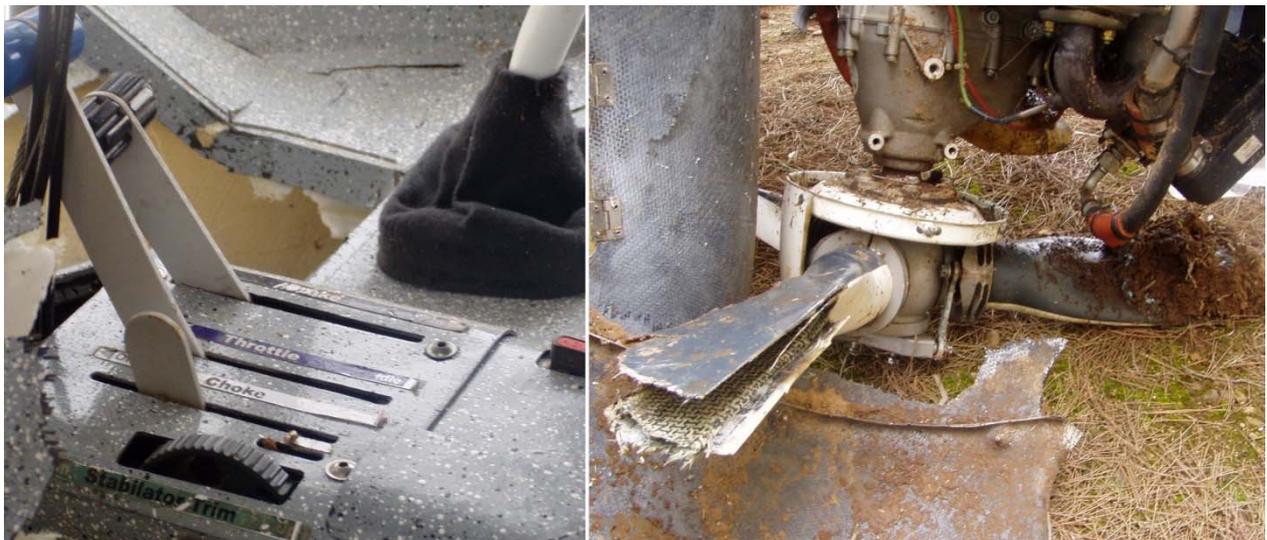
Figure 3. Lever positions in cockpit and propeller blades

The throttle and mixture controls were set full forward. The images in Figure 3 show the positions of the levers in the cockpit, as well as the condition of the propeller blades.

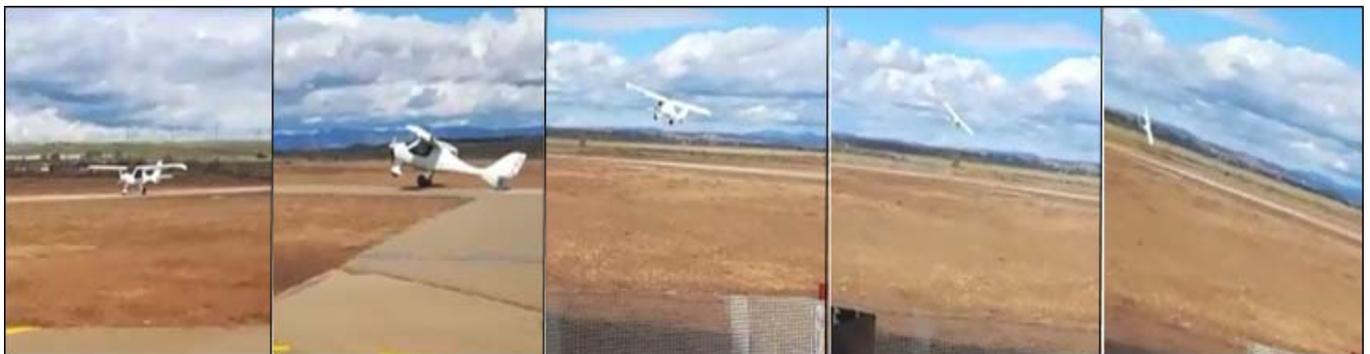
Figure 4. Initial climb and stall

The aircraft taxied to the runway 30 threshold and, after lining up, the pilot immediately began the takeoff run. The aircraft rotated after traveling approximately 80 m from the threshold. As the aircraft climbed, it turned right and then lost altitude, eventually impacting in the plot next to the airfield.

Figure 4 contains five frames that show this sequence, from the start of the climb until just before the impact.

The last frame shows how, just before impact, the aircraft was in a sharp right-bank attitude. The initial contact with the ground was with the right wing, with the airplane eventually coming to a stop in an upside-down position 24 m away from this initial impact mark.

The video recorded by the eyewitnesses allowed investigators to determine that the rotation was started after traveling about 70-80 m from the runway threshold. Immediately after starting the climb, the aircraft began an uncommanded right turn. This was caused by having taken off at a speed that was too low for the aircraft's weight, which resulted in insufficient aerodynamic control of the aircraft. This, in turn, caused the pilot to lose control of the aircraft. The wind conditions present at the airfield induced the aircraft to deviate, which resulted in the uncommanded turn to the right of runway 30.

When the aircraft turned right, influenced by the crosswind from an approximate direction of 200-210°, which then transitioned into a tailwind, the situation worsened, causing the stall that resulted in the airplane's impacting the ground with a right-bank attitude.
