Report

ULM A-010/2019

Accident involving a TL Ultralight TL-96 Star aircraft, registration EC-DS5, at the aerodrome of Mérida-Royanejos (Badajoz) on 8 June 2019

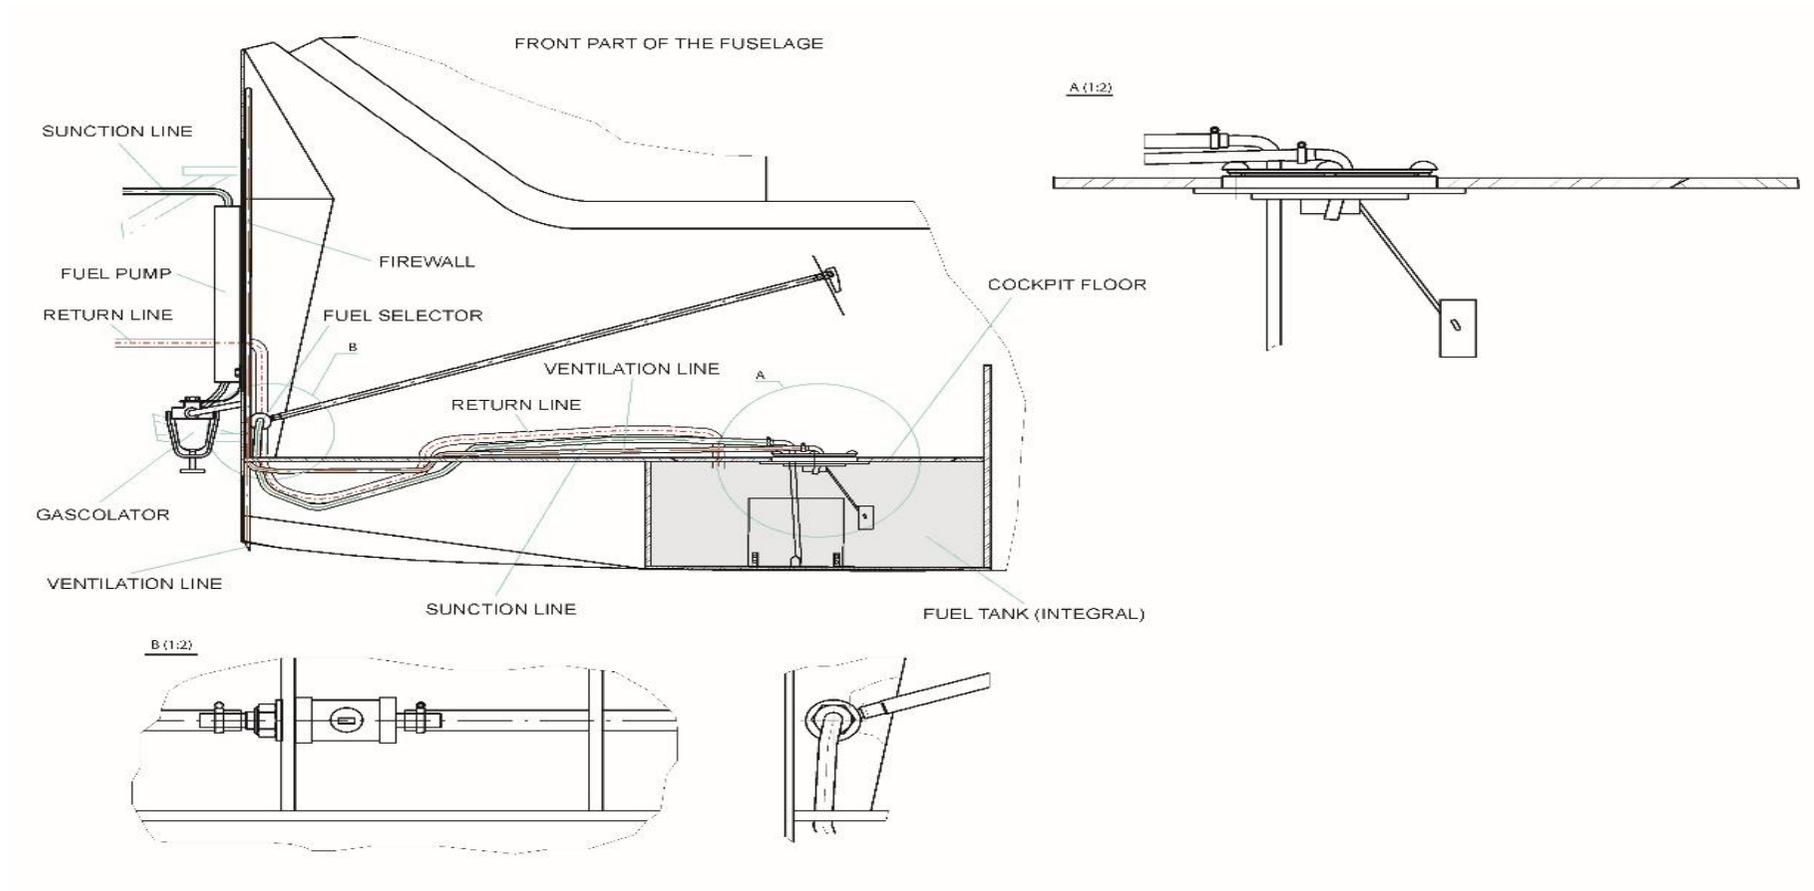
Illustration 1: Diagram of the fuel system installed by the aircraft manufacturer

The aircraft manufacturer stated that there are several couplings and ventilation lines in the floor at the front of the cockpit. The fuel return line is also in this area. These lines are located at the center of the fuselage (widthwise) and covered with a console, the inside of which is made of composite materials. The pilot indicated that the console installed in its aircraft partially covered the lines.

It stated that it was difficult to ascertain where the fuel leak may have originated. It could be that a connector in one of these lines was in bad condition, broken or that the rubber on the lines was old. It added that it could not find any cases in its record similar to this one.

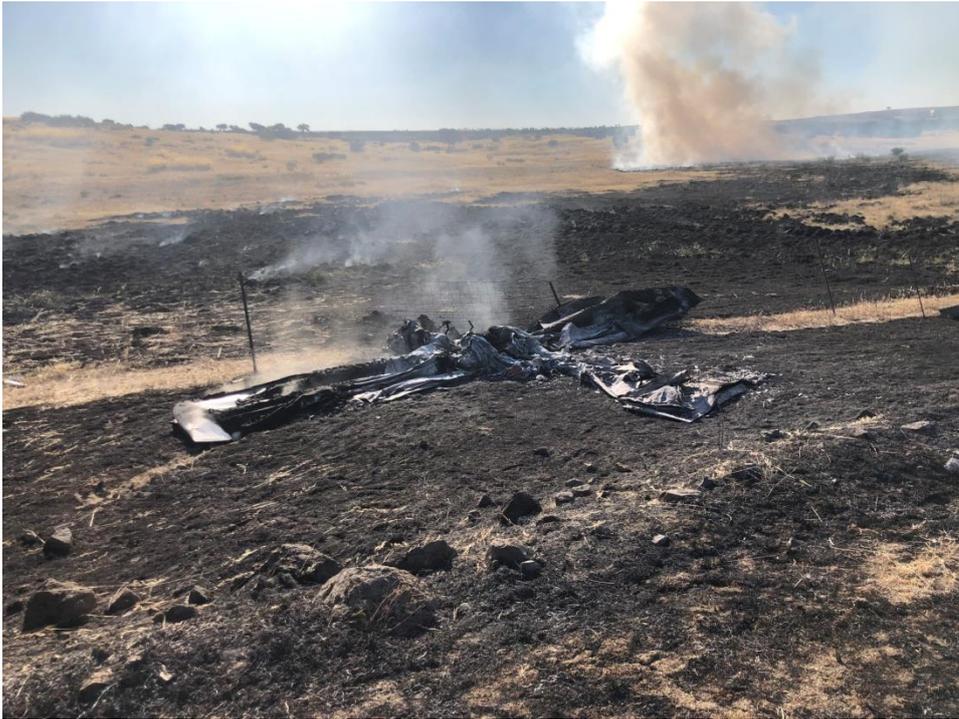
The wreckage of the aircraft was found in the vicinity of the fence that surrounds the aerodrome of Mérida-Royanejos, in Badajoz. The aerodrome fence helped stop the aircraft. The impact with the fence and with rocks near the fence caused the aircraft, which was loaded with fuel, to burst into flames.

Illustration 2: Wreckage of aircraft on wheat field
