Final Report

ULM A-020/2018

Accident involving an Aerospool Dynamic WT9 aircraft, registration D-MEFU, in Valdecebro (Teruel, Spain) on 22 November 2018

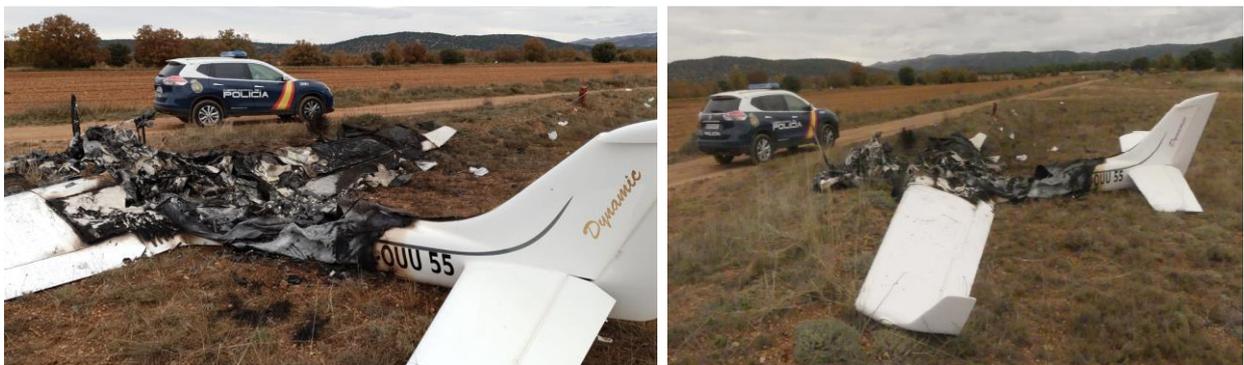
- They found the wreckage of an aircraft on an old, disused landing strip. It was near one end of the strip. The wreckage was on top of a metal cable that was attached at both ends to metal posts.
- At the end of the strip there were two thick, metal posts (some 80 cm tall) that were anchored vertically to the ground and joined by the metal cable to prevent access to the property.
- One of the two metal posts had been torn from its anchorage.
- The aircraft wreckage, almost completely charred, was near the place where the metal posts were anchored. The registration marking OK-OUU 55 was visible on one wing, and the word “Dynamic” was visible on the vertical stabilizer.

Fig. 1: Photographs of the aircraft after the accident

The aircraft was almost completely burned, with the exception of much of its left wing, the rear part of the aircraft and the tail section.

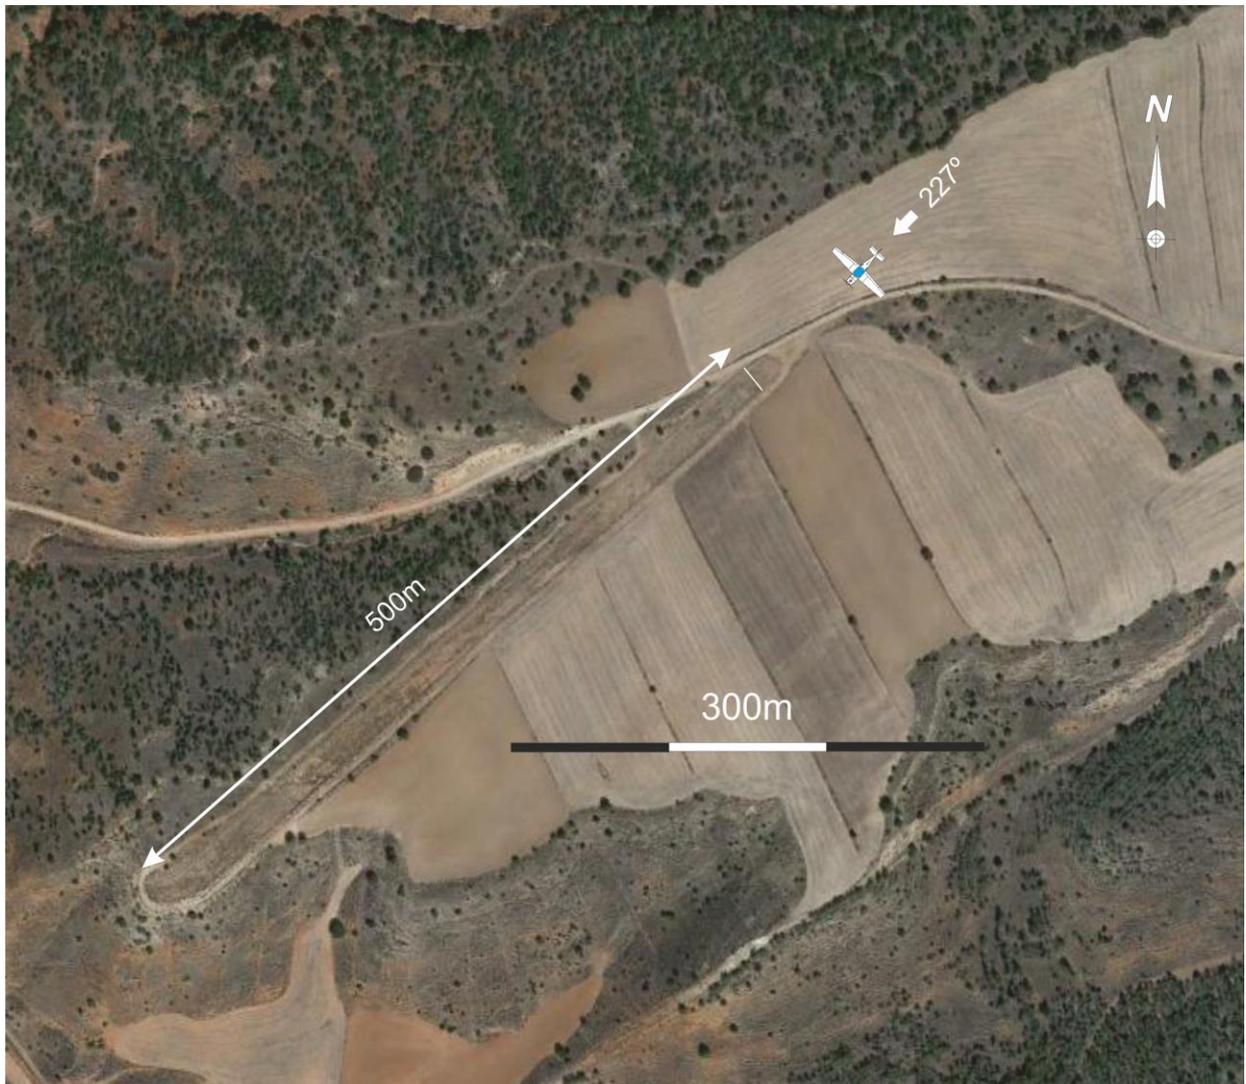
At what would be the northeast threshold of the runway there were two metal posts anchored to the ground. Hanging from their top ends and connecting the posts was a thick, metal cable, attached to the posts using eyelets. The posts were about 15 m apart, spanning the width of the strip, and were intended to keep vehicles from entering it.

Fig. 2: Aerial image of the property and position and heading of the aircraft on its final approach

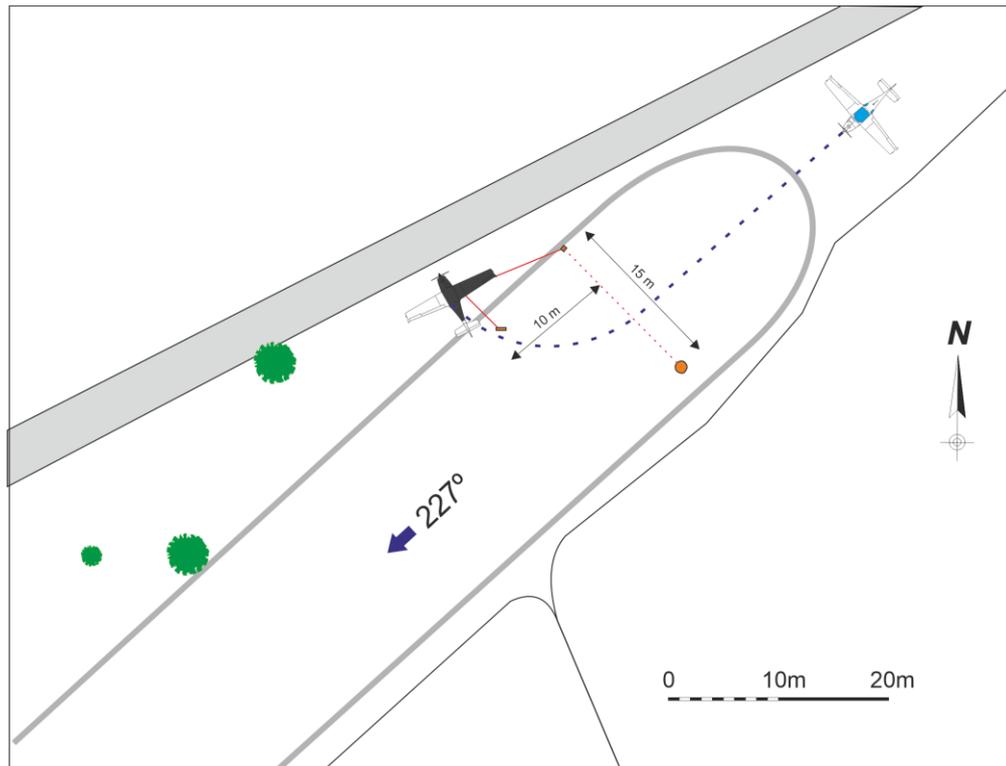
Some 10 m away from the two posts, on the landing strip proper, next to the nearby path, was the aircraft, with part of the propeller and the engine at the boundary between the path and the small mound that serves to separate the two areas, and which stopped the forward motion of the aircraft as it landed. The right wing was angled toward the northeast and the left wing toward the southwest.

Fig. 3: Diagram showing position of aircraft wreckage

The impact occurred as the aircraft was landing on a southwesterly course (approximately 227°), when its main gear was entangled in the strong, metal cable that was used to close off the property.

As a result of this contact, the left post (in the forward direction of motion of the aircraft) was ripped out, which caused the aircraft to travel in a semicircular motion, anchored around the fixed right post (which remained in place), before coming to a stop against the small mound that separated the runway from the adjacent path.

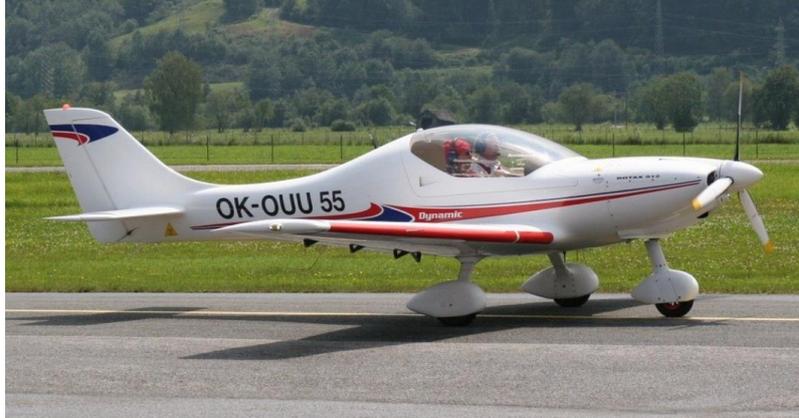
Fig. 4: Aircraft OK-OUU 55

The German police confirmed that this aircraft was at the aerodrome of Reidelbach (Germany), and also verified that this aircraft looked different from the one found in Valdecebro, both in terms of its color and the shape of the wings (specifically, the accident aircraft had winglets, and the one in Germany does not).

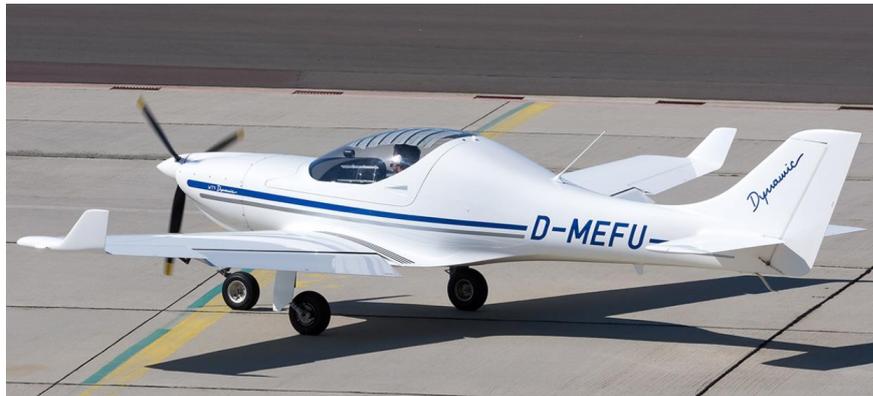
The photo below shows the winglets, which match those found on the accident aircraft.

Fig. 5: Aircraft D-MEFU
