Report on the investigation of the
grounding of
Muros
Haisborough Sand
North Sea
3 December 2016

SYNOPSIS

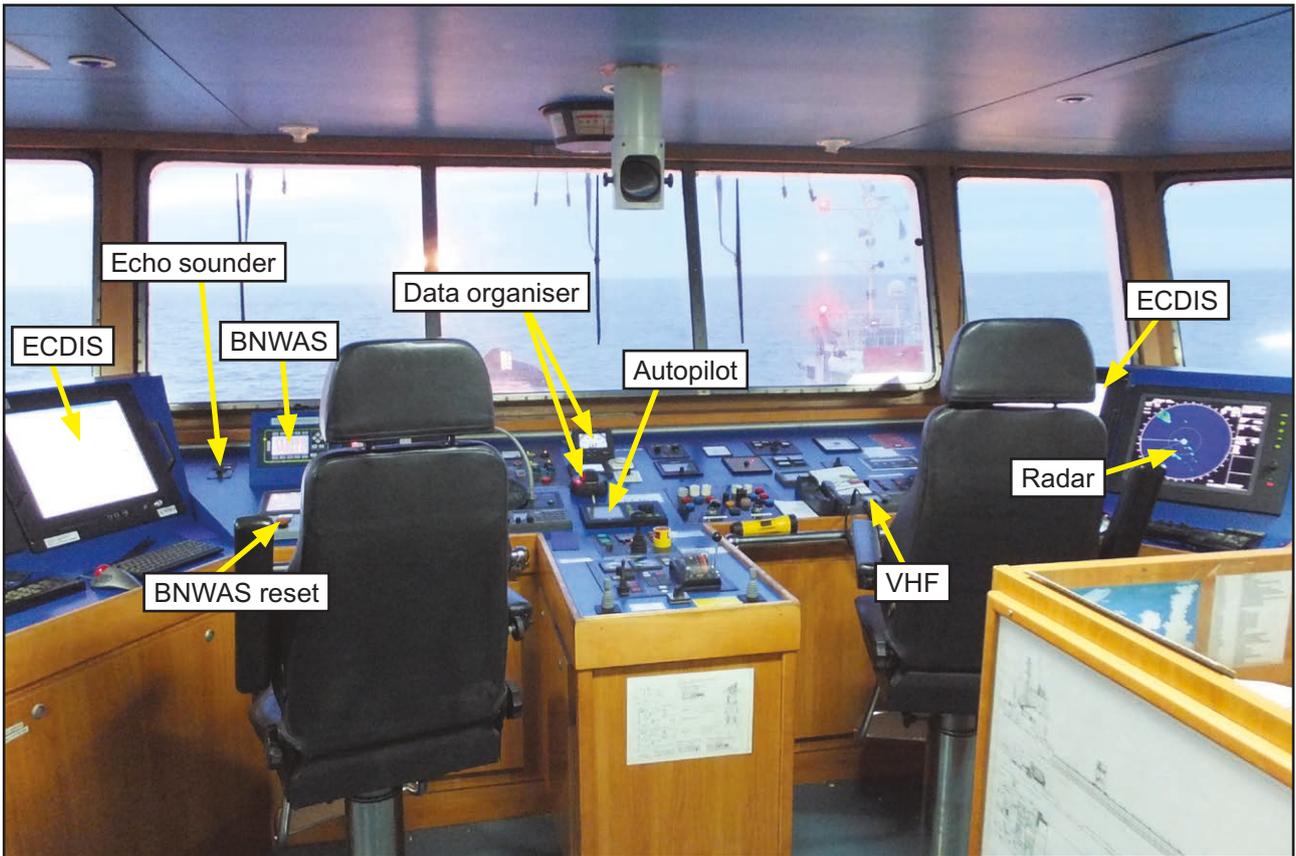
Figure 2: Bridge layout

The 2/O amended the passage plan on the ECDIS at the starboard bridge conning position (**Figure 2**) and at 0025 she adjusted the vessel's heading set on the autopilot to 140° to follow the revised track (**Figure 3**). The 2/O then sat in the starboard chair. The lookout alternated between standing on the bridge's port side and sitting in the port chair. He routinely reset the BNWAS.

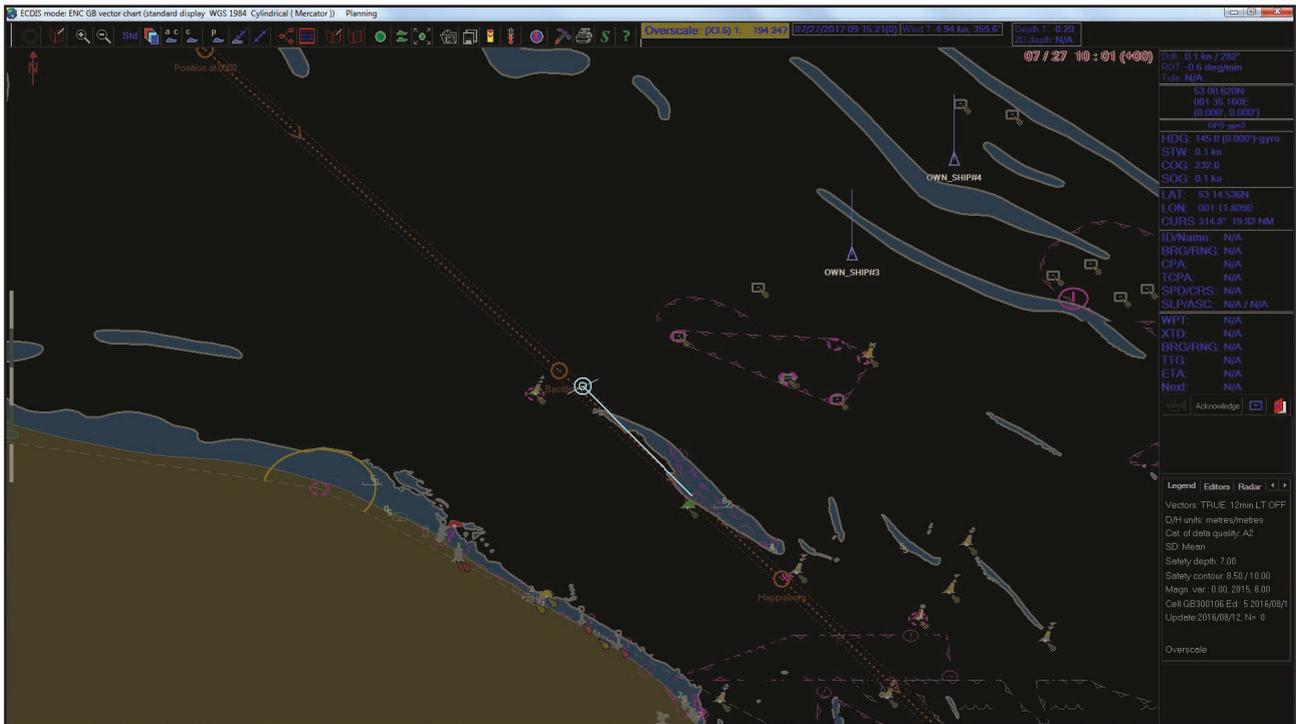
Figure 4: Reconstruction of ECDIS display at 0208

Over the next 1½ hours, the bridge watch remained very quiet with only a few other vessels in the vicinity. At 0208, *Muros* was 600m to the north-east of the revised track and was making good a speed of 10.1kts when the 2/O adjusted *Muros*'s heading to 146° towards waypoint 'Happisburg' to the south of Haisborough Sand (**Figure 4**).

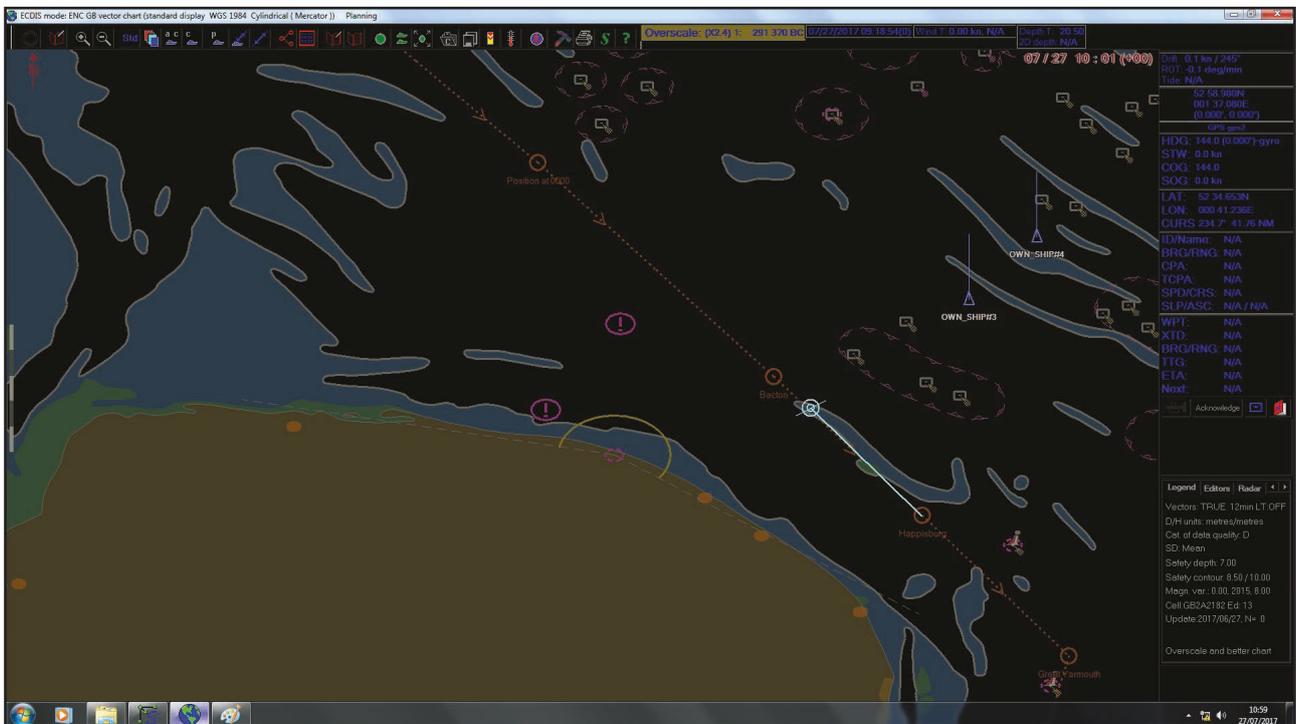
Figure 5: Reconstruction of ECDIS display at 0220

At 0220 (**Figure 5**), the 2/O noticed that *Muros*'s speed shown on the ECDIS display had reduced to 9.1kts. She thought this was unusual as there had been no change in the wind or sea conditions. At 0248 (**Figure 6**), the 2/O felt a change in the vessel's motion and saw its speed quickly reduce. In response, she selected manual steering. The 2/O also called the master and informed him that the vessel's speed was only 0.8kt, but that she did not know why. The master told the 2/O to inform the chief engineer.

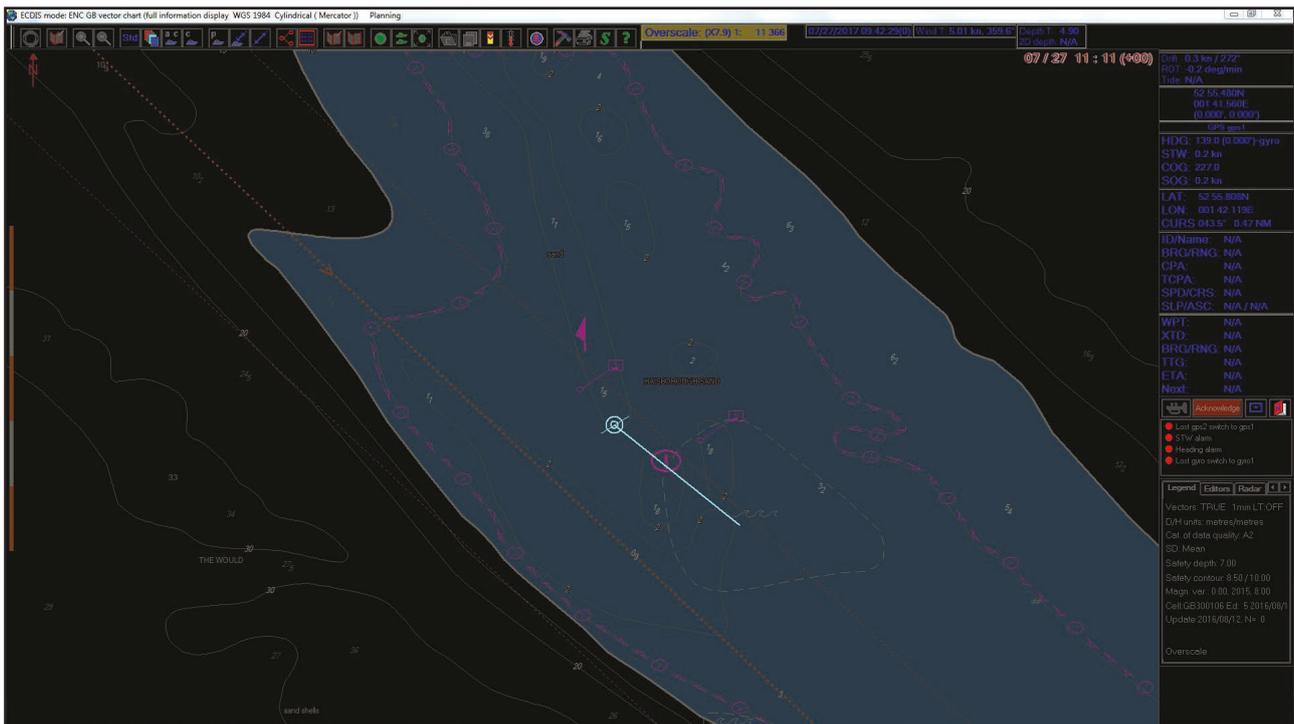
Figure 7: Reconstruction of ECDIS display at 0250 (zoomed in and 'all')

Within 1 minute of being called by the 2/O, *Muros's* master and chief engineer arrived on the bridge. Meanwhile, the 2/O had zoomed in the ECDIS display and changed the chart view from 'standard' to 'all'³, which showed more detailed depth information (Figure 7). The master realised that the vessel was aground and put the engine telegraph control to stop.

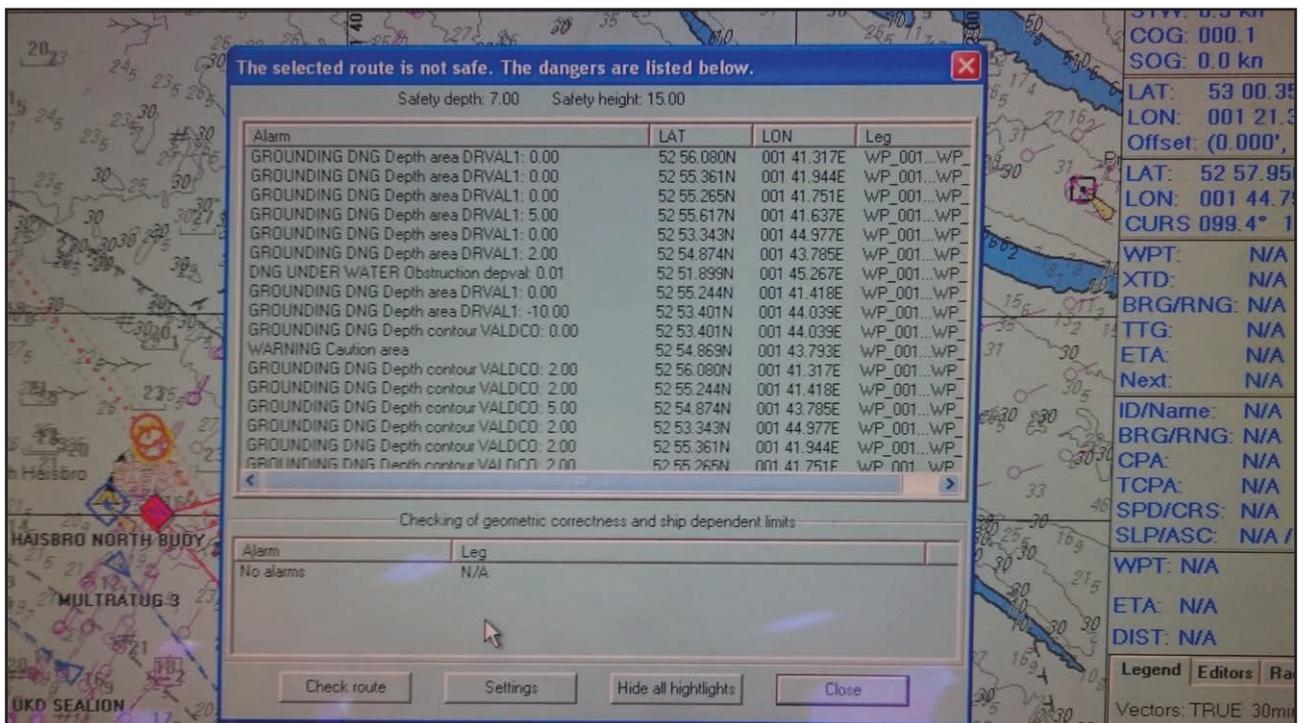
Figure 9: Maris ECDIS900 showing alarms generated on the 'check route' page

When the 2/O had completed her visual check of the revised route, she saved it as a new route in the ECDIS and printed a copy of the plan. On saving, the ECDIS automatically executed its 'check route'⁹ function and many potential charted hazards along the route were displayed. However, the 2/O was aware that the 'check route' function had checked the whole of the route from the berth at Teesport to the berth in Rochefort, and she assumed that the hazards were concentrated in the pilotage areas. The 2/O cleared the window showing the hazards, set the new route as the active route and returned the starboard ECDIS to 'monitoring' mode. The 2/O signed the printed copy of the passage plan and placed it in the chart and radio area at the rear of the bridge.
