## CIAIM REPORT 21/2018

### Collision between the ships FANTASTIC and VIKING STAR at the Port of Barcelona on 12 January 2018

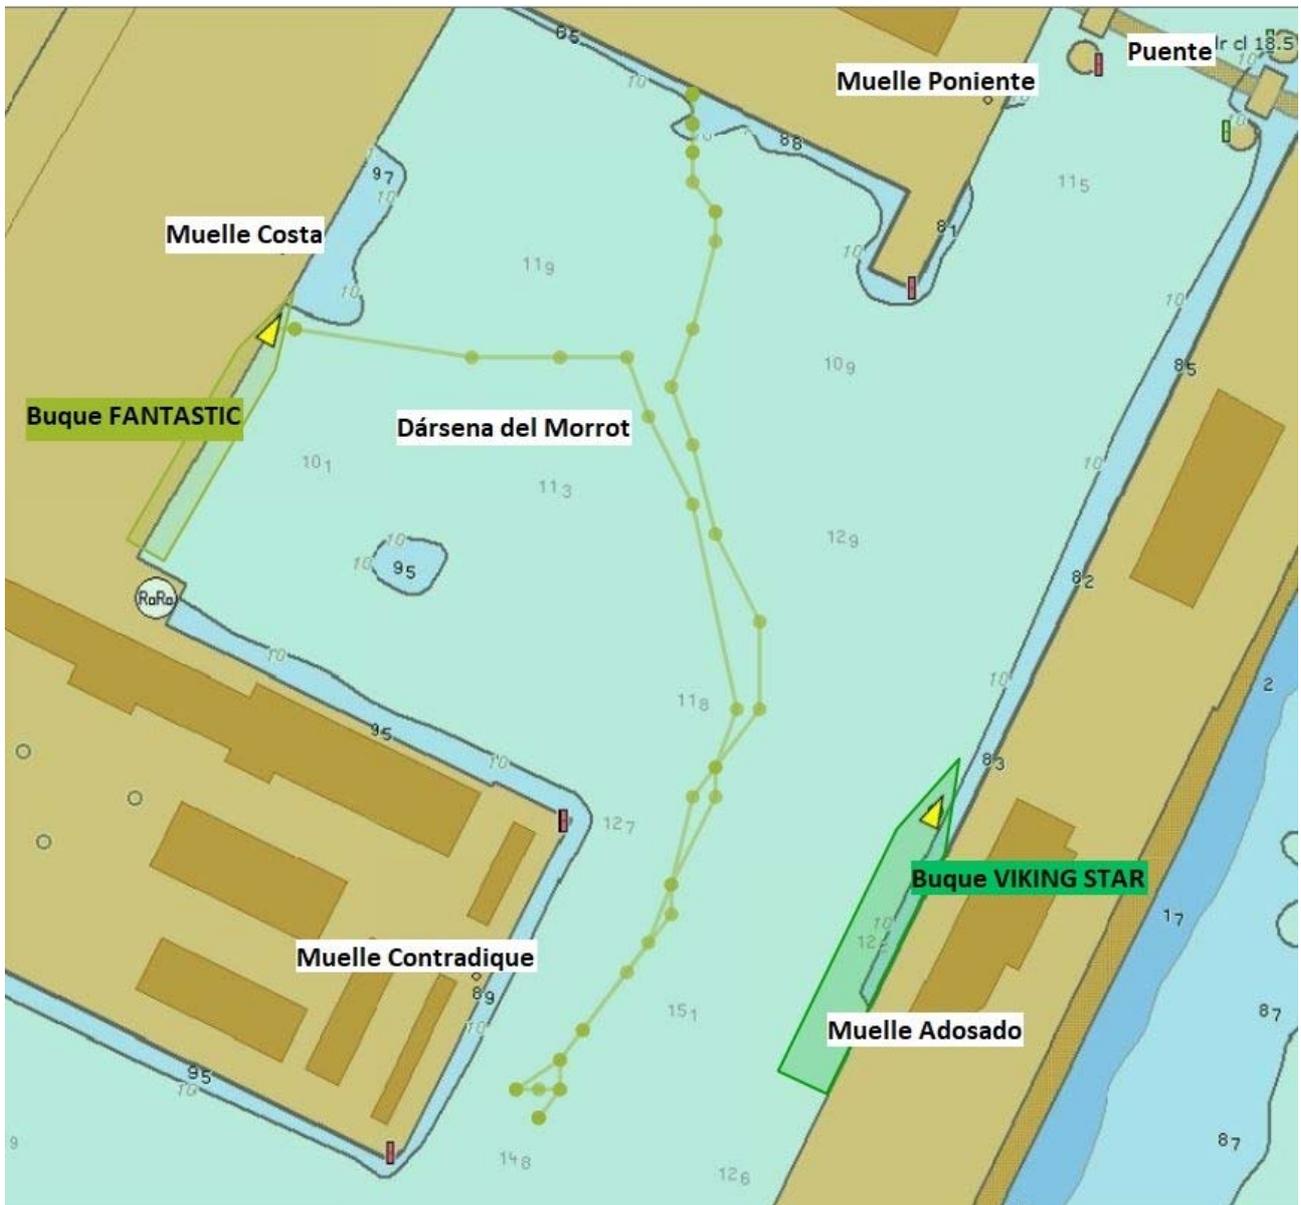
Figure 5. Maneuver performed by the FANTASTIC ro-pax vessel

At 12:00, the electric plant went offline, which immediately caused the main engines to stop, leaving the ship unable to maneuver. The FANTASTIC was in the channel<sup>1</sup> formed by the Contradique and Adosado harbors. By that point it had completed its turn, but the inertia kept the bow turning to starboard. Its speed was approximately 2 knots.

At 12:06, the pilot ordered the port anchor dropped to keep the FANTASTIC from continuing to advance and colliding with the Contradique harbor. But due to the ship's inertia and to having dropped the anchor, the ship started to turn about the anchor, with the bow drifting to port in the direction of the VIKING STAR.

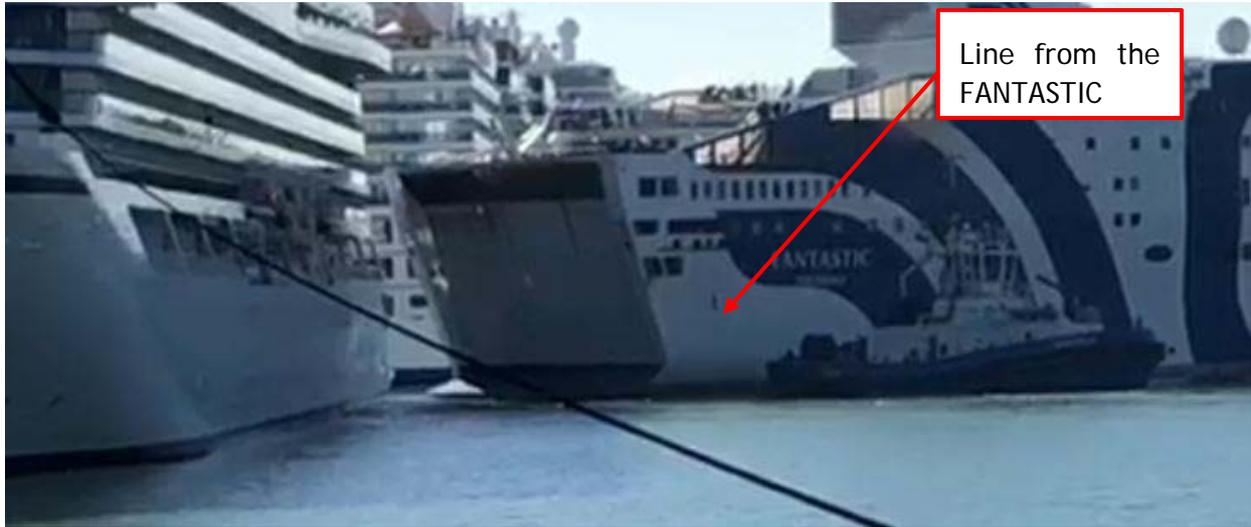
At 12:12, the port quarter of the FANTASTIC impacted the port quarter of the VIKING STAR (Figure 6). The collision removed paint from a 50-cm section of the air draft of the FANTASTIC. A 1-m section of a balcony in the air draft of the VIKING STAR was dented (Figure 7).

At the time of the collision, the tugboat MONTALT, despite being alongside the starboard quarter of the FANTASTIC, had not managed to fasten any lines (Figure 6).

Figure 6. Seconds prior to the collision between the ships

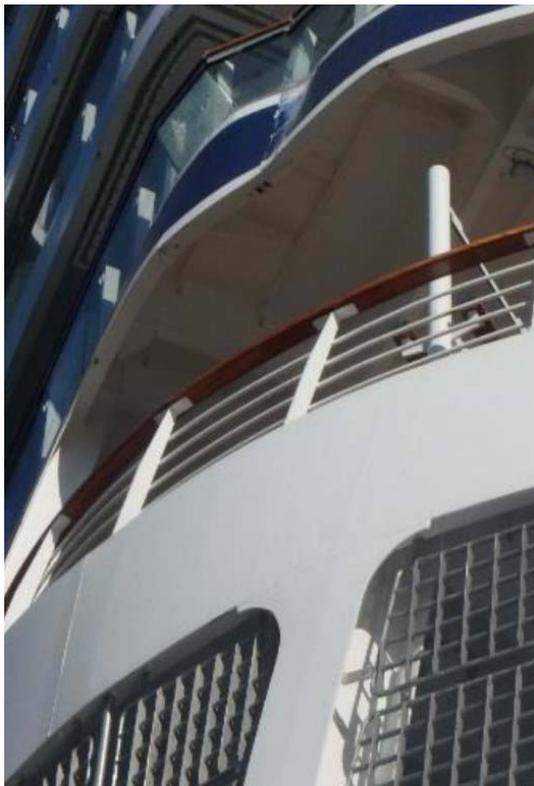
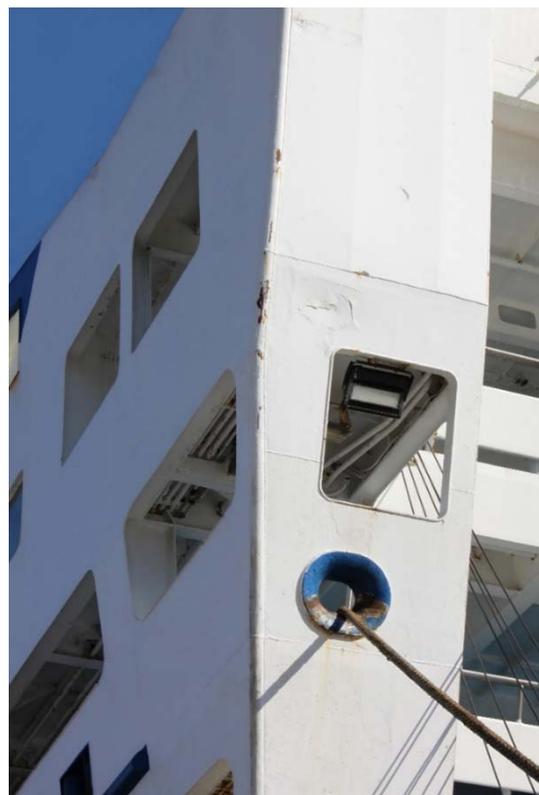
Figure 7. Damage to the VIKING STAR (left) and FANTASTIC (right)

The hull was also inspected to verify the damage sustained by the superstructure. Scratches were found on the plates between decks 5 and 6. No deformations or fractures were found.

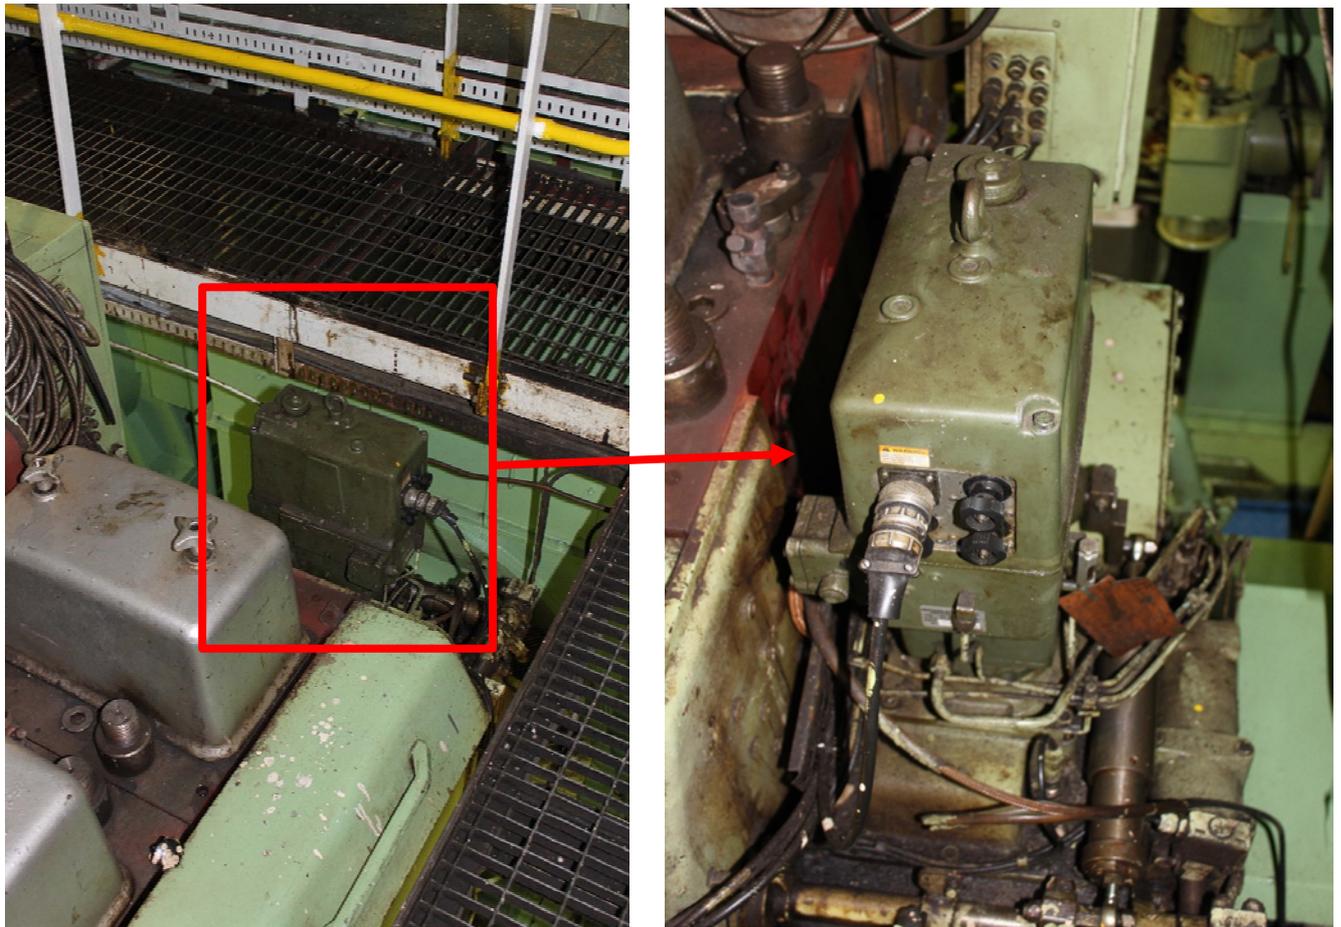
Figure 8. Woodward mechanical governor

According to the chief engineer, the blackout was caused by the failure of the speed adjusting motor on the mechanical governor (see Figure 8) for the #3 auxiliary diesel generator. The failure of the frequency controller caused the Woodward governor to freeze and shifted the load between the three generators. The #3 auxiliary generator had taken up all the load from the two other auxiliary generators. The #1 and #2 auxiliary generators went into reverse power and tripped. The #3 auxiliary generator tripped due to overpower. The electric plant was operating in automatic mode.

This blackout was presumably due to a failure of the speed adjusting motor in the mechanical governor for the #3 generator, a situation that the plant's automatic control system was unable to handle. There is no record to date of this mechanical failure having occurred again.

The speed adjusting motor on the governor for the #3 auxiliary generator was replaced with a spare part available on board. Tests were conducted with auxiliary generators #1, #2 and #3, including load, alarm, safety and automation system tests. During these tests, the electric plant operated correctly.

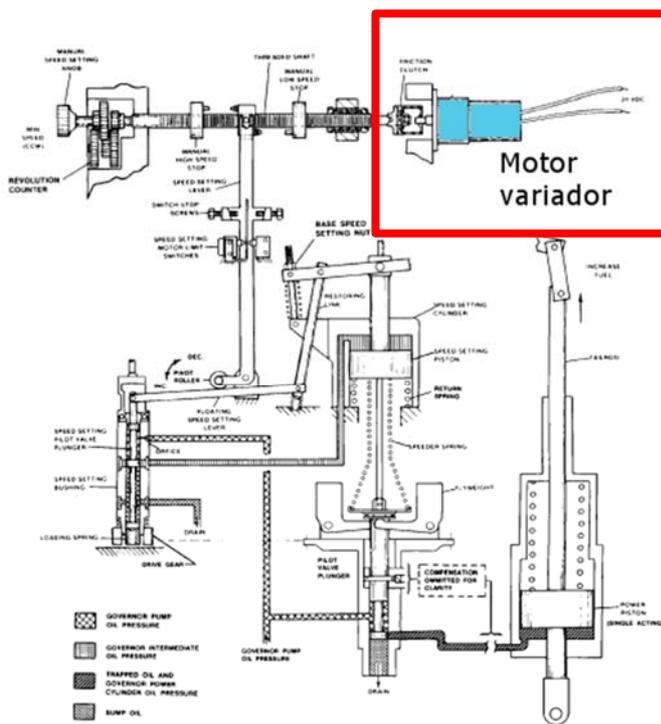
Figure 9. Diagram of the Woodward governor

On the FANTASTIC, load is shared between the generators by adjusting the relevant controls on the Woodward speed governors of the generators, see Figure 9. This adjustment can be made locally at the governor itself, or remotely by using the speed adjusting motor. Therefore, when the speed adjusting motor on the DG3 governor froze, this prevented the crew from adjusting the speed control of the governor remotely, but it did not impede load sharing between the various generators. But for DG1 and DG2 to shed electrical load and go into reverse power, the load sharing has to be adjusted. Since the plant was operating automatically and the governors were not adjusted locally but remotely, the load sharing could only be adjusted if the PMS (power management system) operated the governors during the exit maneuver.
