# **Panama Maritime Authority**

**M/V "CAPE MED" R-071-2014-DIAM**

# REPORT ON THE INVESTIGATION OF THE COLLISION OF

At Algeciras, Spain On the 30<sup>th</sup> May 2014

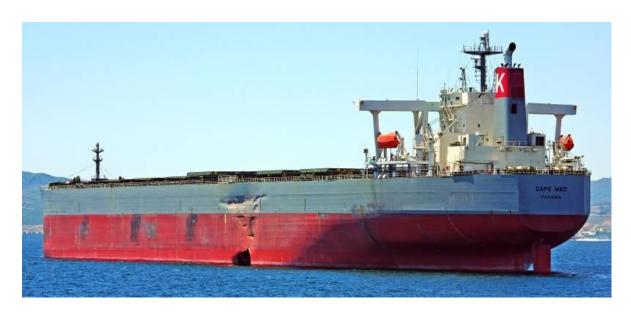
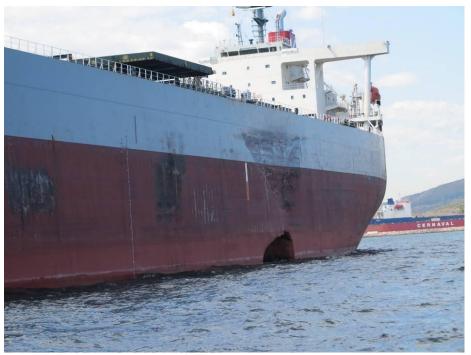
Figure 7.1/7.2

- 4. Hull Damage Impairing Seaworthiness SOLAS Ch. II-21: Hold 7 holed in port side between frames 113 and 112 below water line 196 m draft. About 4 meters in height. Accidental damage after collision with vessel LE SHENG IMO 9177519

- Ballast, Fuel and Other tanks SOLAS II-1: Wing Ballast Tank no. 4 port with plates and stiffeners bent in side shell and upper stool for 20 meters in length. Accidental damage after collision with vessel LE SHENG IMO 9177519

7.1 The CAPE MED sustained damages on her hull in way of hold number 7 between frames 107 and 113 affecting the parallel hull structure and the top side tank no. 4 port.

General view of the CAPE

MED damage on the port side

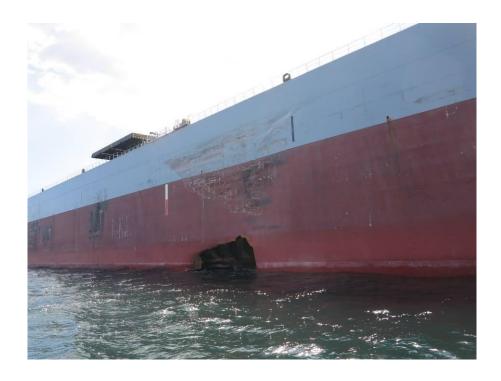
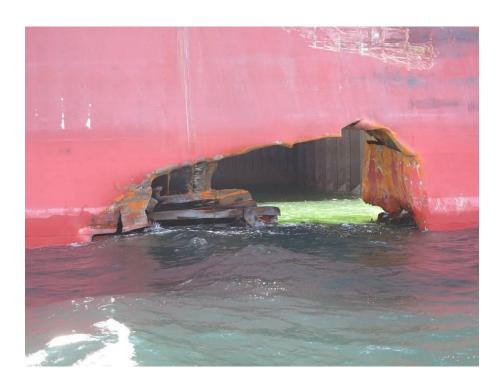
Figure 7.3/7.4 – CAPE MED damage on the port side

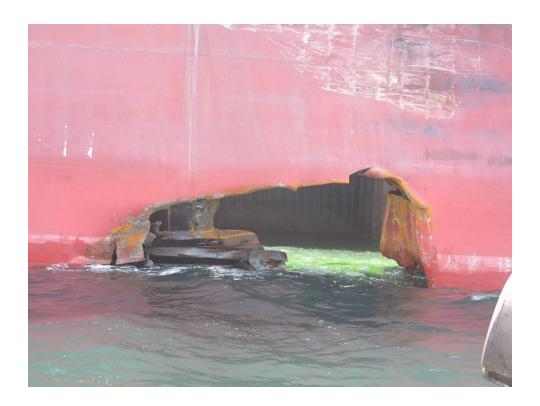
Figure 7.5/7.6/7.7 - CAPE MED damage on the port side

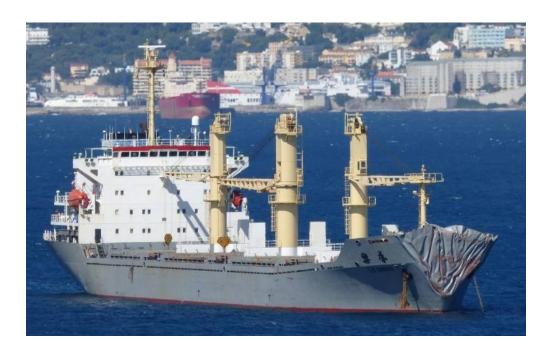
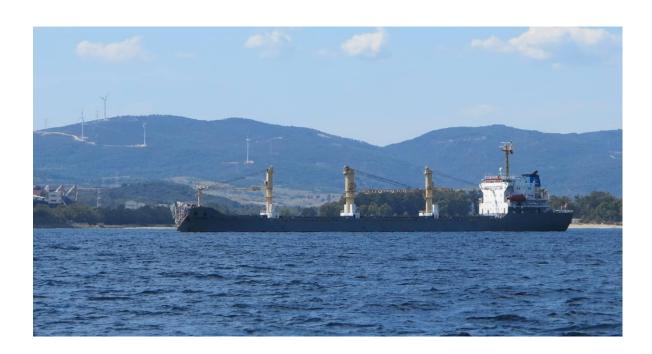
7.2 The LE SHENG sustained damages to the complete fore end including the bulbous bow. But no further details were gathered due to the lack of co-operation with the vessel.

Figure 7.8/7.9 – LE SHENG damages on fore end

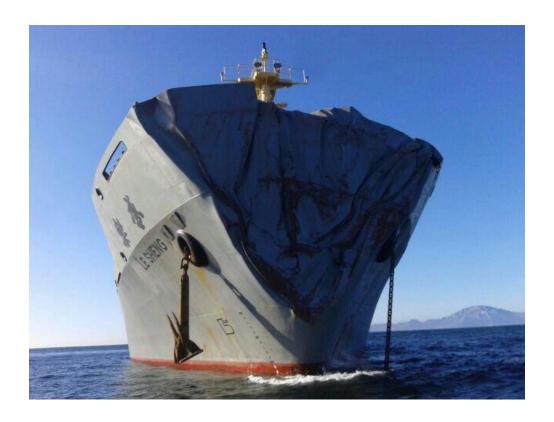
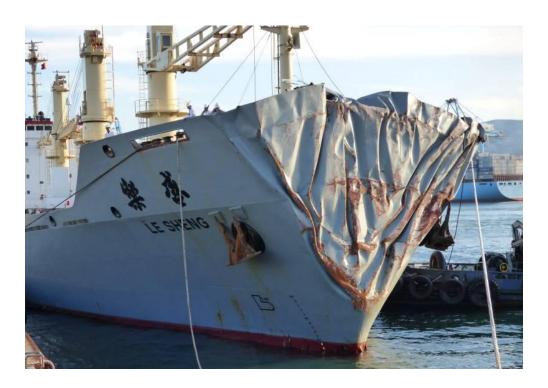
Figure 7.10/7.11 – LE SHENG damages on fore end

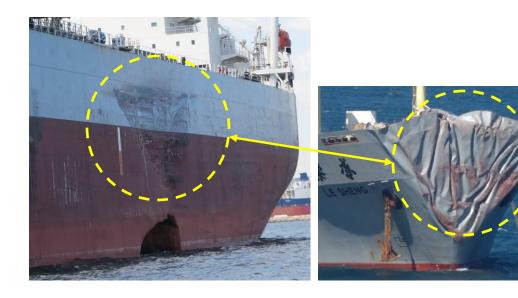
Figure 10.1 – Fore end mark left on the port side hull of CAPE MED
