Report IN-003/2011

Incident involving an Airbus 330,
registration EC-LKE, operated by
Air Europa, at FL240 in the vicinity
of the Toledo VOR/DME (Spain),
on 13 February 2011

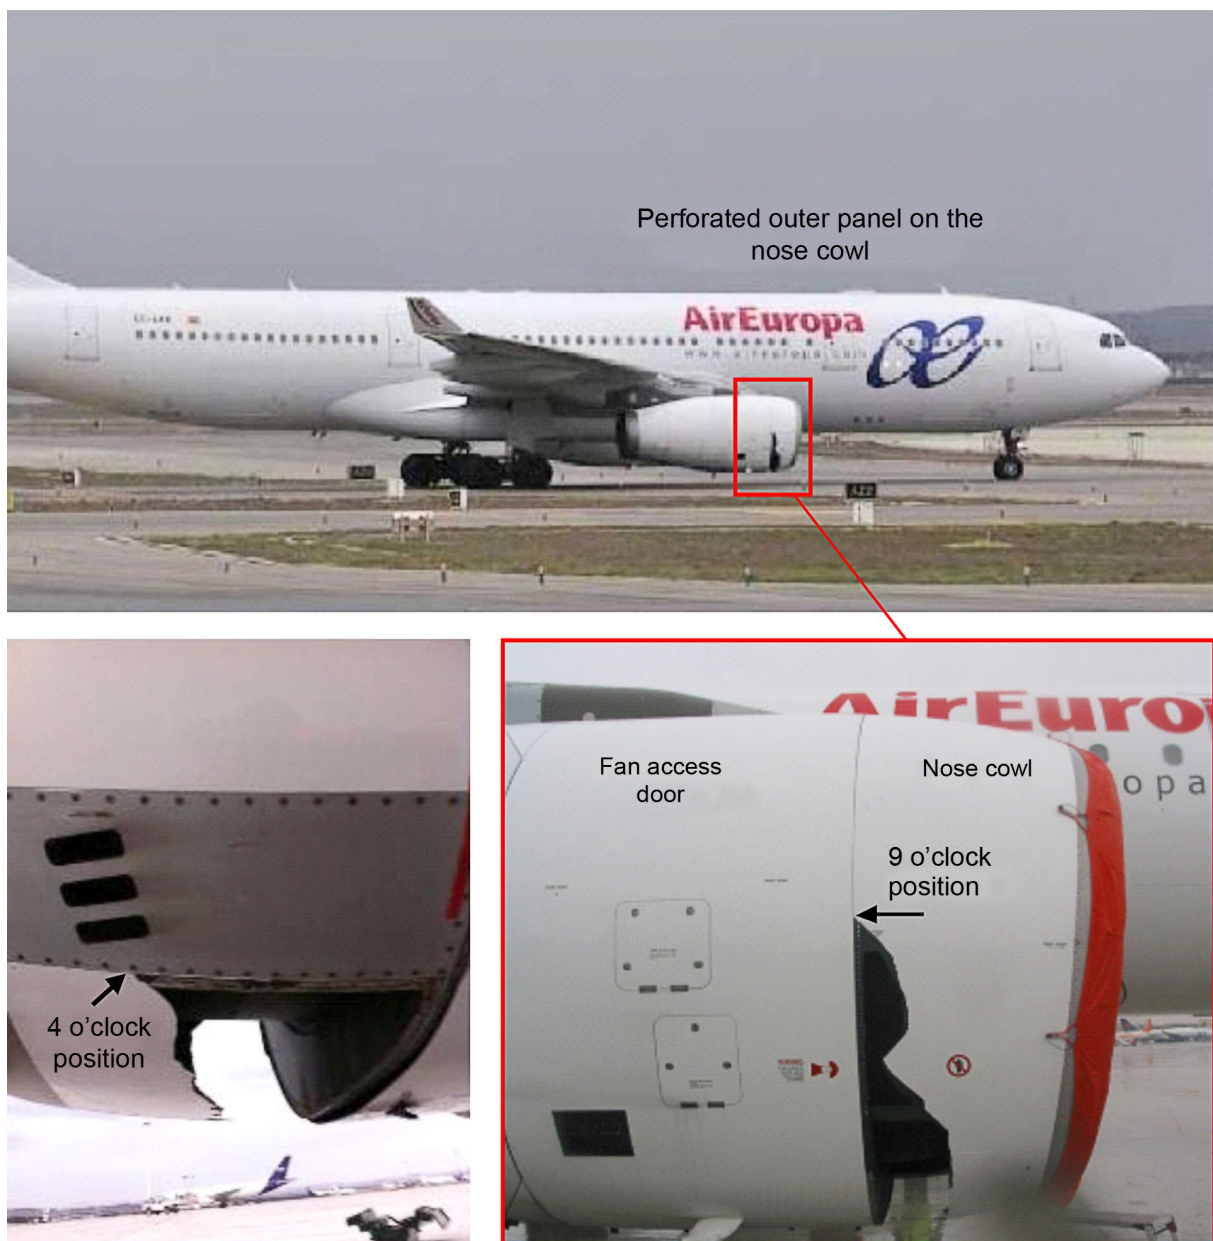
- In the fan blades:
 - About 75% of blade number 4⁶ on the fan was missing. This had been the first blade to fail.
 - About 50% of the trailing blade⁷, number 5, was missing.
 - The remaining blades showed rippling and tearing to varying degrees.
- In the fan case:
 - There was an impact mark at the 2 o'clock position⁸, and a smaller mark at the 3 and 5 o'clock positions.
- In the nose cowl:
 - There was an impact mark with upraised material at the 5 o'clock position, which also affected the fan case.
 - The inner barrel was perforated between the 3 and 4 o'clock positions.

Figure 1. Aircraft after the incident (view from the side of engine n.º 2)

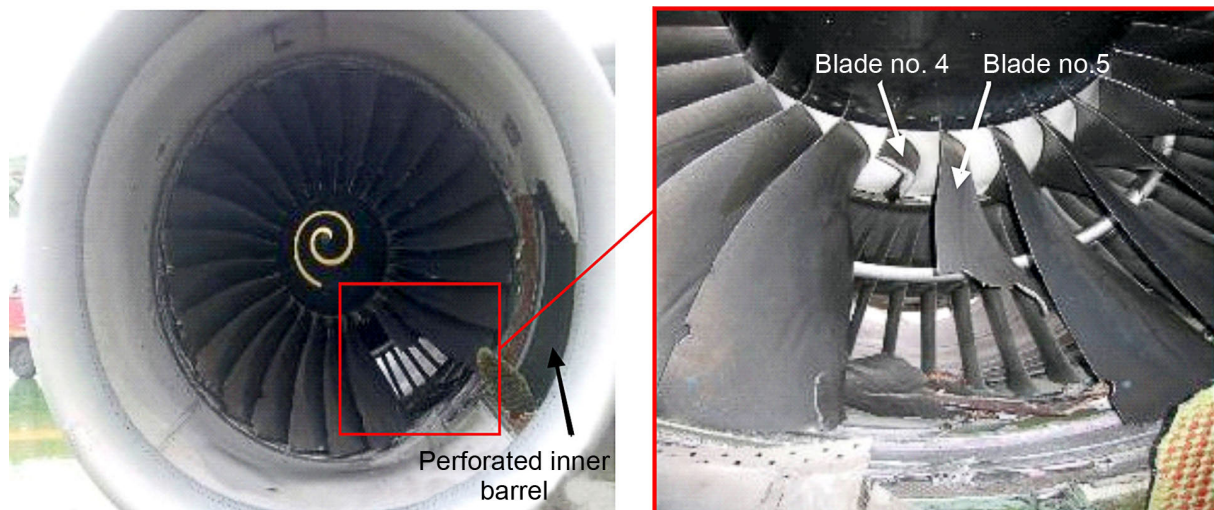
- There was material missing from the outer panel between the 4 and 9 o'clock positions (3.38 m long and a maximum width of 60 cm).
- There had been no loss of fluid or fires in the engine.

Figure 2. Aircraft after the incident (front view of engine n.º 2)

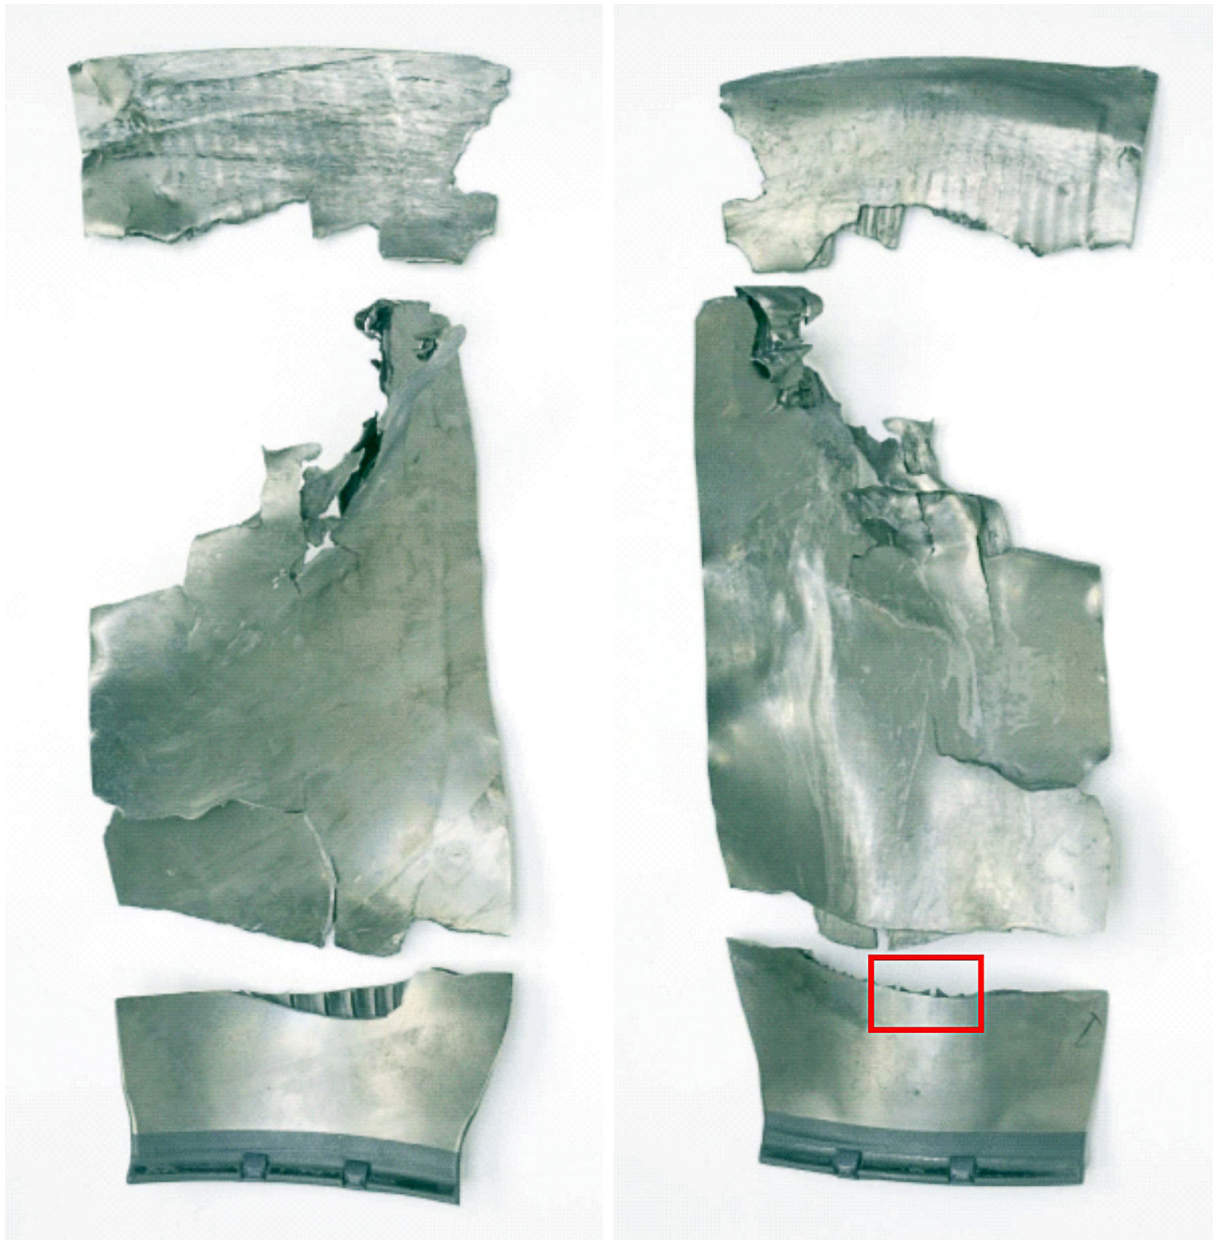
Several fragments from blade n.º 4, but not the entire blade, were recovered during the disassembly and inspection of the engine (figure 6). Of the 9.2 kg that the blade weighs, the fragments recovered weighed 8.3 kg. The blade root was in the best condition, as

Figure 6. Reconstructed blade (left – pressure concave panel, right – suction convex panel)

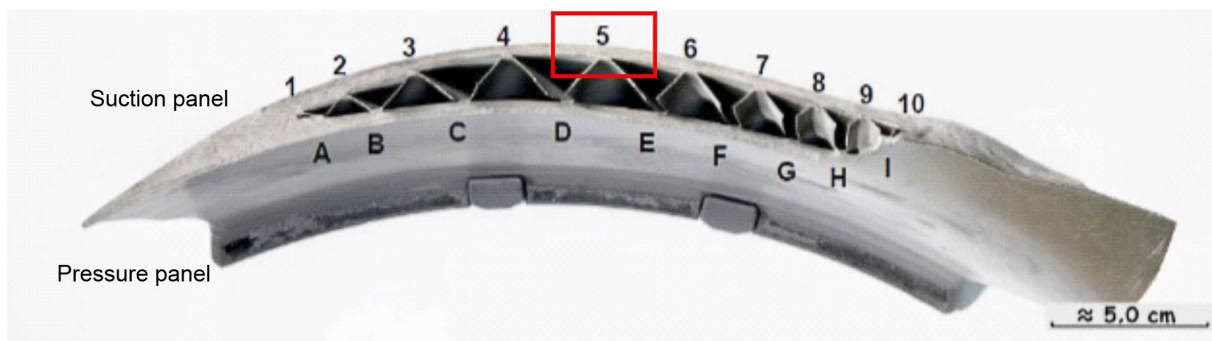
The fracture surfaces (figure 7) on the suction and pressure panels were similar in appearance (coarse and dull), except for the area at bond position³¹ 5. This point was

Figure 7. View of the fracture area at the blade root

on the suction panel, 150 mm away from the blade root and 113 mm from the leading edge. At this position, there was a through-thickness arc of finer textured indicative of fatigue. Clear grey deposits were found in this area, identified as being from the stop-off product used during the manufacture of the blade (see section 1.4.4). After cleaning the area, the fracture surface was analyzed using a scanning-electron microscope (SEM). Only five pockets of striated growth were identified, as well as some small areas of amorphous ductile fracture, consistent with fatigue growth of the crack.

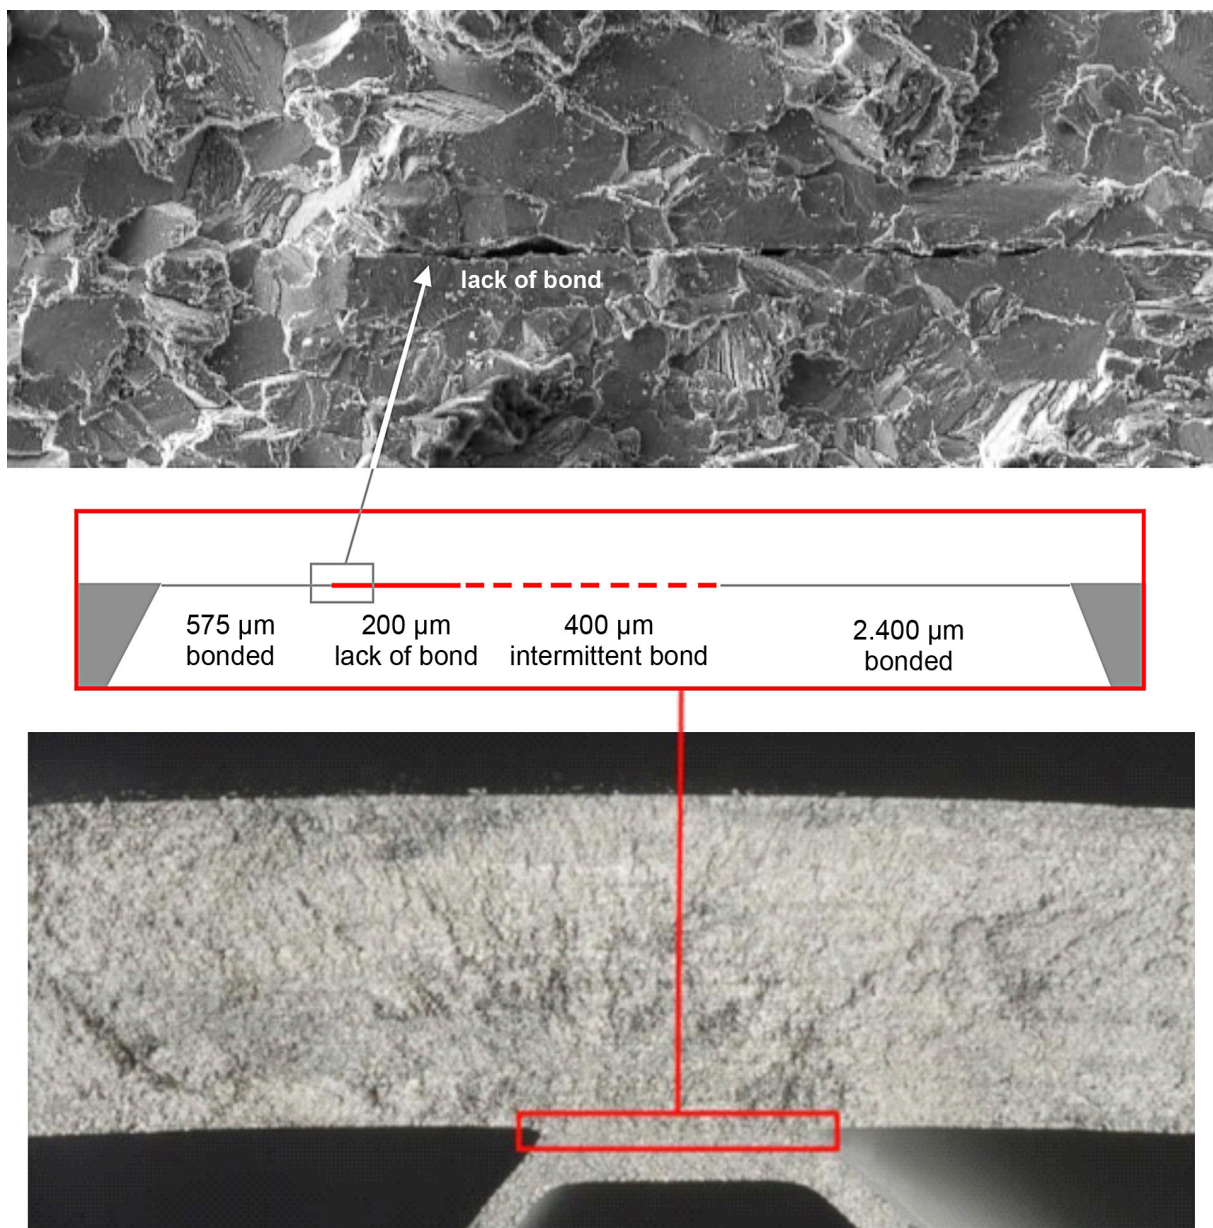
The discontinuity in the material on either side of the gap, which can be seen in figure 8, indicates that the lack of bond had taken place during the manufacturing process, ruling out the possibility that the material had bonded and then separated. There were no abnormalities in adjacent areas and there was no foreign material found in the cracks that would have prevented diffusion bonding.

Figure 8. Fracture surface at bond 5

- The hardness of the material had increased by 12% in a very localized area near the bonding defect (by 200 μm it had disappeared)³⁵.
- A contaminant containing oxygen, nitrogen and carbon (typical of an organic contaminant) had diffused (see note 10). The highest concentration of these elements was evident up to 0.14 μm from the unbonded area. This contaminant had caused a small and localized increase in the hardness adjacent to the lack of bond feature.

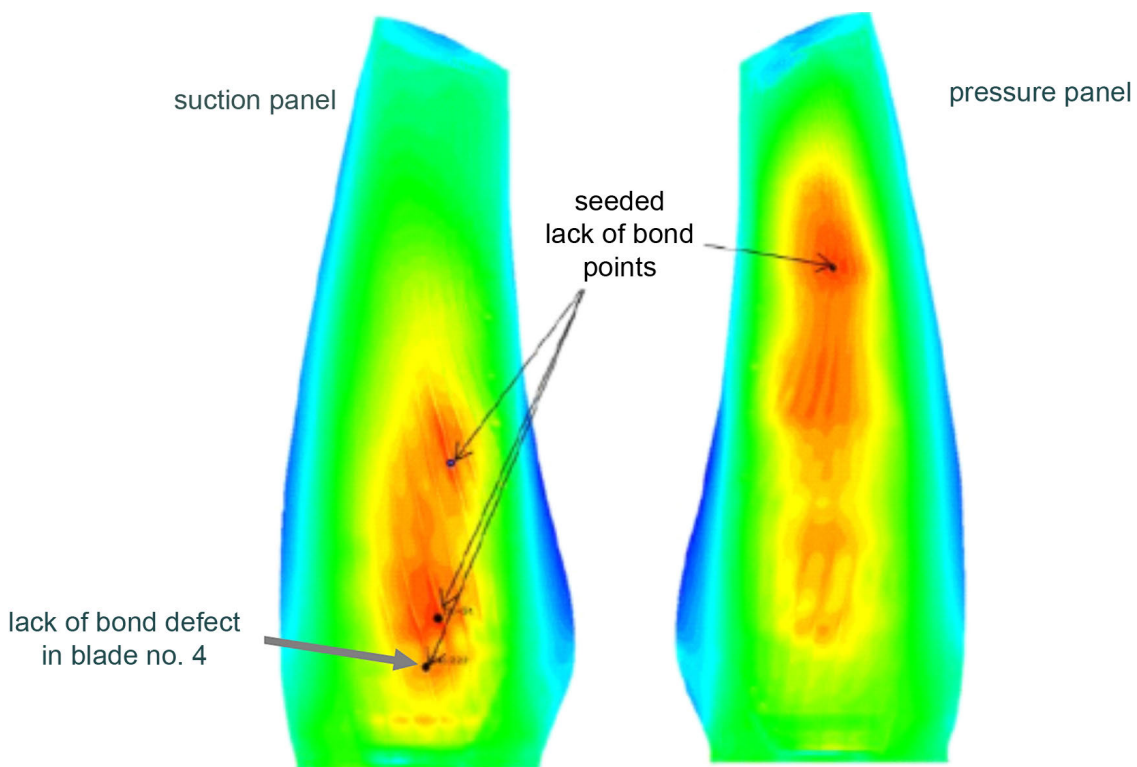
- Two blades were made with circular, 1-mm bonding defects located at the points of maximum stress on the suction and pressure panels (1F, 2F and 1T) and at the point of the defect in blade n.º 4. These blades were tested under HCF conditions. The

Figure 9. Areas where bonding defects were incubated

results showed that no cracks appeared at any of the locations with the seeded lack of bond defects.
