## Technical report S-16/2012

# Investigation of the collision between vessel BESIKTAS PERA and vessel SUPER FAST BALEARES, at the port of Valencia on the 1<sup>st</sup> of September 2011

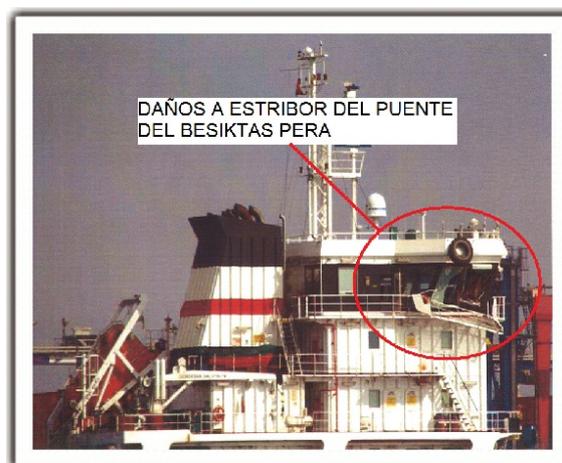
As a consequence of the impact vessel SUPER FAST BALEARES suffered damage to her starboard tack lining above the manoeuvre deck, while vessel BESIKTAS PERA suffered damage to the wheelhouse windows and the wheelhouse deck's starboard side aileron handrails. No contamination or personal injuries occurred.

Figure 2. Damage to BESIKTAS PERA

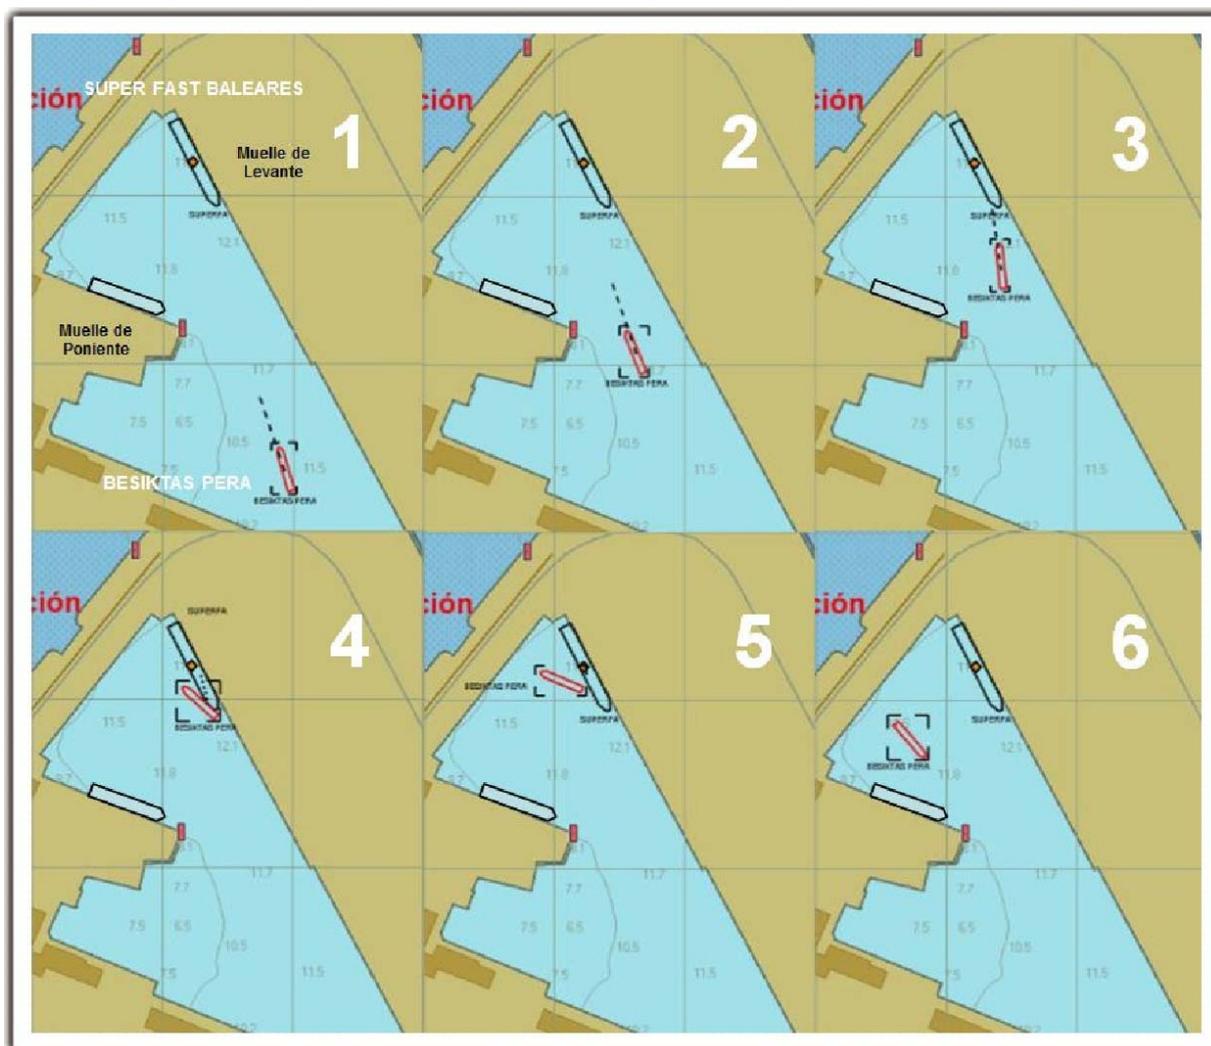
Using the dynamic graphs of the geographic positions transmitted by BESIKTAS PERA's automatic identification system (AIS), which were recorded by Valencia's Rescue Coordination Centre, the course followed by the vessel, which is shown in Figure 5, has been reconstructed.

Figure 5. Reconstruction of the course followed by the vessel

In view of the above, this commission has concluded that the accident was probably caused by planning errors on the part of the Master on board the vessel while carrying out the manoeuvre inside the port yard. An underlying factor was the erroneous estimation of the manoeuvring capacity of the vessel on the Master's part.

1. To tailor the vessel familiarization period for Masters to assume command according to the services that the vessel is going to be providing.
