Technical report IN-005/2022

Incident on 8 February 2022, involving a BOEING B767-332ER aircraft operated by Delta Air Lines, registration N1602, in UIR LECM (Galicia, Spain)

CIVIL AVIATION ACCIDENT AND INCIDENT INVESTIGATION COMMISSION

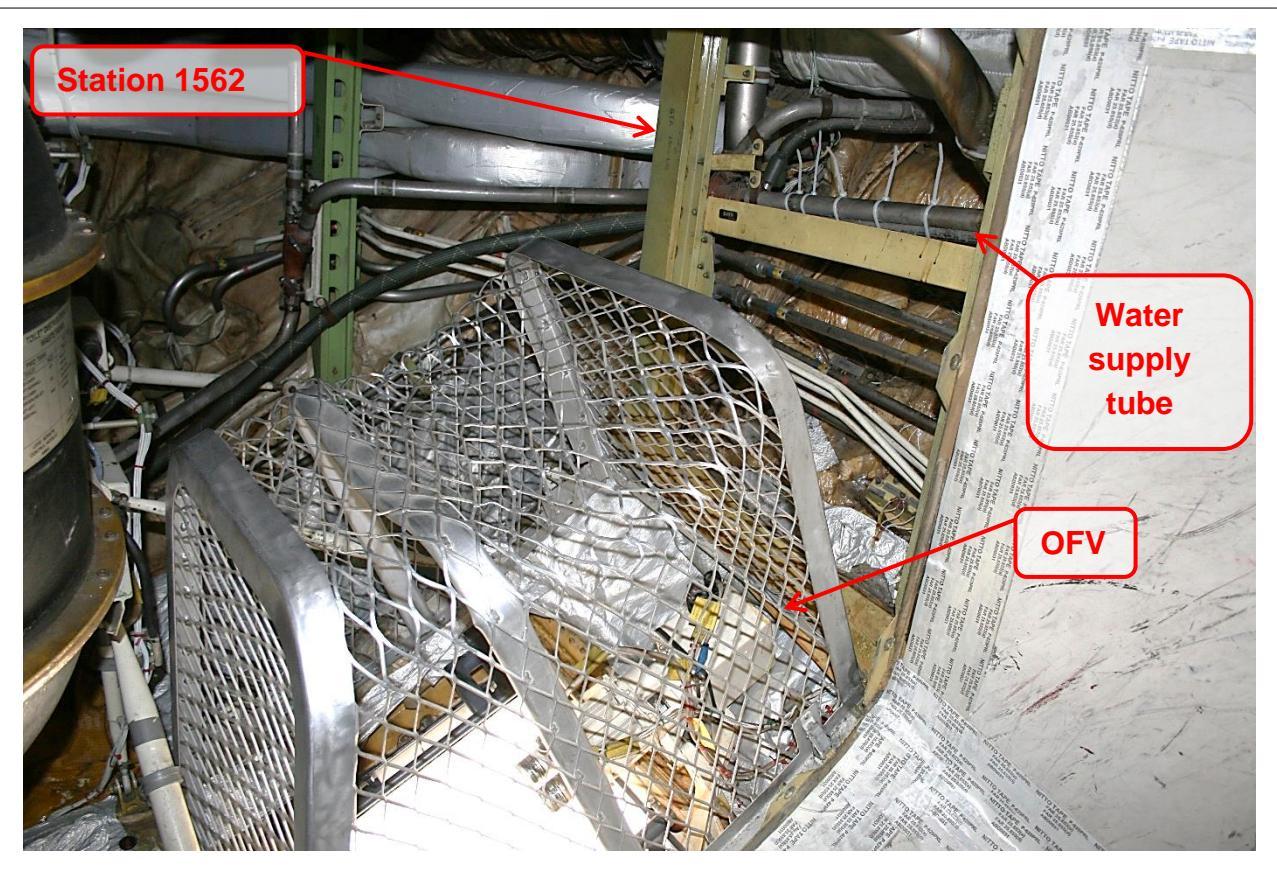
One of the water supply tubes is located near the OFV at station 1562.

FIG. 3 POSITIONS OF THE OFV AND WATER SUPPLY TUBE

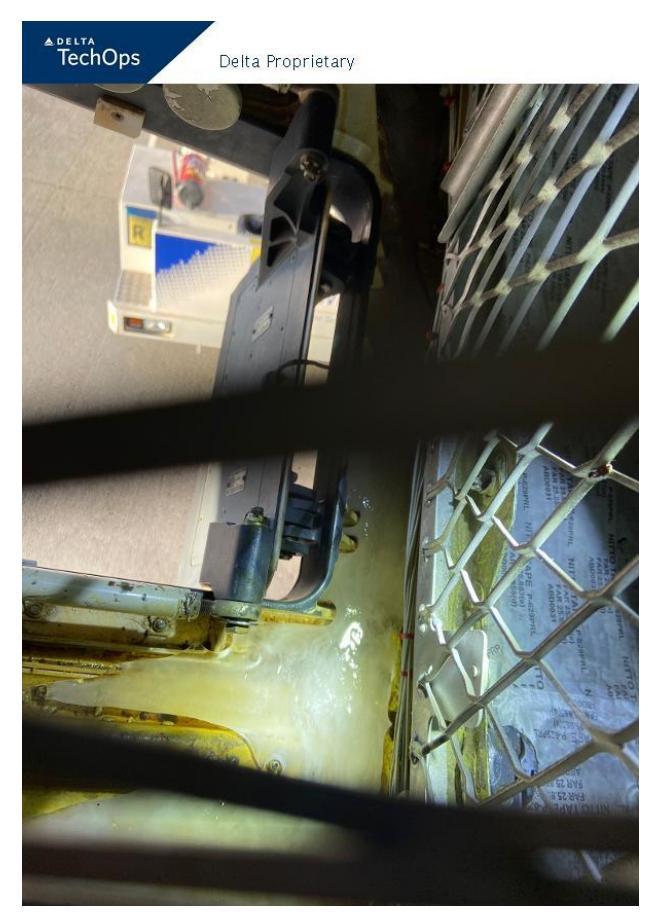
The investigation has revealed that the incident was caused by water leaking from a tube with a broken clamp which, when it froze, blocked the outflow valve doors.

On the day of the incident, when the aircraft arrived in Madrid, the operator's maintenance personnel reported that they had found ice in the OFV.

Fig. 11 Remains of ice in the OFV^{25}

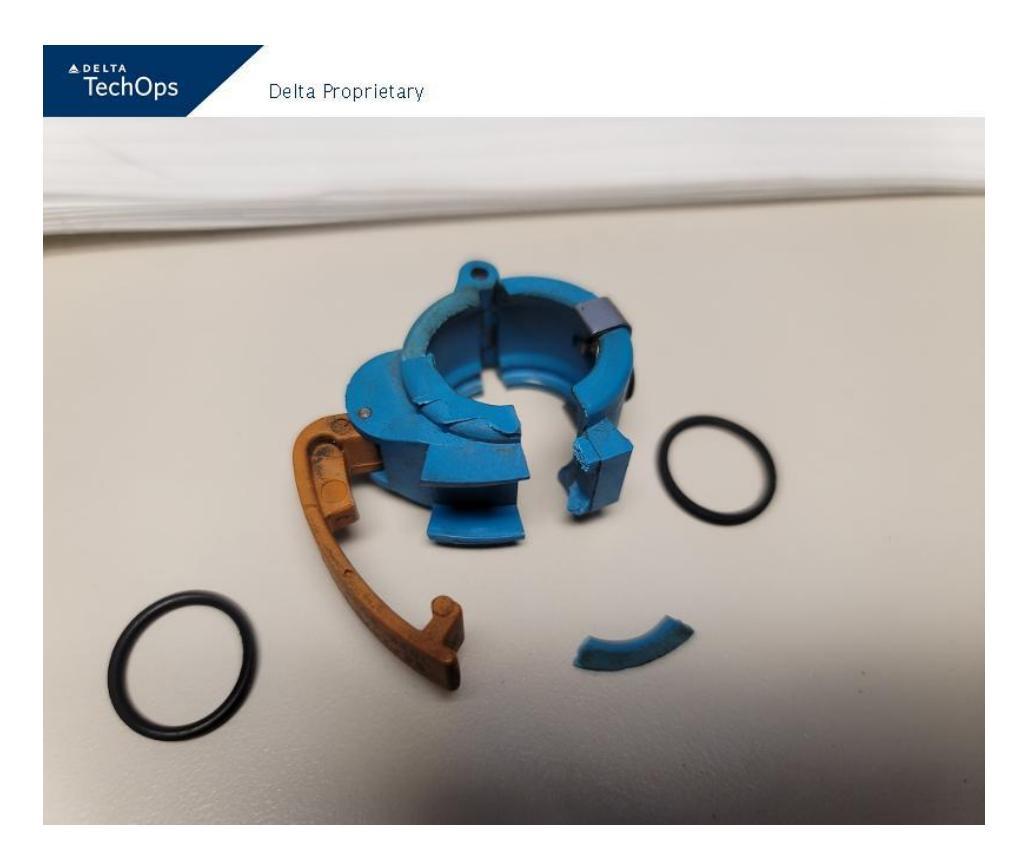
After the flight, maintenance inspected the aircraft and found ice on the outflow valve, a tube near the valve leaking water, and a broken plastic clamp securing the tube.

Subsequently, the operator's maintenance personnel detected a water leak from the tube with PN 79211-012 underneath the rear galley at station 1562, which was secured with a broken plastic clamp with PN CA62507-56BL.

FIG. 12 CLAMP²⁶

Lastly, two recommendations have been issued to the aircraft manufacturer with regard to considering replacing the plastic clamps and evaluating whether to include additional actions in Task 803 of 21-31 of the FIM when the BITE test returns no fault on the ground following a failure of the automatic pressurisation system with the manual control operating normally in flight.

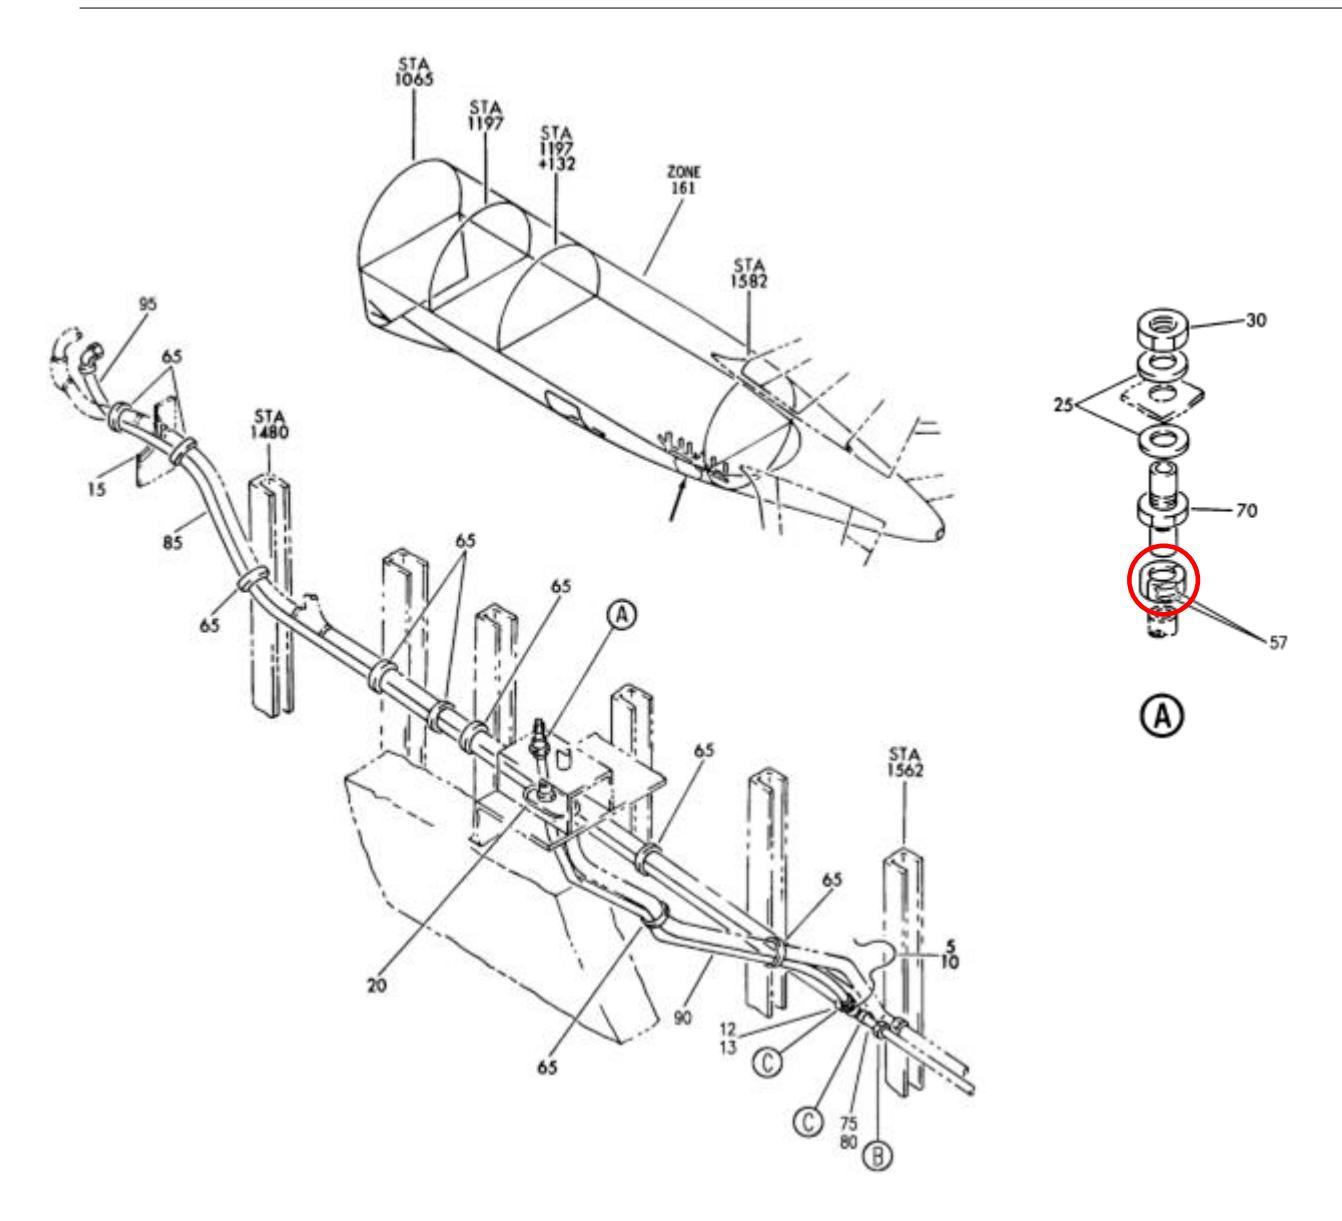
The image in Figure 3 shows the location of the water supply tube. In this area, the water leak was visible, but its exact origin was hidden. The images below show the location of the tube (number 90) and the clamp highlighted in red, with a close-up labelled as A:

FIG. 13 LOCATION OF THE TUBE (NUMBER 90) AND THE CLAMP HIGHLIGHTED IN RED²⁷. IMAGE COPYRIGHT © BOEING. REPRODUCED WITH PERMISSION.

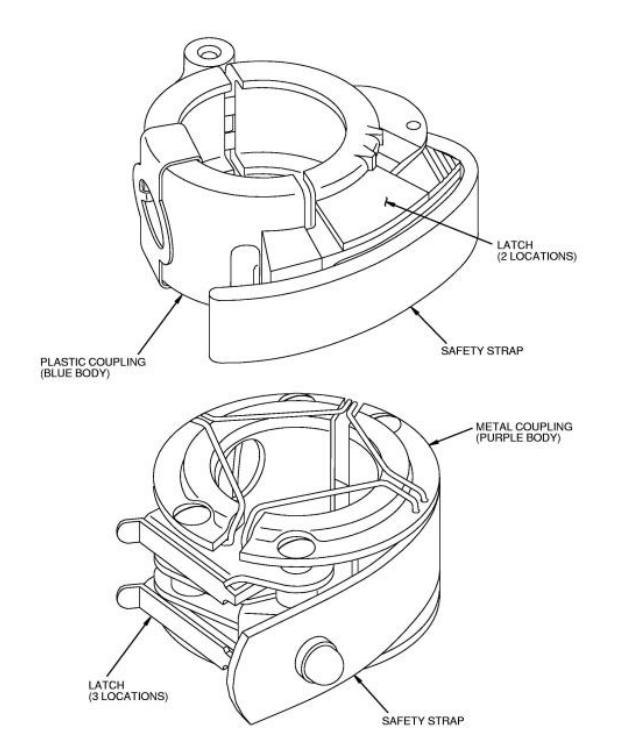
The image below shows the differences between the clamps. The first is the plastic clamp, and the second is the metal one.

FIG. 15 PLASTIC AND METAL CLAMPS USED IN THE WATER SYSTEM³⁰. IMAGE COPYRIGHT © BOEING. REPRODUCED WITH PERMISSION.

The IPC provides one-way interchangeability from the plastic CA625 series to the metal 14C33 series. However, there are no publications explicitly addressing the need to make this change in section 46 (the section in which the OFV is located).

With the incorporation of this bulletin, the blue plastic clamps with PN CA6250()-56BL or PN CA6200()-56BL were replaced by purple metal clamps with PN 14C33-08.

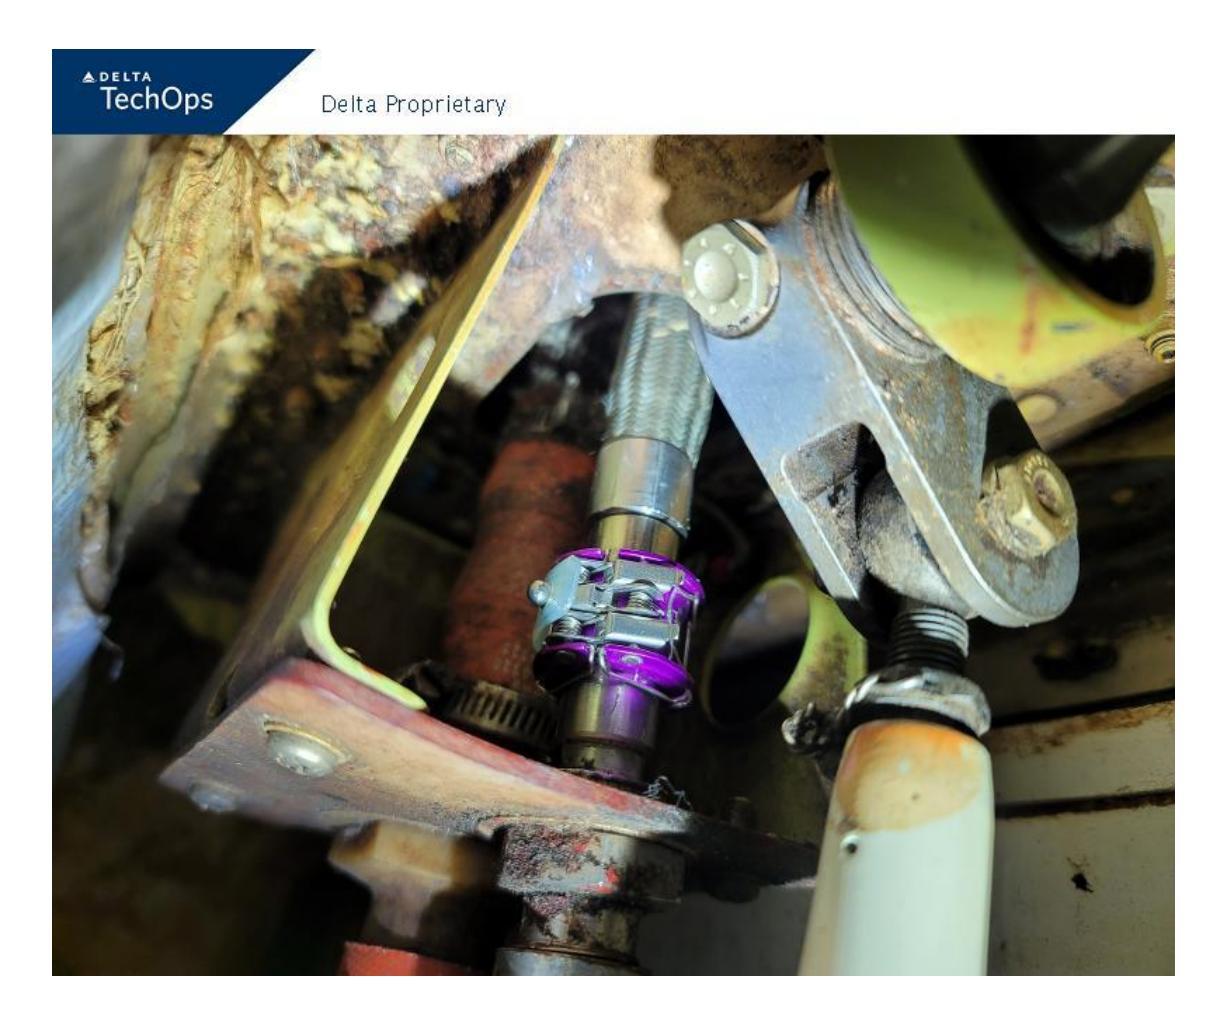
FIG. 6 REPLACEMENT METAL CLAMP.

Additionally, the 767-300 series aircraft with fittings instead of clamps had the drains cleaned and flushed to mitigate the possibility of overflow. Any aircraft that was not in service will have the fleet campaign actions performed prior to return to service.
