Report A-010/2013

Accident involving a Boeing 767-200 aircraft, registration XA-TOJ, operated by Aeromexico, during takeoff from the Madrid-Barajas airport (LEMD, Spain) on 16 April 2013

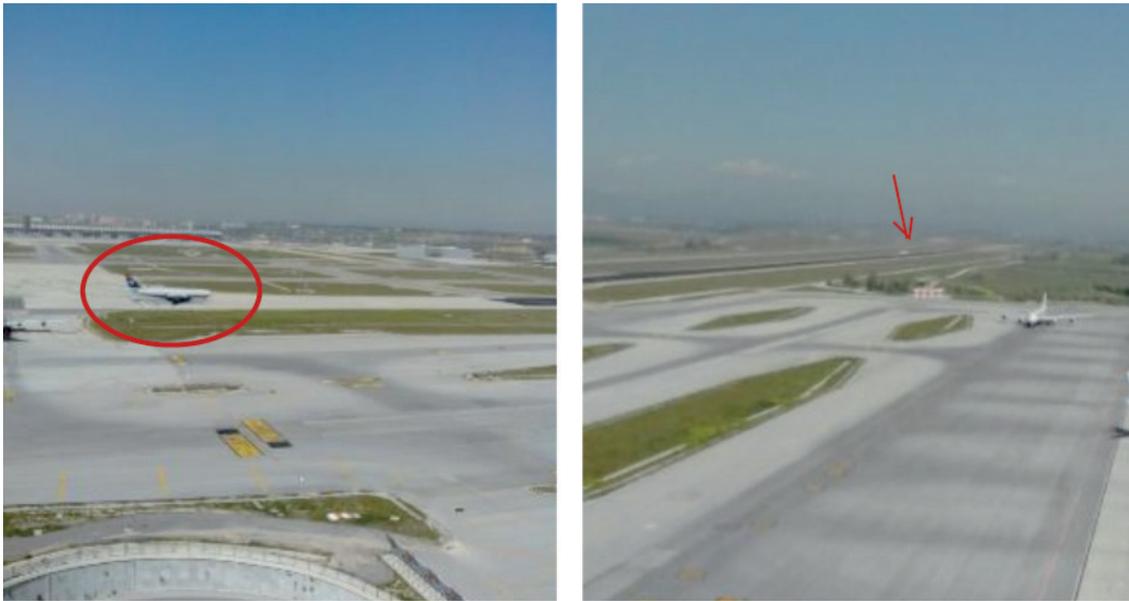
Figure 6. View from the controller's post of an aircraft similar to the Aeromexico B767 at the threshold and while rotating

During the investigation the visibility of an aircraft in a similar position, both at the runway threshold and at the point of rotation (see Figure 6), was checked from the position of the 36 local takeoff controller's position in the tower so as to determine whether the controller could have seen the aircraft scraping the runway.
