# Technical report

## A-032/2019

Accident on the 19th of July 2019,  
involving a Piper PA 28-140 aircraft,  
registration EC-GDC, in Villarrubia de  
Santiago (Toledo)

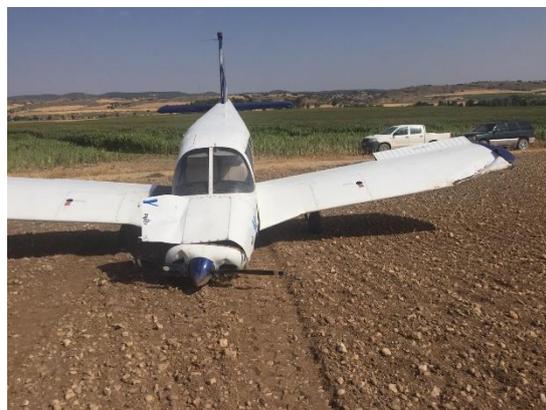
Photograph 4. Aircraft in the field adjacent to the accident site

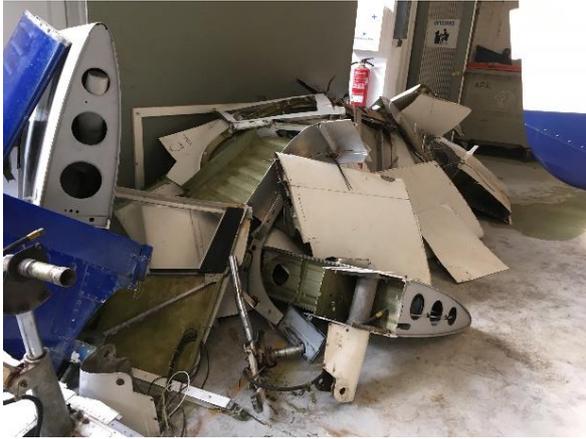
Photograph 8. Aircraft wreckage after its fragmentation

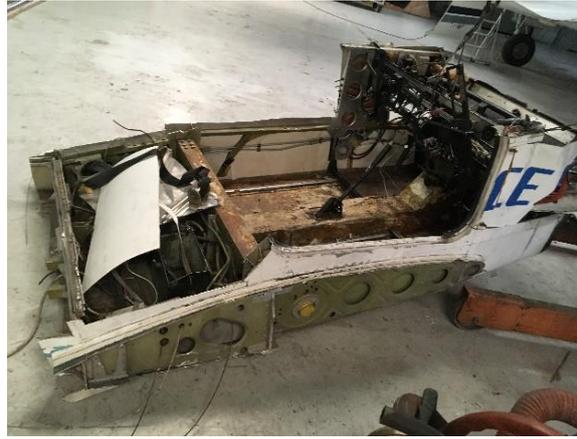
The only remaining part of the cabin was the lower fuselage, without the cover. The indicator panel was missing the instrumentation but did have the power controls.

Photograph 9. Aircraft cabin wreckage

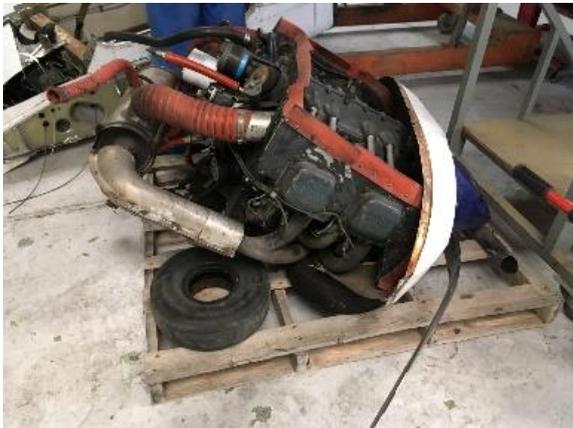
Photograph 10. Engine from the damaged aircraft

The oil lines and fuel hoses were sectioned, no obstructions were observed inside, and no engine stains were observed due to possible leakage. The motor clamps were properly adjusted. The exhaust and intake manifolds were unobstructed and free of carbon deposits. The mixture knob in the cockpit had mobility and was unblocked but wasn't correctly connected to the engine because the connecting cable wasn't crimped, the protective sleeve was loose, and the cable elbowed by an inadequate position maintained, showing permanent deformation.
