**HELLENIC REPUBLIC  
HELLENIC BUREAU FOR MARINE CASUALTIES' INVESTIGATION**

**MARINE CASUALTY SAFETY INVESTIGATION REPORT  
04/2018**

**GROUNDING AND FOUNDERING OF TUG BOAT VIKING**

**January 2021**

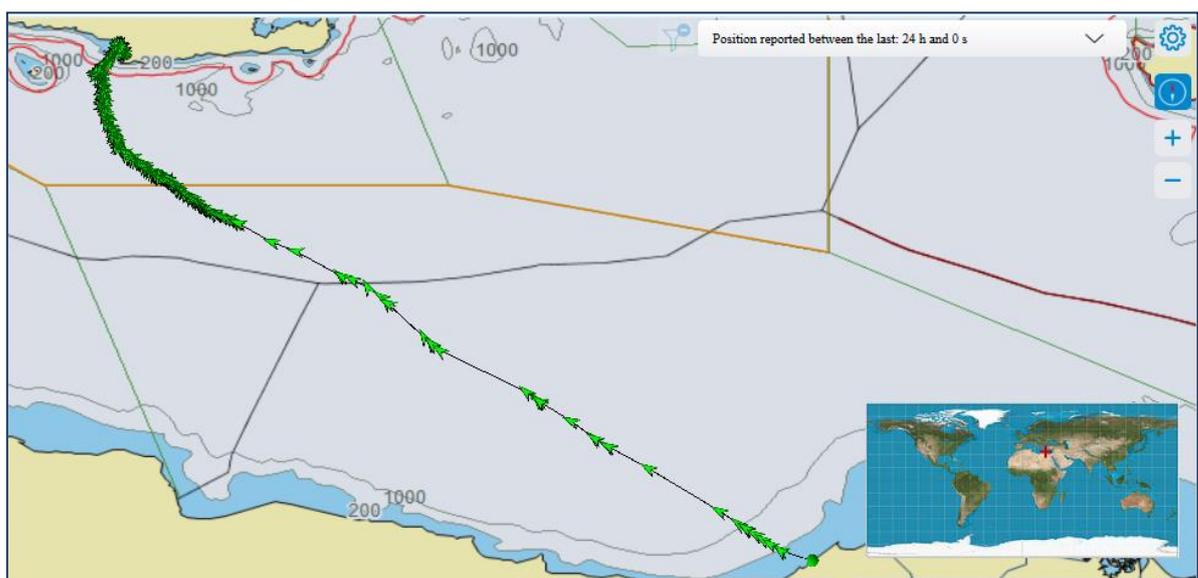
**Figure 3:** The route followed by the convoy of T/B VIKING and towed vessel, from Alexandria (Egypt) to the S of Crete island (Greece) (source: EMSA/IMDatE)

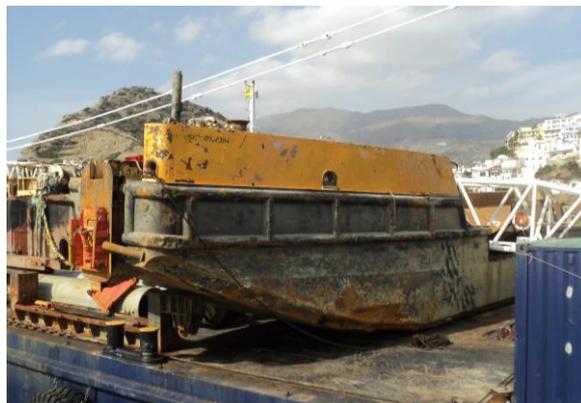
The managing company of NEPTUNE KHAN salvaged the vessel on the 13<sup>th</sup> of February 2019.

**Figure 11:** capture of the NEPTUNE KHAN on the salvage platform
