**DATA SUMMARY**

Date and time	<b>Thursday, 17 January 2013; 17:26 local time</b>
Site	<b>Runway 28 at the Cuatro Vientos Airport (Madrid, Spain)</b>

Registration	<b>EC-ICG</b>
Type and model	<b>PA-60-601P (Aerostar 601P)</b>
Operator	<b>Private</b>

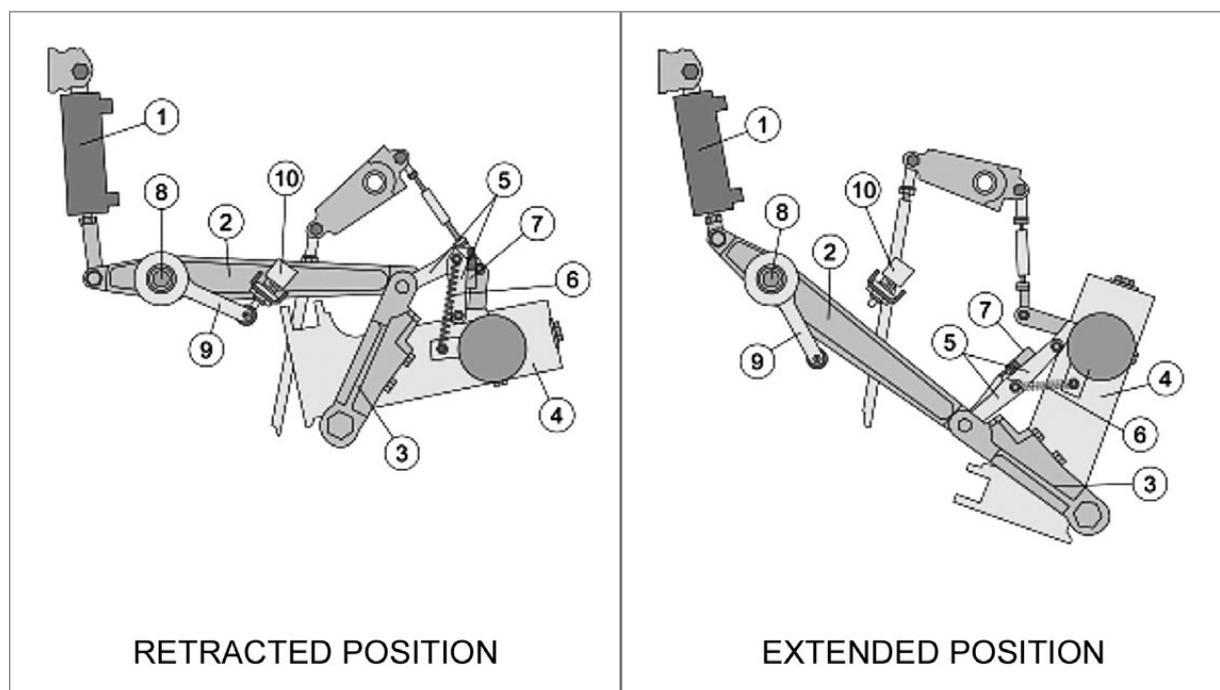
Figure 1. Diagram of the nose gear

The landing gear is hydraulically operated. The nose gear (Figure 1) is retracted by the action of a hydraulic actuator (item 1) which, when it extends, swing the upper drag link (item 2), which in turn drags the lower link (item 3), and with it the leg (item 4). There is no way to lock the gear in the retracted position, meaning that a loss of hydraulic pressure will cause it to drop due to gravity. When the hydraulic pressure is released from the cylinder, the weight of the leg compresses the stem on the actuator and the leg extends. Once this happens, an overcenter (item 5) keeps the two drag links aligned, keeping them from folding and the leg from retracting. A spring (item 6) stretches the overcenter to keep it locked.

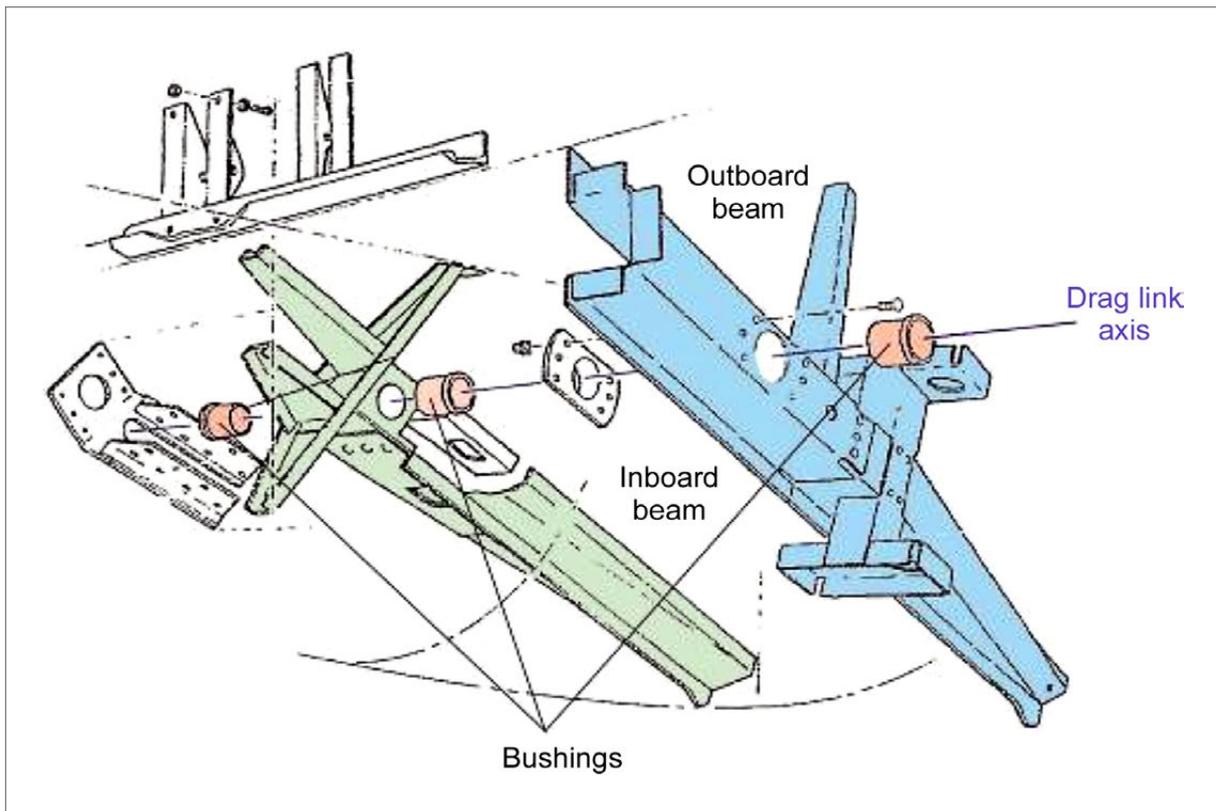
Figure 2. Anchoring beams for the axis of the main drag link

The rotating axis of the upper drag link (item 8) is screwed to the link itself and it rotates inside bushings housed in two U-shaped beams that are fixed on either side of the left landing gear bulkhead by means of rivets (Figure 2). Mounted at the outer end of the axis is a cam (item 9) that, when the gear retracts, makes contact with a micro-switch (item 10) that then sends the gear-up signal.

During the previous annual inspection, in March 2011, a crack was detected on the interior attaching beam for the upper locking link axis on the landing gear. The crack was repaired by riveting a reinforcing plate over the area with the crack. This repair was not performed by following any specific documentation from the manufacturer, which does not have documents for structural repairs, instead referring to an FAA document<sup>3</sup>. Also during this inspection a bushing was replaced on a loose locking bar hinge. Apart from this repair, there are no records of any changes or reinforcements being made to the original structure.

The plate that had been used to reinforce the area where a crack had been detected two years earlier was itself cracked.
