Technical report

A-011/2021

Accident occurring on 19 April 2021 involving the DIAMOND DA20-C1 aircraft, registration EC-LAO, at Sant Jaume dels Domenys (Tarragona)

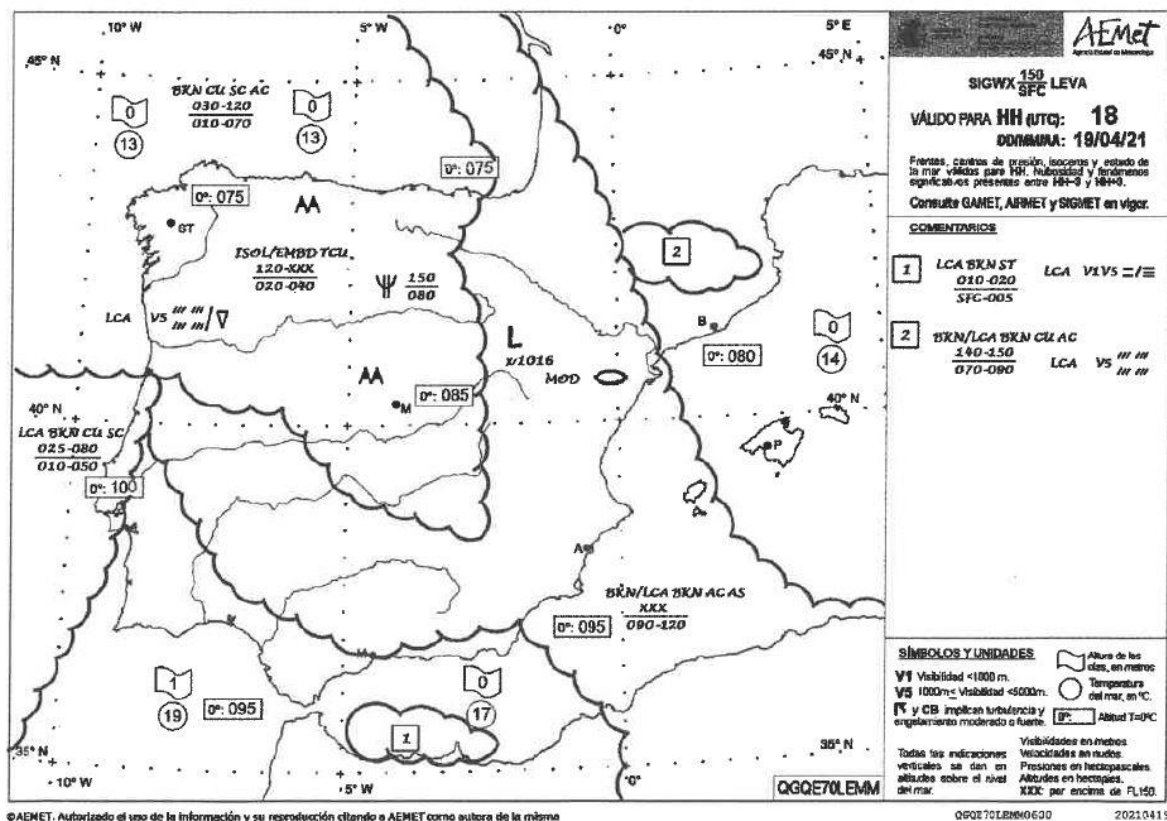
The significant weather chart for 18:00, which was valid from 15:00 to 21:00 UTC, forecast no significant weather phenomena in the area in which the flight was to take place.

Figure 2. Low-level significant weather chart valid for 18:00 UTC on 19 April 2021

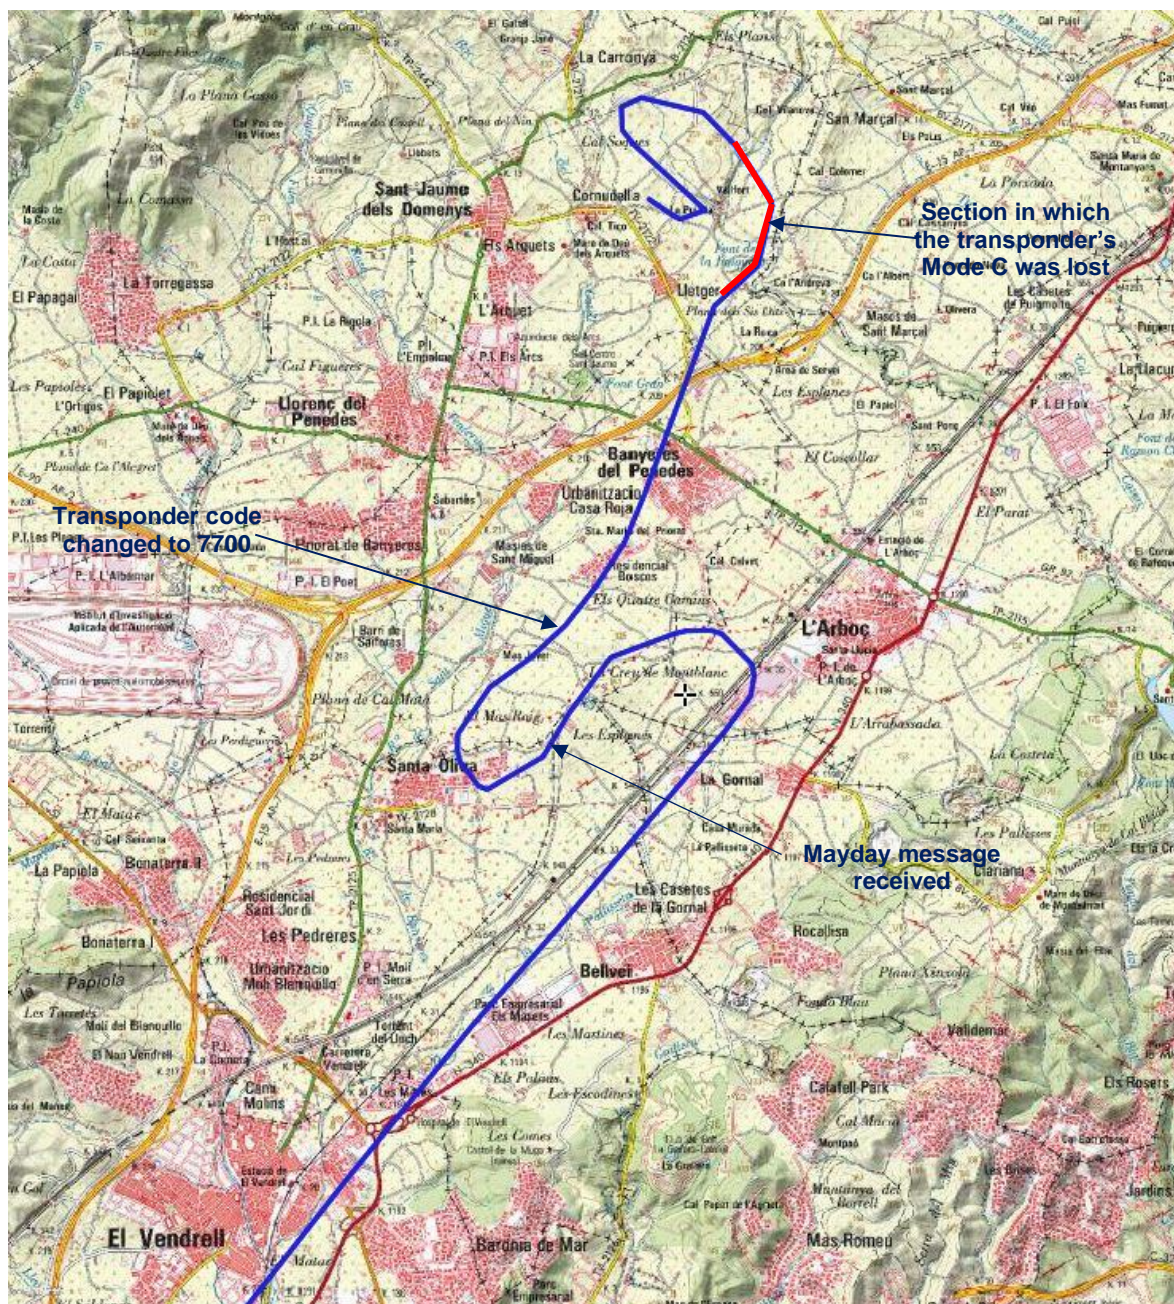
Moreover, the data also shows that at 17:38:02, when the aircraft was at 1,300 ft, the transponder's Mode C was lost. The signal was recovered some 45 s later, when the aircraft was at 1,100 ft.

Figure 3. Radar trace of the final part of the flight, superimposed onto a topographical map

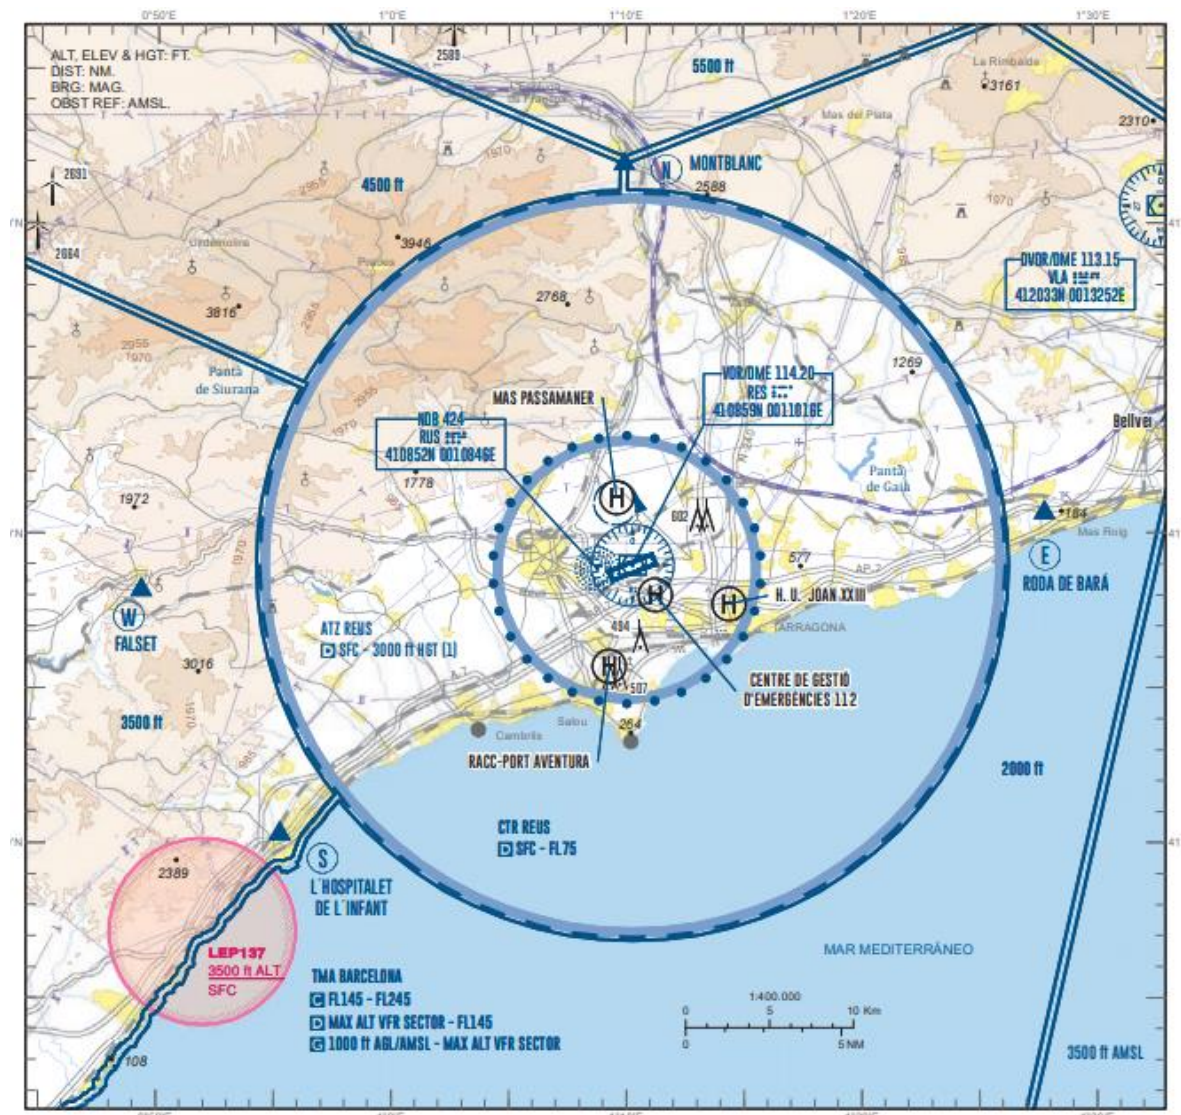
Figure 4. Extract from the visual approach chart / VAC – ICAO for Reus Airport, published in the AIP for Spain

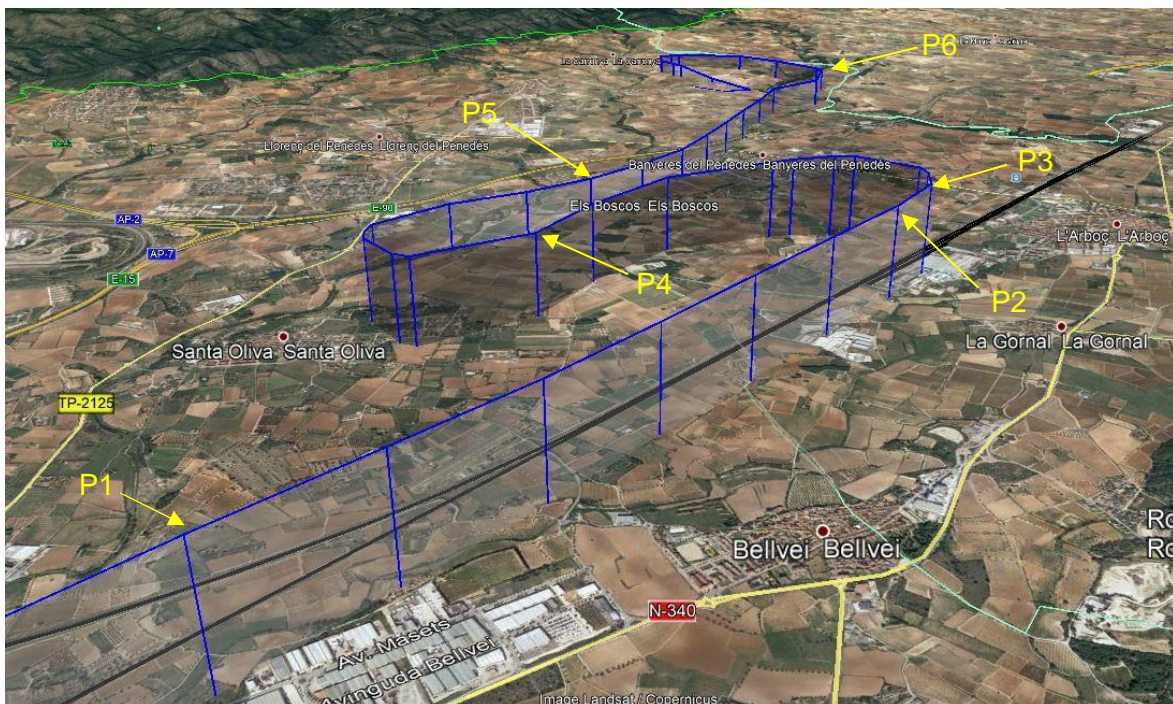
Figure 5. Image of the final part of the aircraft's trajectory, obtained using the data from the “Safesky” app

At the start of this period (marked P1 in Figure 5), the aircraft was around 2 km north-east of the town of El Vendrell, flying on a heading of 041° at an altitude of 1,847 ft and with a ground speed of 209 km/h.

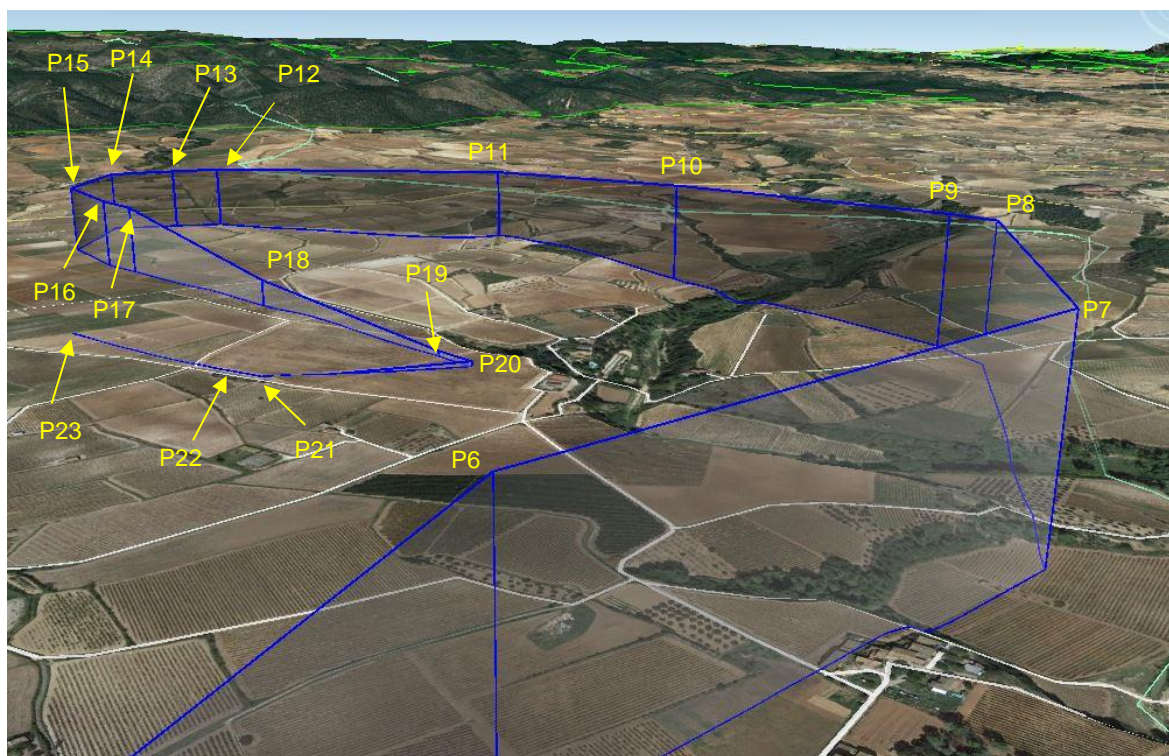
Figure 6. Image of the final part of the aircraft's trajectory, obtained using the data from the "Safesky" app

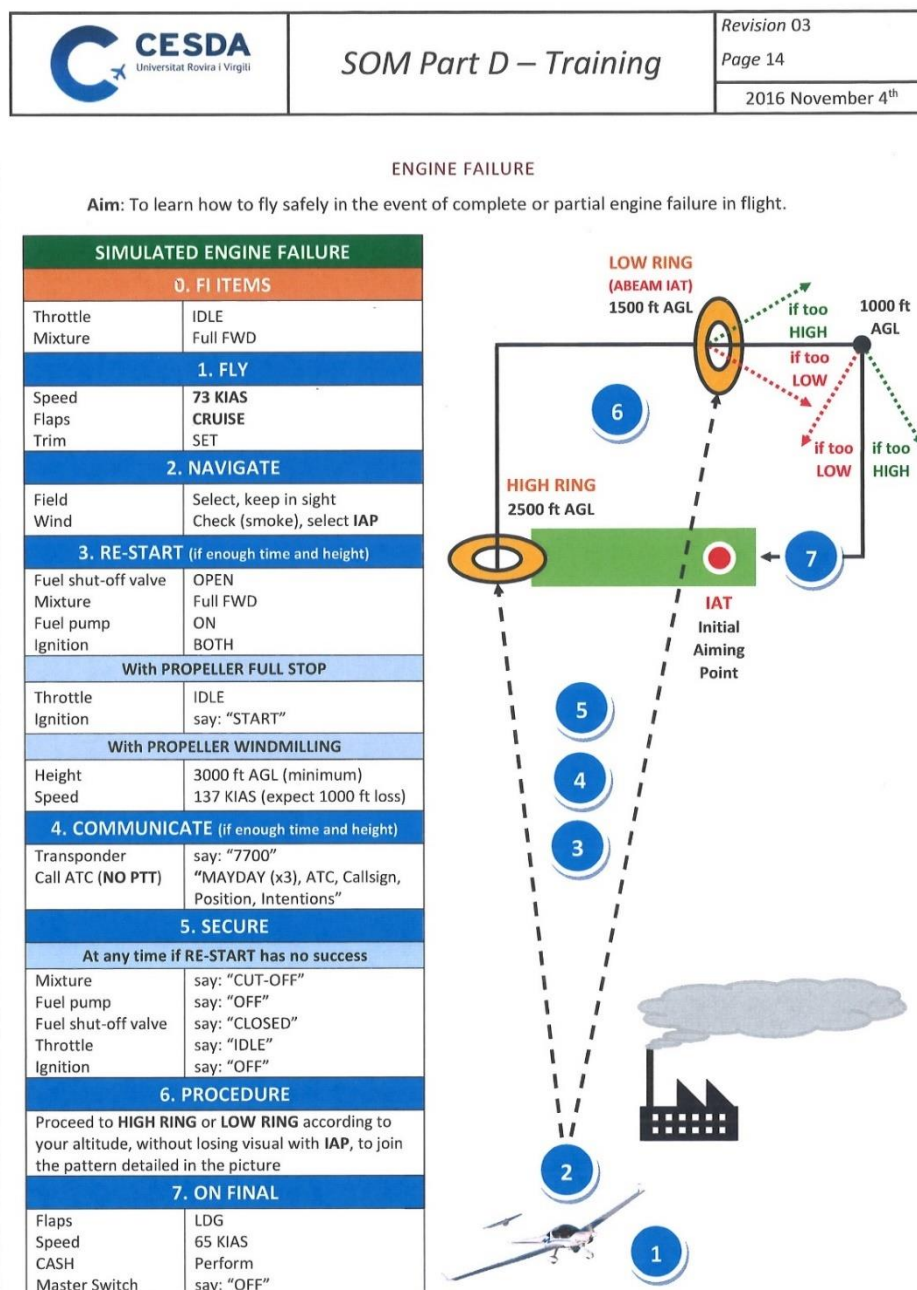
Figure 10. Procedure for teaching and practice on how to deal with an engine failure during flight, with specific regard to the Diamond DA20-C1 aircraft

The procedure addresses the majority of likely scenarios: complete or partial lack of power, propeller windmilling or stopped, etc. It also specifies the actions to take in each instance to restore normal operation. Additionally, it provides instructions for performing a forced landing if the attempts to restart the engine are unsuccessful.
